Technical Service Bulletin

87 Air conditioning does not blow cold

87 16 73 2042340/2 June 28, 2016. Supersedes Technical Service Bulletin Group 87 number 15-72 dated October 29, 2015 for reasons listed below.

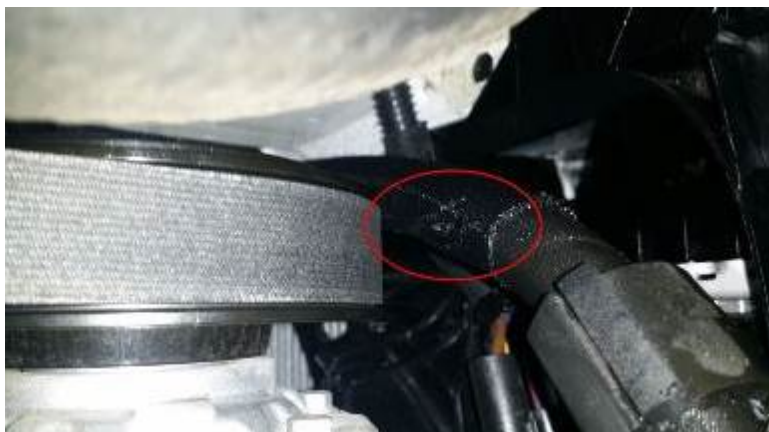
The technical diagnosis reveals that there is no refrigerant in the circuit. The refrigerant hose that connects the suction side of the compressor to the condenser is found to be damaged, as the rubber portion of the hose is making contact with the compressor pulley (Figure 1 and Figure 2).

A production issue with the assembly gauge used during assembly of the hose was found. This issue caused the hose to be assembled with an incorrect geometry. As a result, the lie intended to keep the hose away from the air conditioning compressor pulley was compromised.

Figure 1. Point of hose contact with air conditioning compressor pulley.

Replace the damaged refrigerant hose and ensure that the natural lie of the hose is away from the air conditioning compressor pulley. Evacuate and recharge the refrigerant circuit and replace any lost PAG oil that may have been discharged from the system. Failure to maintain the correct total amount of PAG oil in the circuit will lead to premature air conditioning compressor failure.

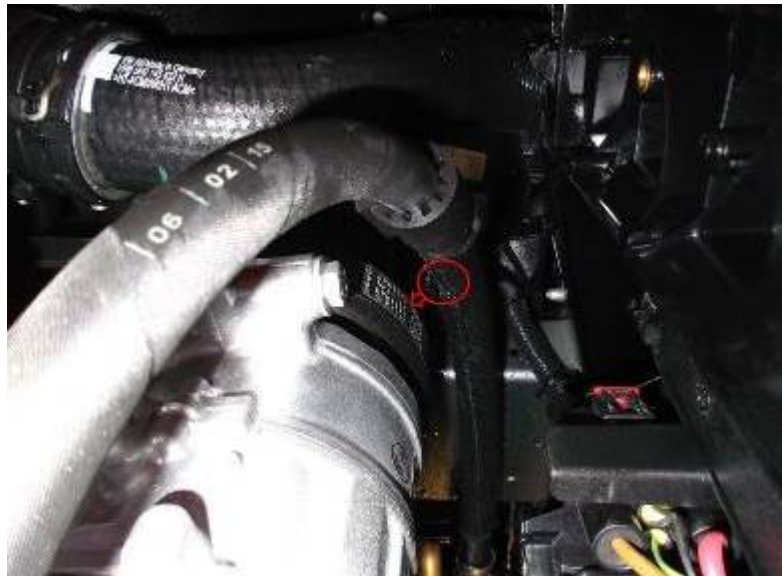
Figure 2. Point of hose contact with air conditioning compressor pulley – rear view.
