Technical Service Bulletin

91 MMI 3G+ MMI inop; blank screen at startup; various technical issues (K0942 ZUG update; supersedes K0814 update)

91 16 47 2030465/8 June 23, 2016. Supersedes Technical Service Bulletin Group 91 number 15-83 dated May 8, 2015 for reasons listed below.

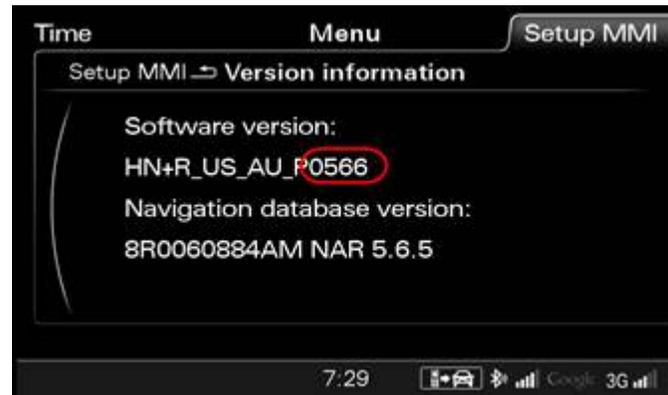
Tip: The MMI software version can be found under *Menu >> Setup MMI >> Version Information*. The software version will show the 4-digit software version number with a “P” or “K” prefix (“P” for Production and “K” for Service”) (Figure 1).

Figure 1. Example showing MMI software version (0566).

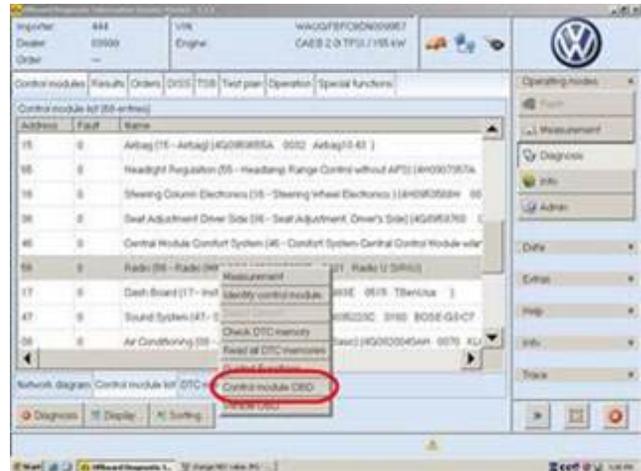
Figure 2. Radio self-diagnosis.

1. Verify the HD radio is enabled in the MMI by navigating to *Radio >> Settings*.
 - If the HD radio options are present in the MMI menu, proceed directly to Step 6.
 - If the HD radio options are not present in the MMI menu, continue with Step 2.
2. Using ODIS, right-click on *56 – Radio* in the Control module list, and select *Control Module OBD* (Figure 2).

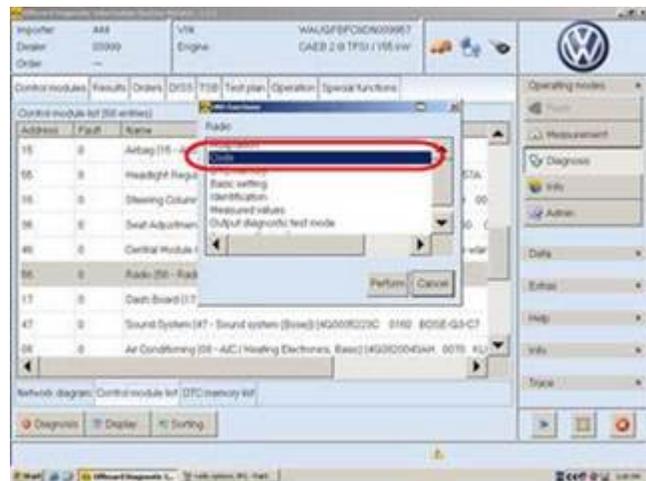
Figure 3. Code radio option.

3. Select *Code* (Figure 3).

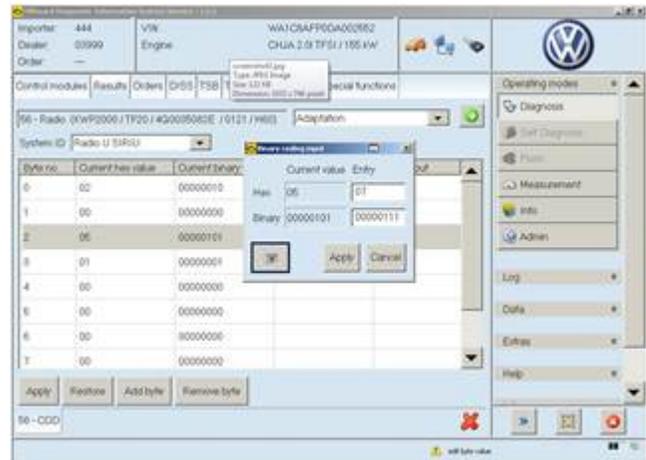
Figure 4. Changed radio coding.

4. Verify the coding in byte 2 is HEX 07.
 - If it is not HEX 07, change the coding to HEX 07. Apply changes (Figure 4).

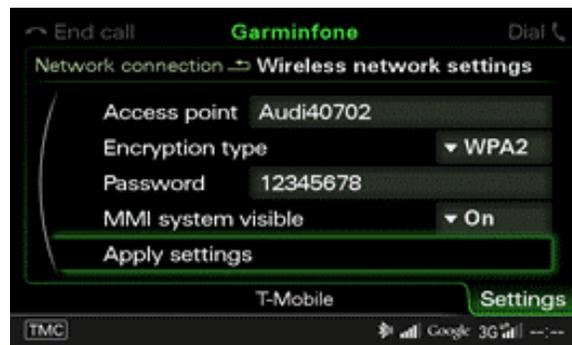
Figure 5. Wireless network settings.

5. If the coding had to be changed, perform a 3-finger reset on the MMI system. When the coding is successful, the HD radio options will show in the Band settings on the MMI.
6. As part of the update, wireless settings and paired devices will be deleted. All devices will need to be re-paired after the update, and all wireless settings restored to the customer's settings. To access the Wireless network settings on the MMI (Figure 5), press *TEL >> Settings >> Wireless network connection >> Wireless network settings*. Record all settings so they can be re-entered at the end of the update.

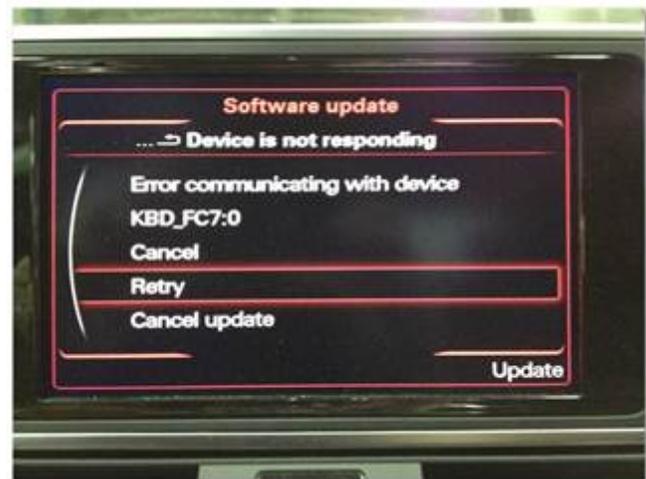
Figure 6. A device requiring a 'Cancel' selection.

Some earlier model year 2012 vehicles, or vehicles equipped with Bose® sound systems may experience certain modules that will not update properly during Step 16 of TSB 2028141. If this should occur, either choose 'Cancel' (Figure 6), or 'Skip device' (Figure 7), depending on the type of error. Do *not* choose 'Cancel update', as this may cause the software update to fail entirely. After the update is finished and the summary page is shown, select 'Retry' at the bottom of the list if it is available to attempt to update the modules again. If 'Retry' is greyed out, then the software update was successful. Select 'Continue' to proceed. In some cases 'Retry' may have to be repeated two or three times to get all modules to update successfully.

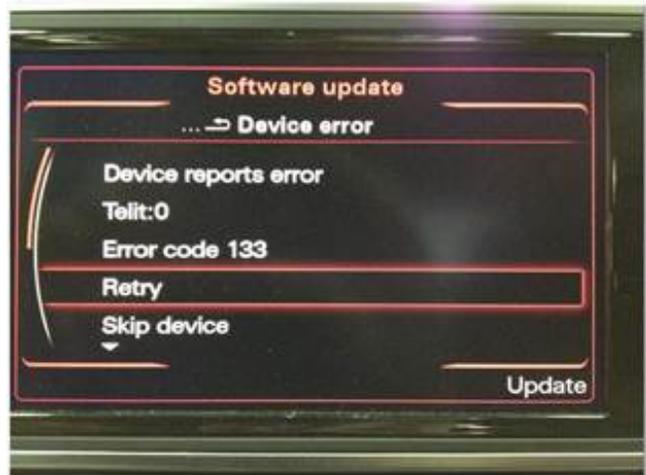
Figure 7. A device requiring a 'Skip device' selection.

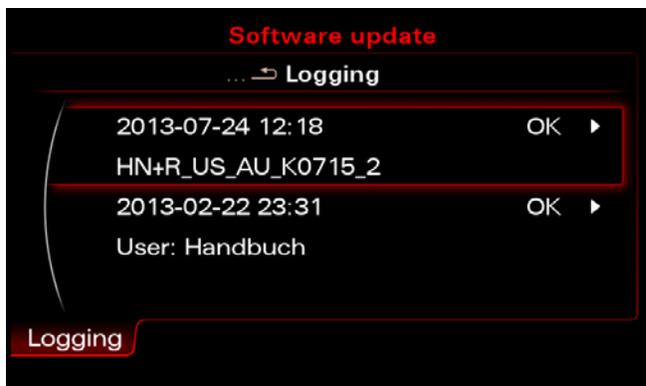
Figure 8. Software update log showing a successful software installation.

- Verify that the software update has been completed successfully by accessing the logging page (Figure 8). To access this screen, proceed to step 8 in TSB 2028141 and press the lower left softkey. A successful update will show the date the update was performed and the software that was installed (HN+R_US_AU_K0715_X), with 'OK' listed on the right (example 0715 installation). The 'X' may be one of several different numbers. If K0715_X does not have any rows with 'OK', the update must be retried until it is successful. For the latest P0942 update, this line would show K0942_X.

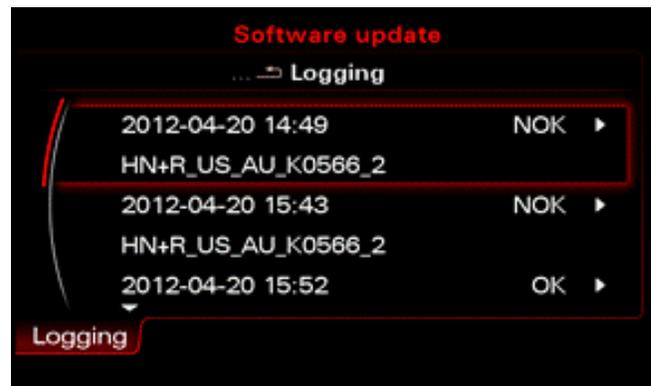
Figure 9. Software update log showing 2 failed attempts before a successful installation.

Tip: If the update must be performed two or more times due to modules not updating correctly, a screenshot of the software update log is required (Figure 9). This should be kept on-hand for warranty auditing purposes. To take a screenshot, insert an SD Card into slot 1. For A6/A7/A8/Q7, press and hold the left and right arrow keys at the same time. For A4/A5/Q5, press and hold the bottom two softkeys at the same time. All 4 softkeys will flash when the screenshot is taken. A screenshot should be taken of each page in the logging display.
