Technical Service Bulletin

91 Rearview camera intermittently inoperative (DTC 2203)

91 16 48 2041430/3 June 23, 2016. Supersedes Technical Service Bulletin Group 91 number 15-19 dated October 15, 2015 for reasons listed below.

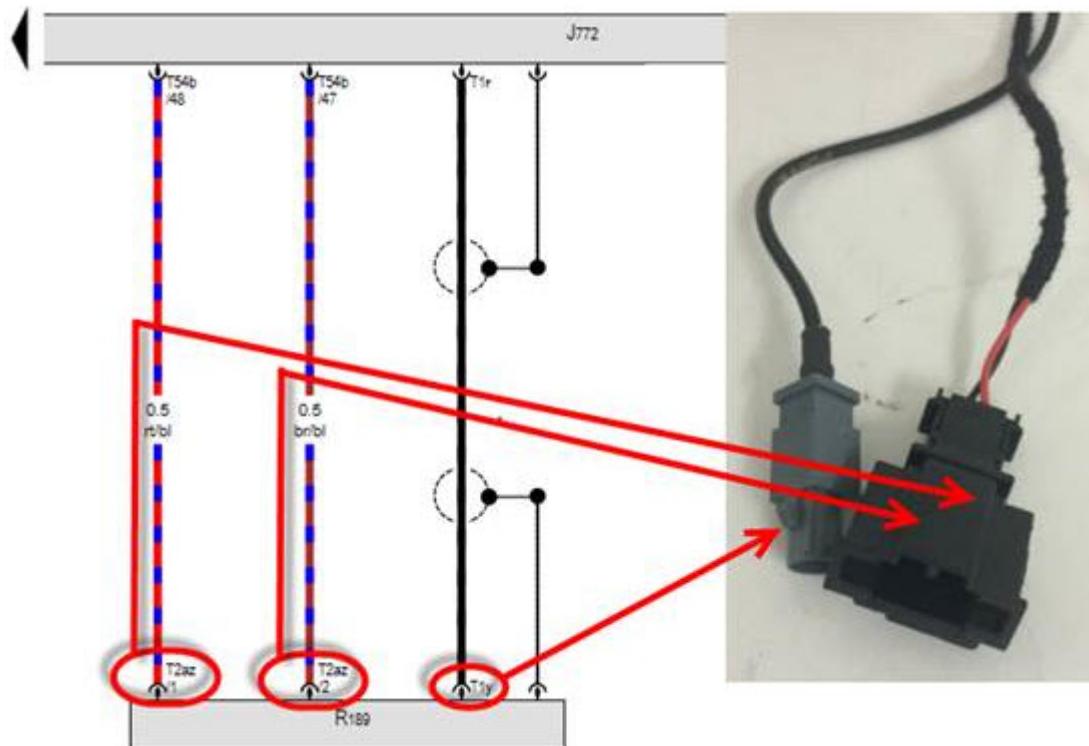
Figure 1. Check the wiring of the R189 reverse camera at connector T2az and T1y.

1. Before proceeding, confirm that the DTC and one of the fault symptoms listed in the *Condition* are logged in the rearview camera system control module, J772 (address word 6C). If the DTC is not listed with one of the fault symptoms, this bulletin does not apply.
2. Check the wiring of the R189 reverse camera at connector T2az and T1y (Figure 1). Repair any loose connectors or pins, corrosion, or any other physical damage.

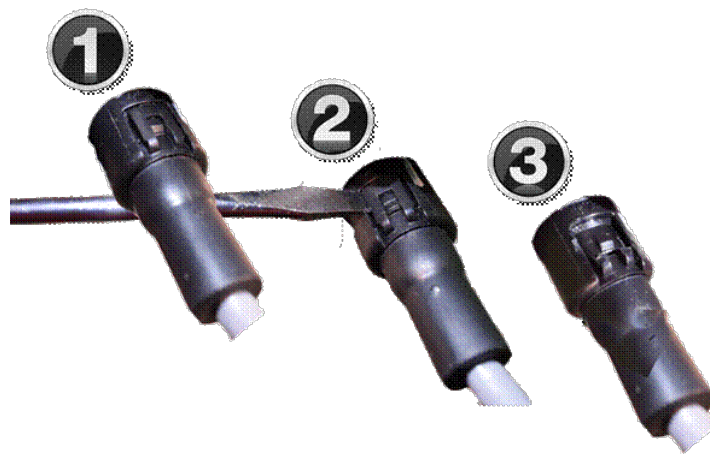
Figure 3. Locate locking tab (1), lift up on tab with screwdriver (2), snap tab off (3).

4. Remove the original harness from the reverse camera (Figure 3):

- First, locate the locking tab on the reverse camera harness.
- Next, using a small flat head screw driver, lift up on the locking tab.
- Finally, snap the old locking tab off the defective harness to prevent reuse.

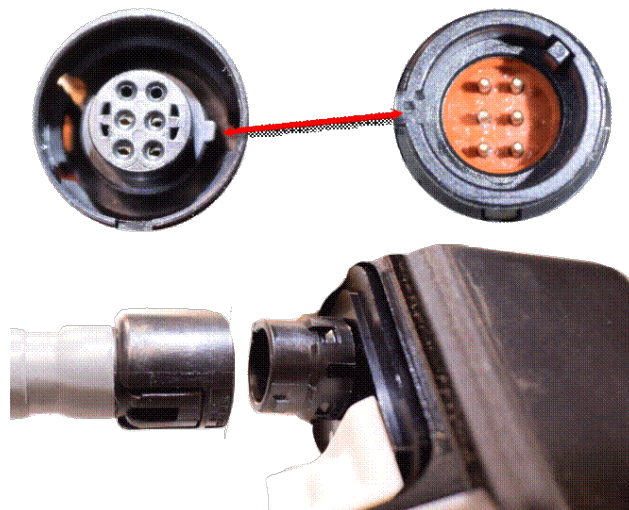
Figure 4. When installing the new reverse camera harness onto the camera assembly, ensure that the connectors are correctly aligned.

5. Carefully install the new reverse camera harness onto the camera assembly, as the harness can only be installed one way. The connector is keyed on both the camera and the electrical harness to prevent incorrect installation. Ensure they are correctly aligned during installation (Figure 4).
