TECHNICAL BULLETIN
K407 UPS4816-6bNAS1
14 JUL 2016

Update Prior to Sale: AWD V6 Petrol S/C Cross Brace Foul

XE (X760)

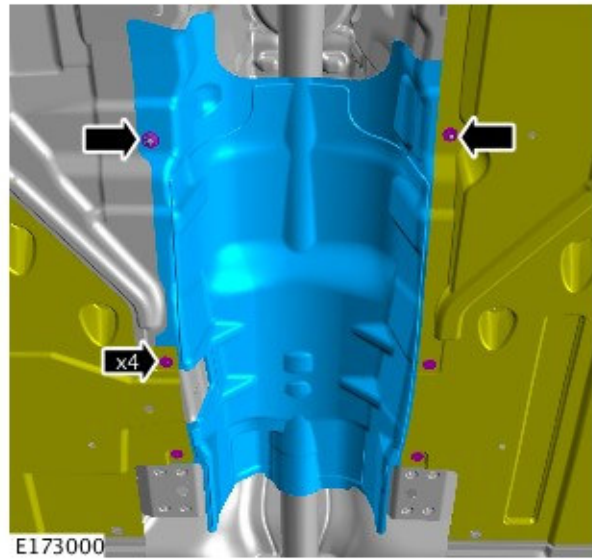
1. Remove the exhaust system front silencer (see TOPIX Workshop Manual section 309-00C: Exhaust System).
2. Remove the heat shield.

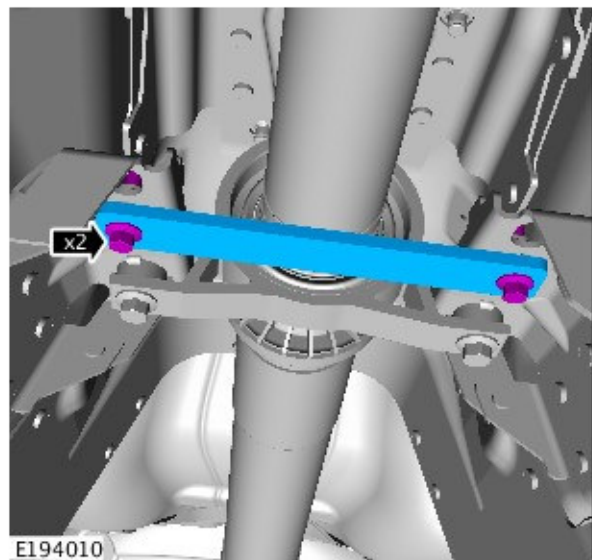
3. Remove the cross brace and fixings.

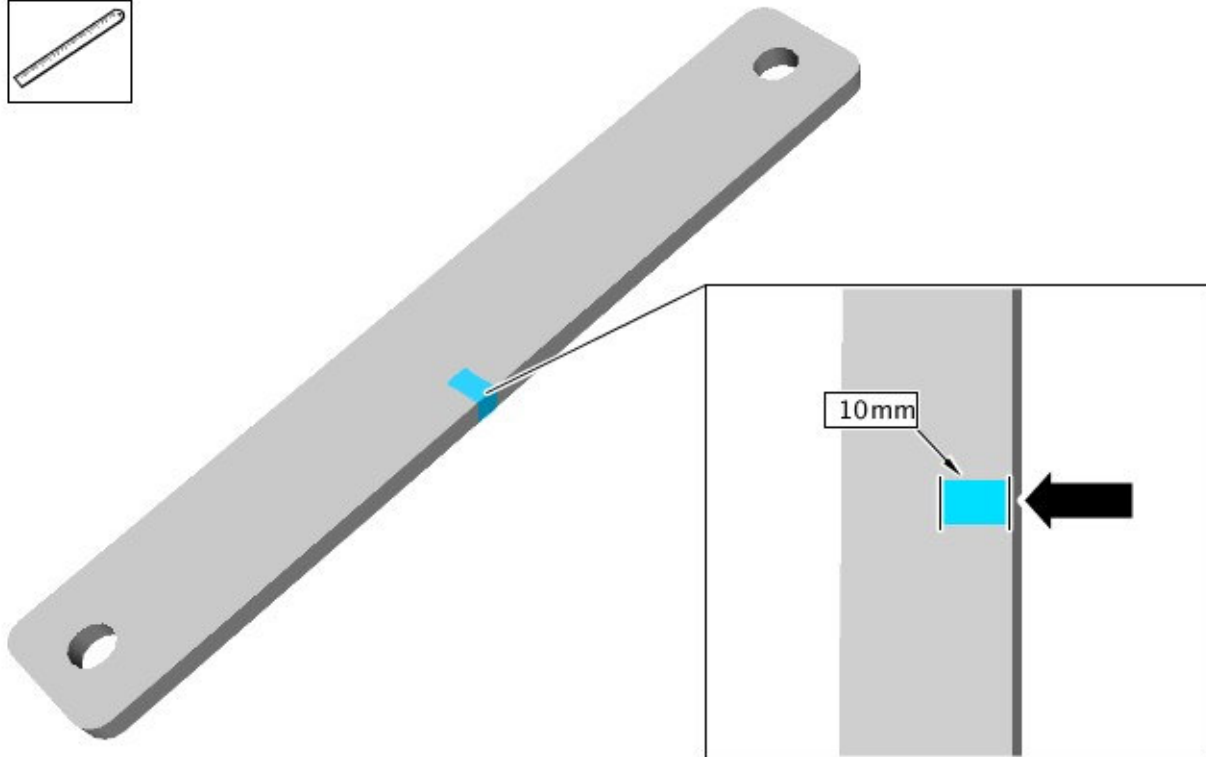
E194840

**NOTE: If the contact damaged length is more than 10mm, submit an Electronic Product Quality Report (EPQR), including a picture of the cross brace damage.**

Inspect the cross brace contact damaged length.

- If the contact damaged length is less than 10mm, discard the cross brace, clean the damaged area on the driveshaft, and paint with Rust-Oleum High Heat Black (248903).
 - Continue to Step 6.
- If the contact damaged length is more than 10mm, discard the cross brace, install a new driveshaft (see TOPIx Workshop Manual section 205-01: Driveshaft), and release the vehicle.
 - Submit an Electronic Product Quality Report (EPQR), including a picture of the cross brace damage.

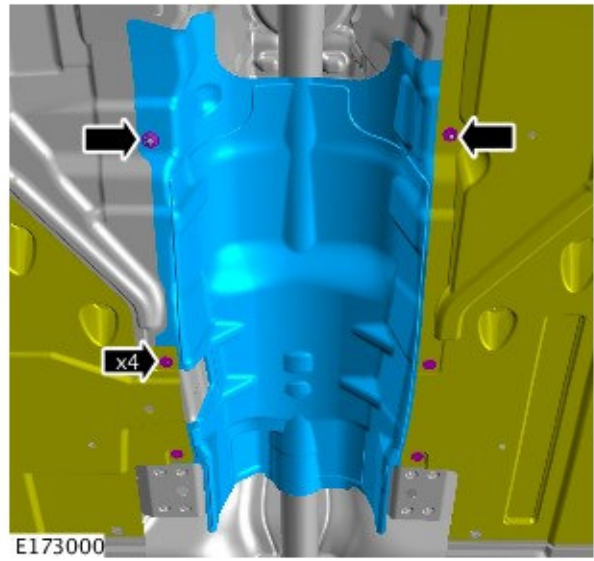
6. Install the heat shield.

- Torque: **9Nm**
