| Reference | SSM72808 |
| Models | XE / X760 |
| Title | Diagnosis – XE Scraping/clicking noise when accelerating or cornering |

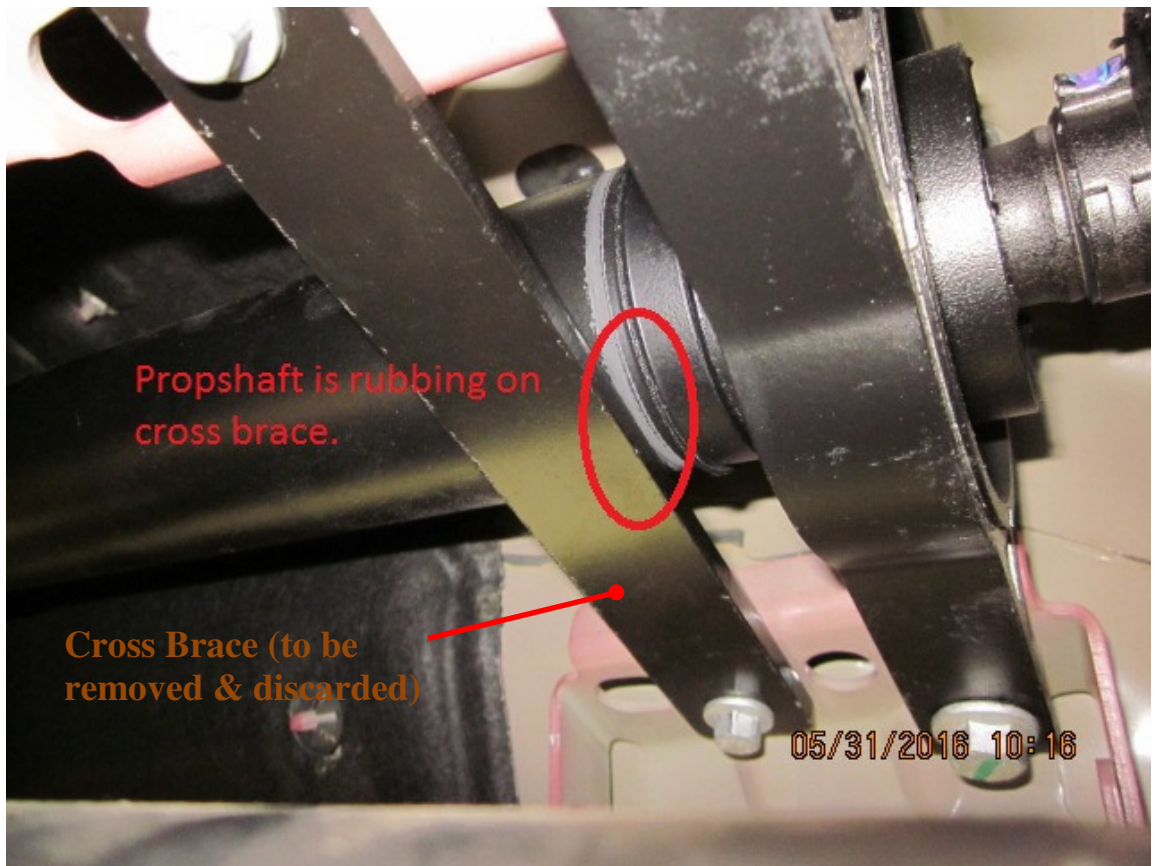
Contact between the underbody cross brace and the driveshaft.

Propshaft is rubbing on cross brace.

Cross Brace (to be removed & discarded)

- Place the vehicle on a suitable ramp
- Remove the exhaust centre section.
- Remove the heat shield covering the driveshaft centre baring.
- Check a cross brace (as shown in the attachment) is fitted and if so remove and discard.
- Inspect the driveshaft for contact damage this may require replacement if damage is evident.
