Campaign – Hinge Fastener Replacement

MODIFICATION INSTRUCTION

Bulletin No. 2016-1

2014, 2015 EBB-40, EBB-60 trailers

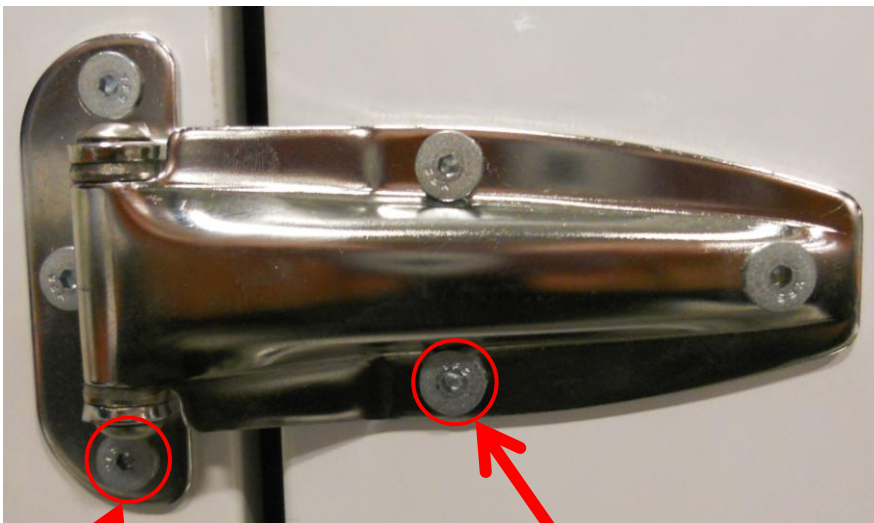
Screw heads may be found missing on hinge assemblies

Remove screws from one hinge at a time and replace with supplied parts. Torque value for each fastener is 41 in-lb or 3.5 ft-lb.

Note that original screws on this side may be secured from behind with machine nuts. If so equipped, nuts may be reused.

New screws (depicted) require a 0.125" hex tool. Recommended torque 41 in-lb or 3.5 ft-lb.
