LOOSE RADIATOR GRILLE AND/OR SQUEAK RATTLE FROM RADIATOR GRILLE AREA - OHIO ASSEMBLY PLANT - BUILT ON OR BEFORE 24-OCT-2016

TSB 16-0164

2017 F-Super Duty

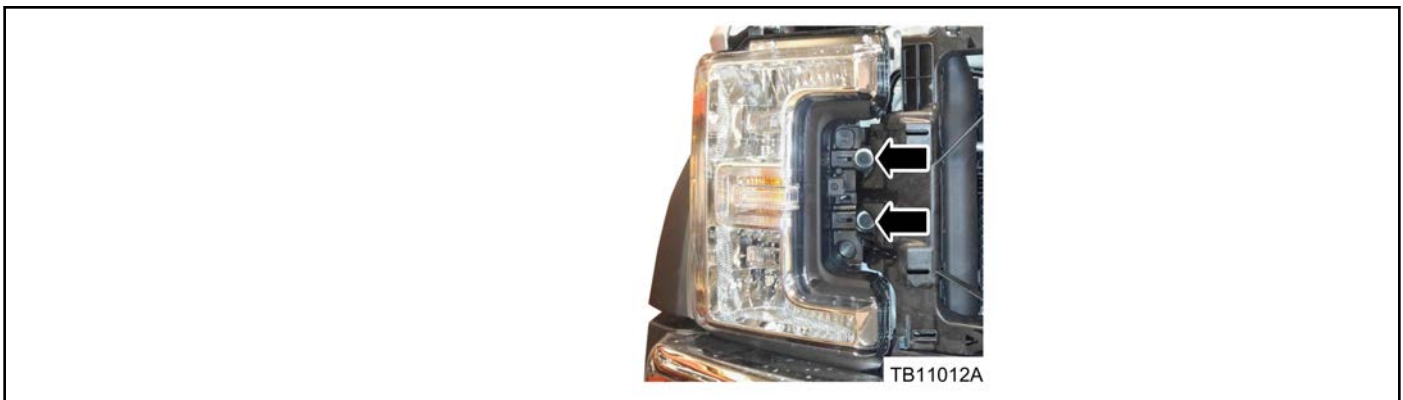
Figure 1 - Article 16-0164

Some 2017 F-Super Duty vehicles built at the Ohio Assembly Plant on or before 24-Oct-2016 may exhibit a loose radiator grille and/or squeak rattle from radiator grille area. This may be due to improper torque of the radiator grille reinforcement bolts.

- a. The right side of the vehicle is shown, left side is similar.
5. Reinstall the radiator grille. Refer to WSM, Section 501-08.

1. Does the vehicle exhibit a loose radiator grille and/or squeak rattle from radiator grille area?
 - a. Yes - proceed to Step 2.
 - b. No - this article does not apply. Refer to online Workshop Manual (WSM), Section 100-04 for normal diagnostics.
2. Check the vehicle identification number (VIN). Is the 11th digit of the VIN a D, which indicates the truck was built at Ohio Assembly Plant?
 - a. Yes - proceed to Step 3.
 - b. No - this article does not apply. Refer to online Workshop Manual (WSM), Section 100-04 for normal diagnostics.
3. Remove the radiator grille. Refer to WSM, Section 501-08.
4. Torque the four radiator grille reinforcement bolts located near the left and right headlamps to 40 Nm (30 lb-ft). (Figures 1)
