Technical Service Bulletin

37 Customer may report harsh shift concerns; no faults are stored and concern is reproducible

37 16 68 2030007/6 September 19, 2016. Supersedes Technical Service Bulletin Group 37 number 14-48 dated October 2, 2014 for reasons listed below.

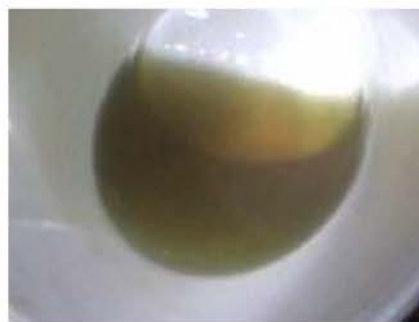
Figure 1. Fluid photograph example showing approximately one inch of fluid in the white cup, and tilted on an angle to show depth and color.

1. Perform a road test with the customer to determine if the concern can be duplicated. Pay attention to the following conditions: vehicle speed, ambient temperature, engine temperature, upshift or downshift, coasting or braking, panic stop or normal stop, and uphill or downhill drive.
2. Check the transmission oil level/condition, and correct if needed. Take a photograph of the fluid (Figure 1). Run a GFF scan to ensure that no faults are present.
