**CLICKING OR RATCHETING TYPE NOISE FROM REAR OF VEHICLE -  
2.7L ECOBOOST - AWD - BUILT ON 16-OCT-2016 AND THROUGH 18-  
NOV-2016**

**TSB 16-0169**

2017 Continental

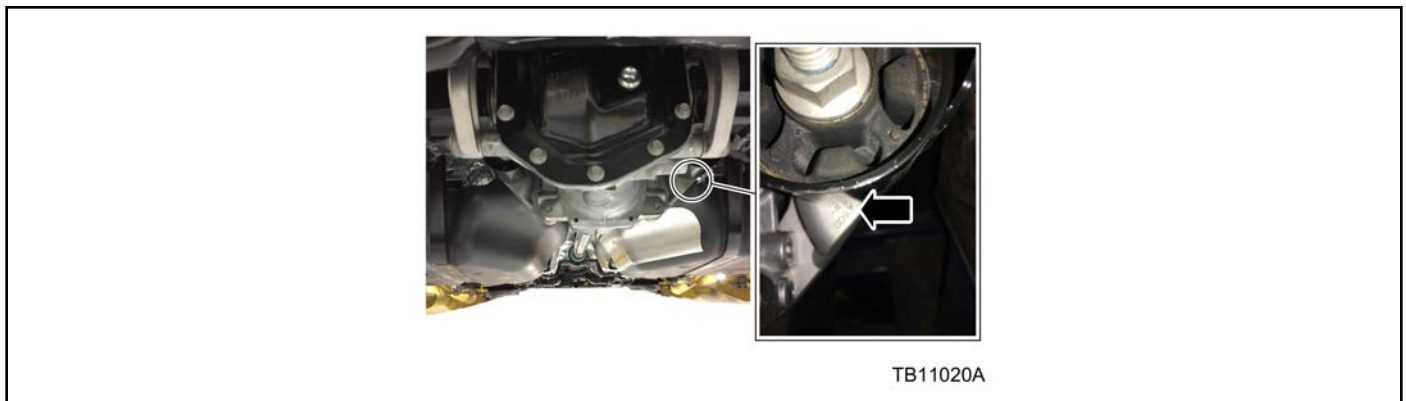
Figure 1 - Article 16-0169

1. Does the customer state that the vehicle exhibits a clicking or ratcheting type of noise from the rear of the vehicle during acceleration?
  - a. Yes - proceed to Step 2.
  - b. No - this article does not apply. Refer to Workshop Manual (WSM), Section 100-04.
2. Raise the vehicle. Refer to WSM, Section 100-04.
3. Visually inspect the right side of the rear drive unit (RDU) front mounting bracket from the rear of the vehicle and looking forward. Are you able to read GD93 on the bracket? (Figure 1)

- a. Yes - this article does not apply. Refer to WSM, Section 100-04 for normal diagnostics.
  - b. No - proceed to Step 4.
4. Using a jack stand, support the front of the RDU.
5. Remove the right side front RDU mounting bracket and install it on the left side. Remove the left side front RDU mounting bracket and install it on the right side.
  - a. Tighten mounting bolts to 90 Nm (66 lb-ft)
6. Remove the jack stand and lower the vehicle. The repair is complete.
