TECHNICAL BULLETIN

JTB00503NAS1

Second Row Seatbelt Chute Gap Too Large

F-PACE (X761)

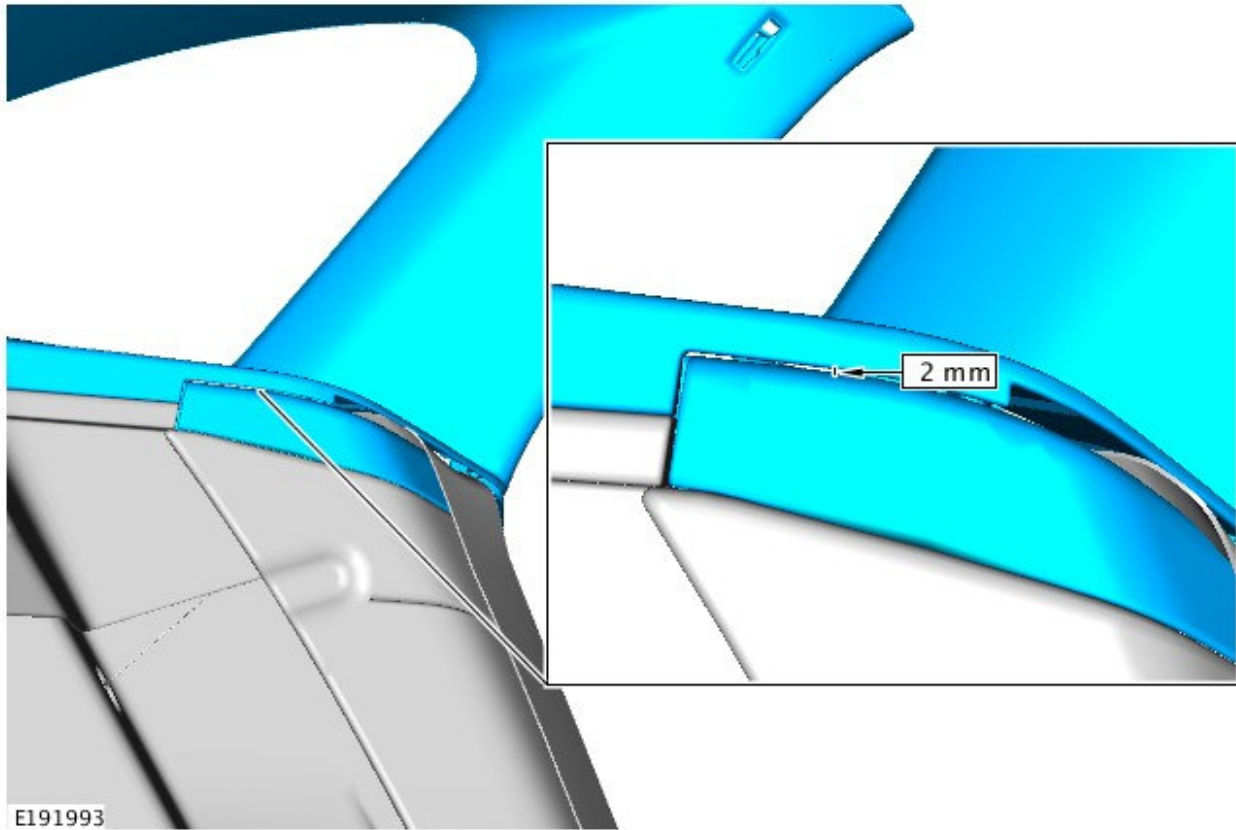
1. Using a suitable tool, check the gap between the C-pillar trim and the seatbelt chute.

- If the gap is less than 2 mm, do not continue with this Service Instruction.
- If the gap is larger than 2 mm, continue to Step 2.

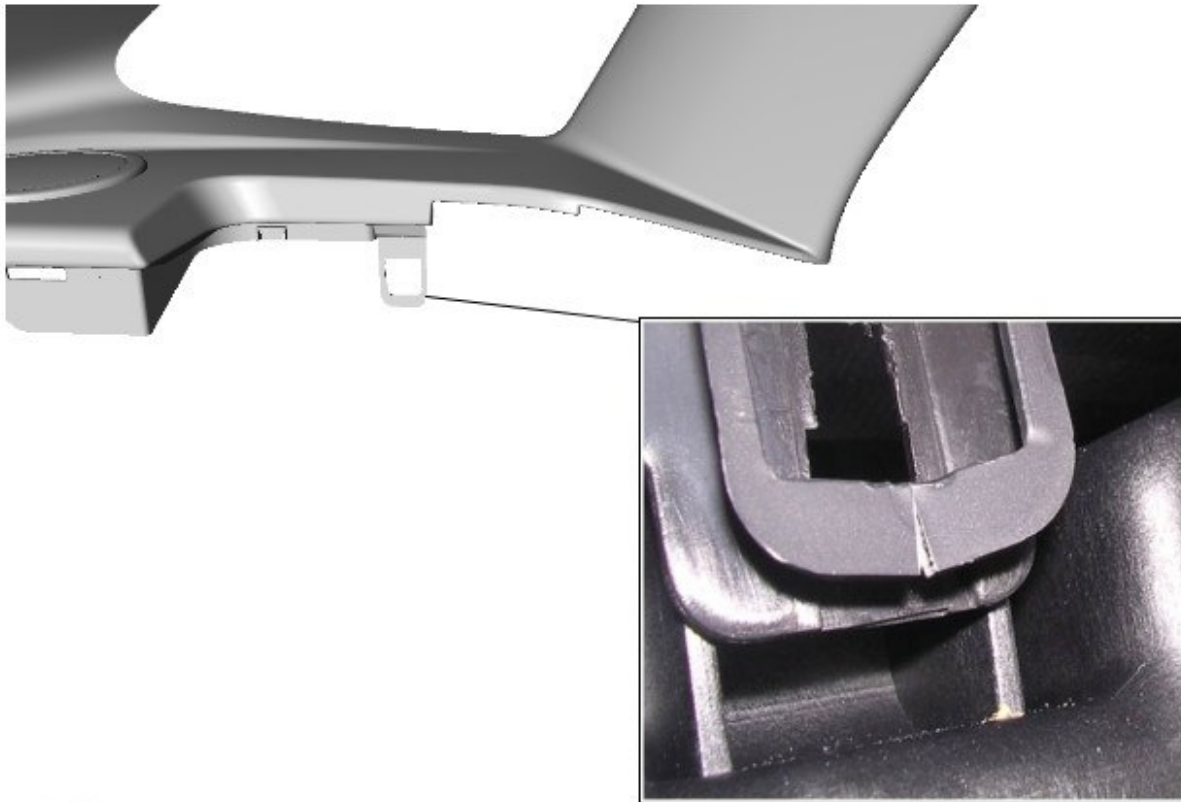
E191982

4. Visually check the C-pillar trim slot.

- If the C-pillar trim slot is not damaged, continue to Step 5.
- If the C-pillar trim slot is damaged, discard the C-pillar trim.
 - Continue to Step 5.

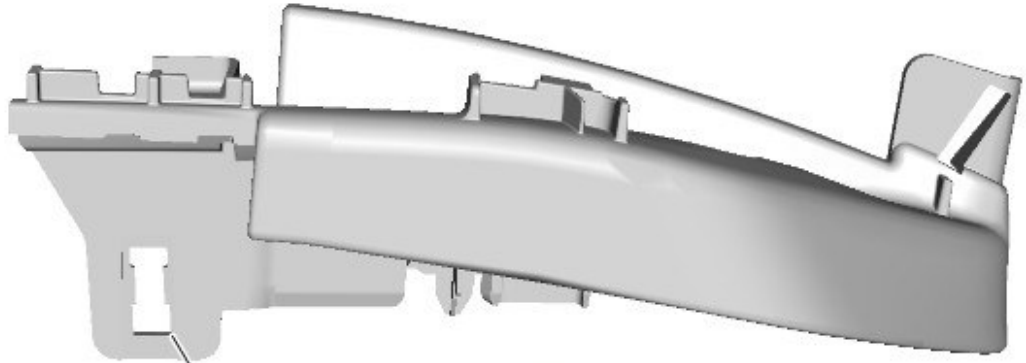
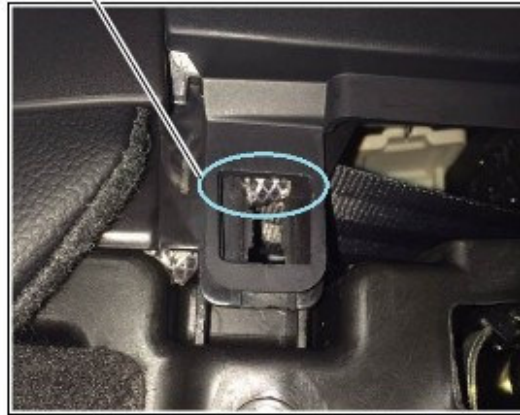
E191981

5. Check to see if the seatbelt chute has the plastic modifier fitted.

- If the seatbelt chute does not have the plastic modifier, continue to Step 8.
- If the seatbelt chute has the plastic modifier, continue to Step 6.
