TECHNICAL BULLETIN
JTBO0458NAS1
17 AUG 2016

SECTION: 211-02

'Rattle' Noise From The Front Of The Vehicle

XE (X760)

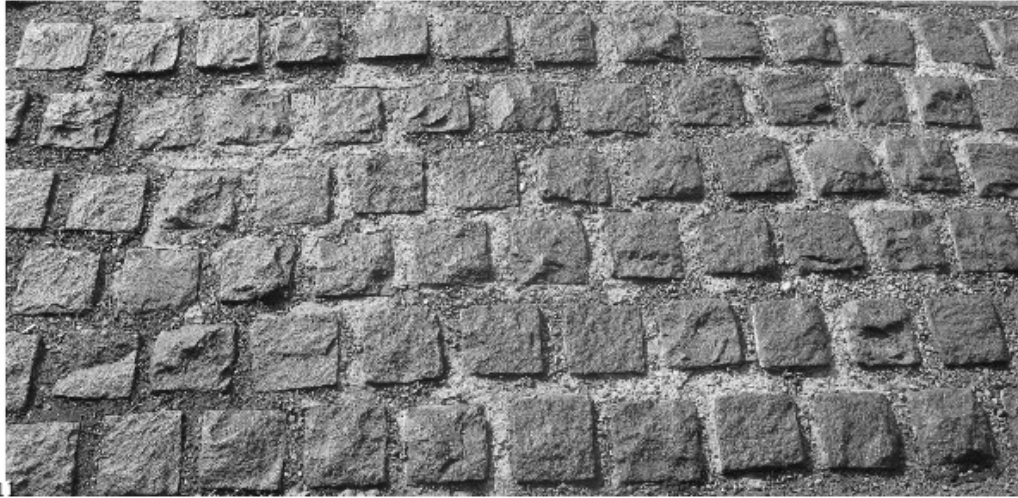
E15961

1. Typical road surface

that can generate the rattle sound.

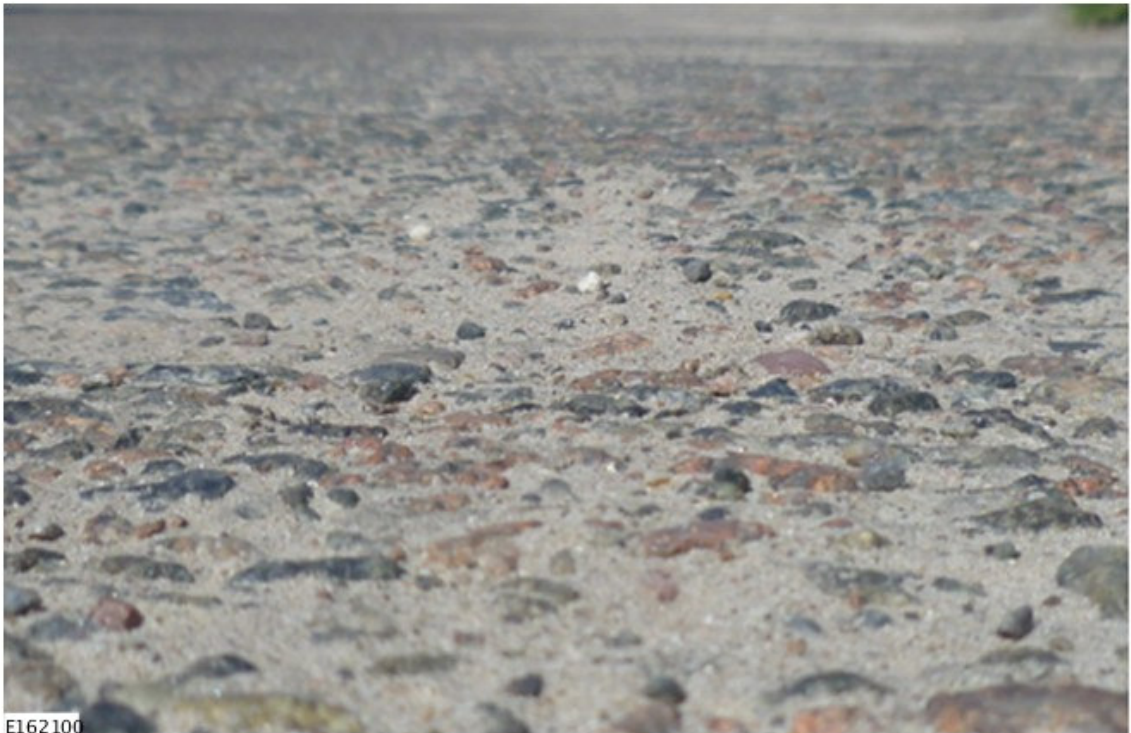
E162100

2. Typical road surface that can generate the rattle sound.
