TECHNICAL BULLETIN

K407NAS1

Service Action: AWD V6 Petrol S/C Cross Brace Foul

XE (X760)

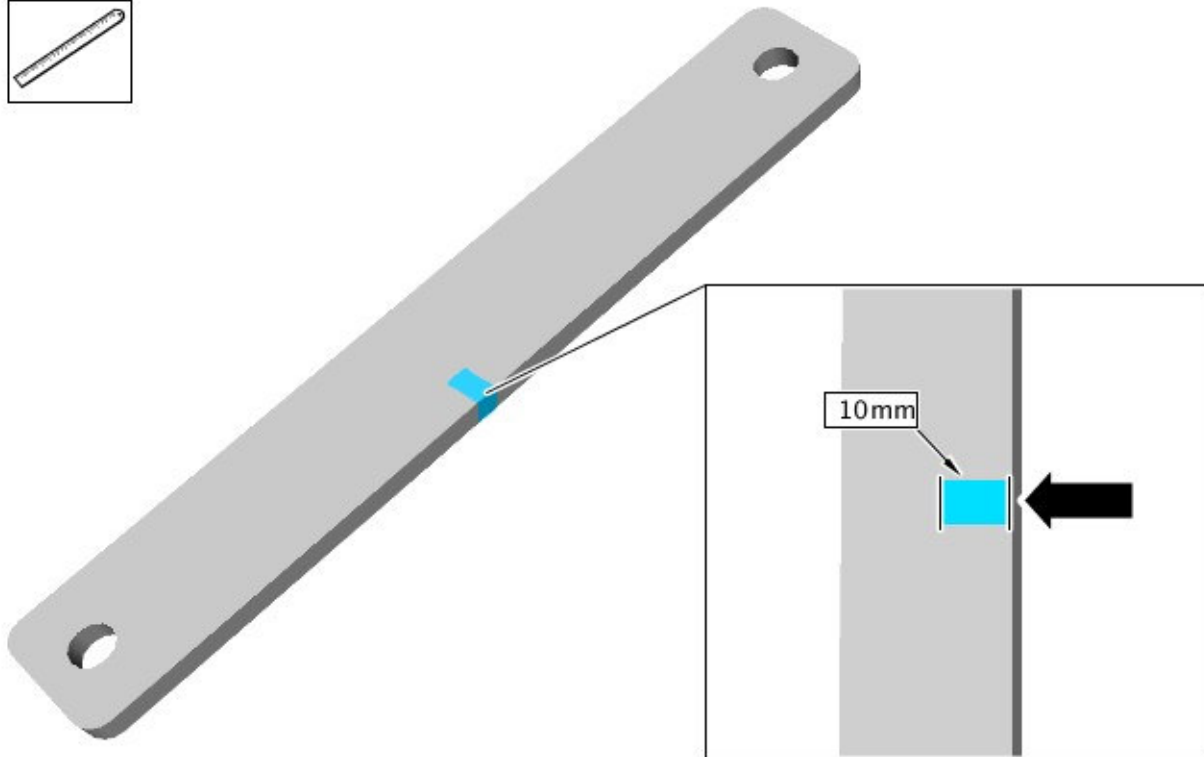
E194840

**NOTE: If the contact damaged length is more than 10mm, submit an Electronic Product Quality Report (EPQR), including a picture of the cross brace damage.**

Inspect the cross brace contact damaged length.

- If the contact damaged length is less than 10mm, discard the cross brace, clean the damaged area on the driveshaft, and paint with Rust-Oleum High Heat Black (248903).
 - Continue to Step 6.
- If the contact damaged length is more than 10mm, discard the cross brace, install a new driveshaft (see TOPIx Workshop Manual section 205-01: Driveshaft), and release the vehicle.
 - Submit an Electronic Product Quality Report (EPQR), including a picture of the cross brace damage.
