# Service Bulletin

**Subject:** Cooled Seat Fan Making Tapping Noise When in Use

**Models:** 2014-2017 Chevrolet Impala (VIN 1)  
Equipped with Ventilated Driver and Passenger Front Seats (RPOs KU1, KU3)

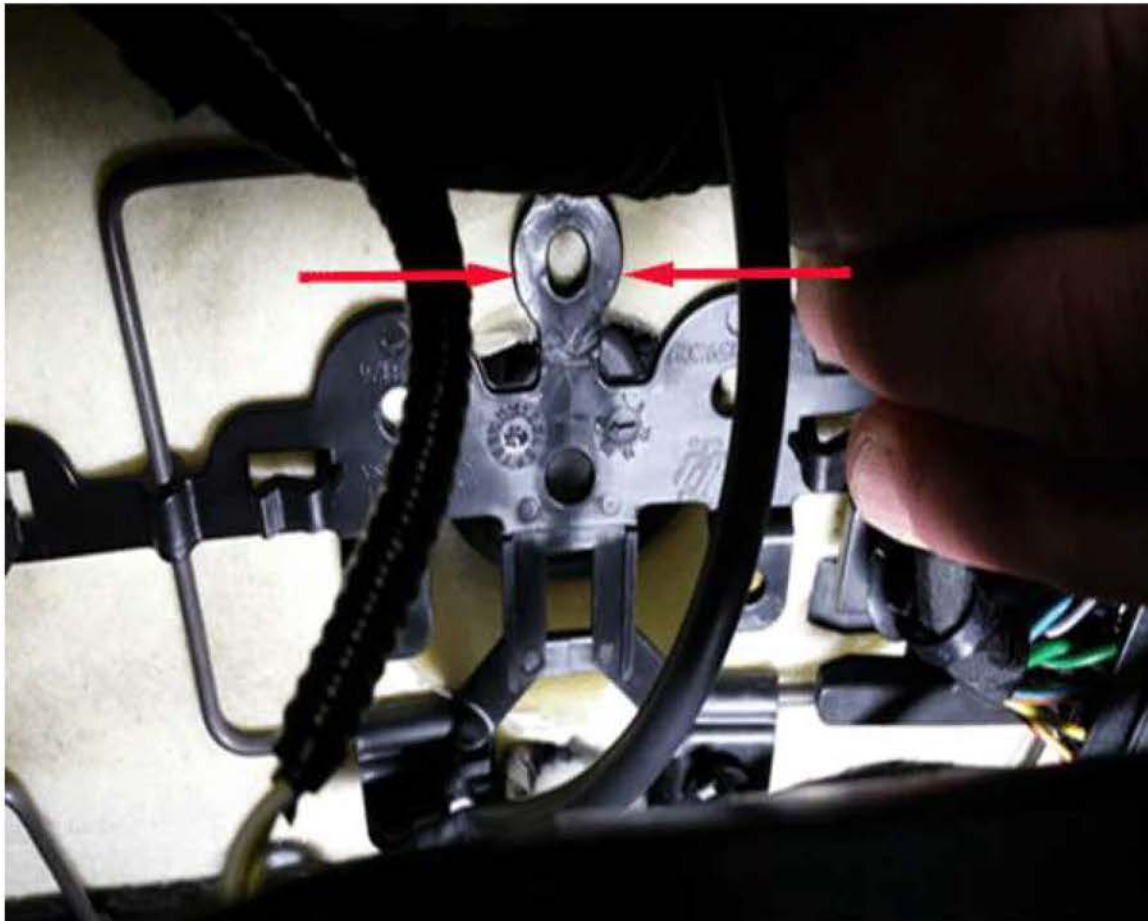
Some customers may comment on a tapping noise heard when using cooled seats.

This condition may be due to the seat cushion heat harness coming in contact with the cooling fan.

Re-route the seat cushion heat harness under the flex mat away from the cooling fan and attach a harness clip to the new location under the seat as shown above.
