# Service Bulletin

**Subject:** Normal Characteristic — Roof Panel Wavy Near Roof Panel Moldings or Ditch Moldings

**Models:** 2010-2017 Chevrolet Equinox  
2010-2017 GMC Terrain

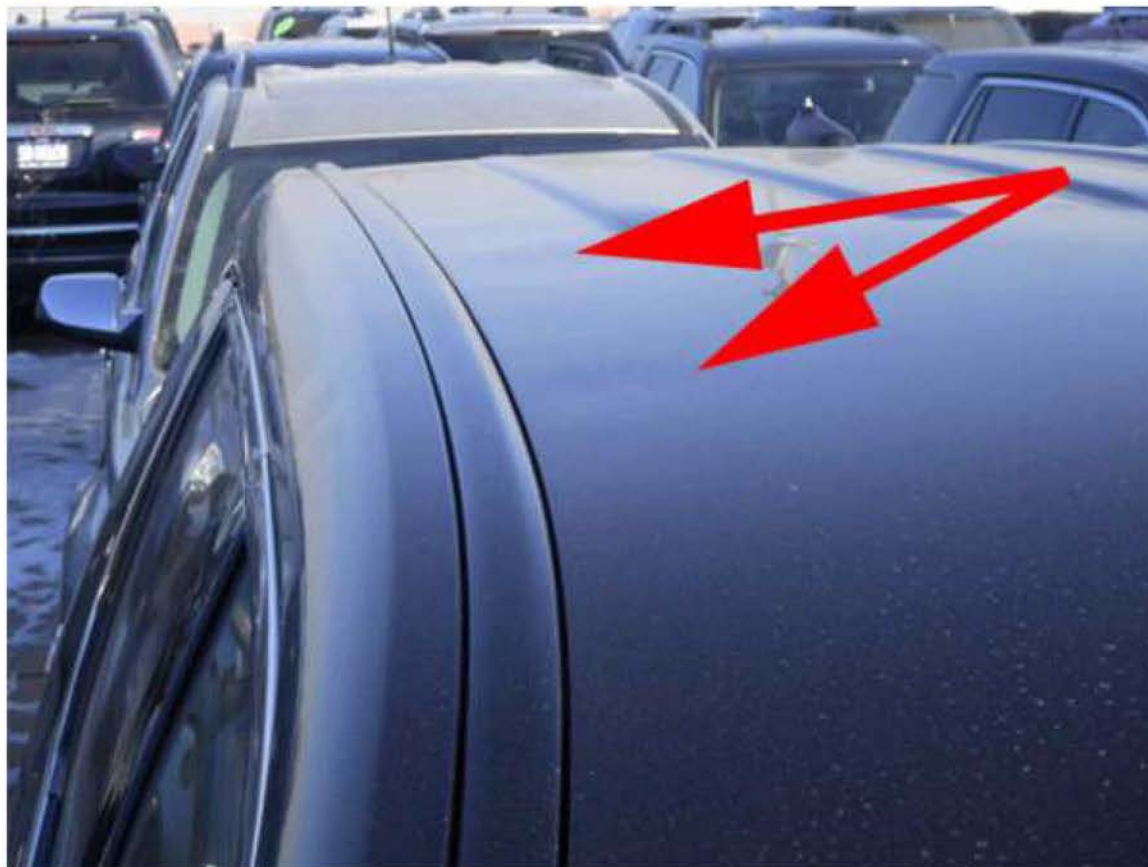
Some customers may comment on denting or waviness along the outer edges of the roof panel near the roof panel moldings (ditch moldings). This is caused by the welding process of the roof panel to the side door (closure) panel.

This is a normal operating characteristic of the vehicle and no repair attempts should be performed.
