Service Bulletin

Subject: Loss of Power Steering Assist, Hard to Steer, and/or Service Power Steering Message on DIC

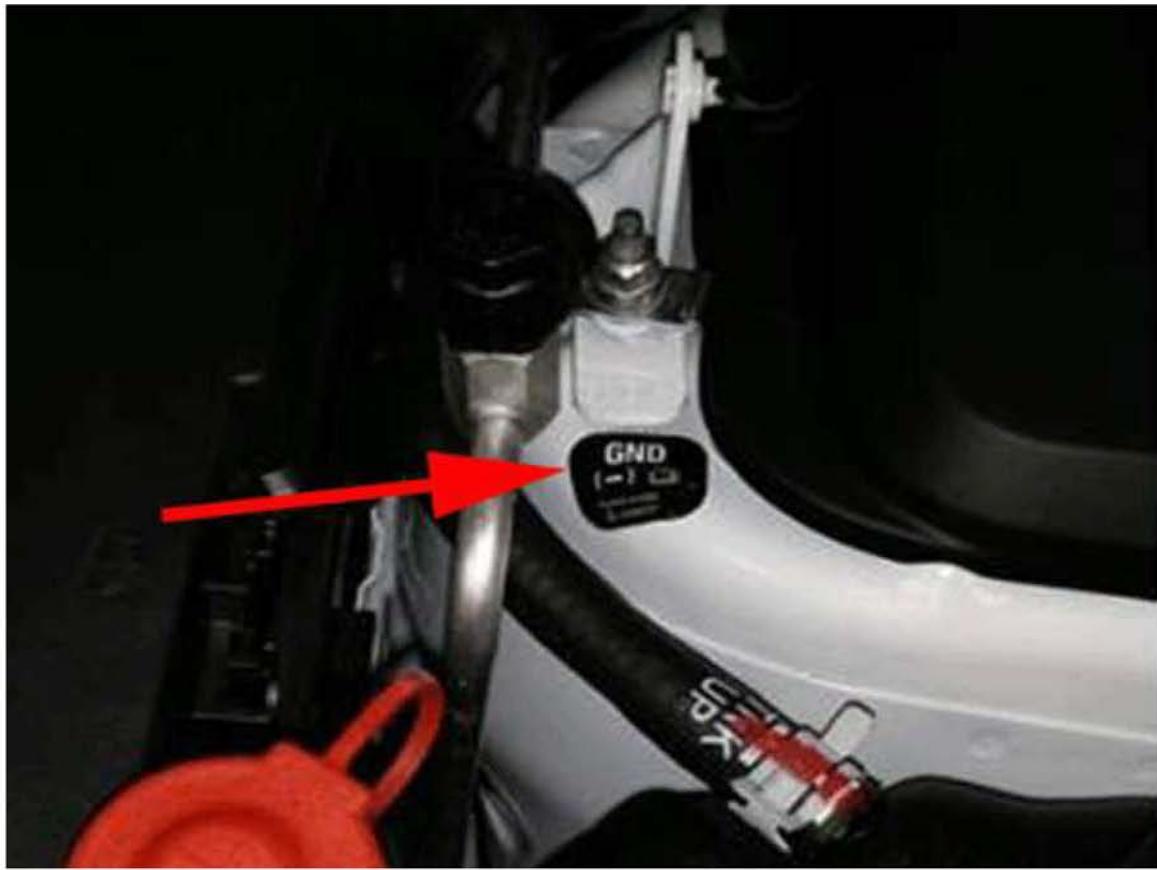
Some customers may comment on loss of power steering assist, hard to steer, and/or Service Power Steering message on DIC.

This may be caused by a blown/failed power steering fuse, which could be a result from improper jump starting.

1. Locate the power steering fuse.
2. Check to determine if the fuse is open. To do so, check for continuity using a Digital Multimeter (EL-39200) or a continuity tester.
3. If the fuse element is broken, replace the fuse.

Important: When installing the new fuse, tighten the fasteners to 5 N·m (44 lb in).

- After fuse is replaced, install an electrical ground point label, GM P/N 10384767, in the approximate location as illustrated above.
