TECHNICAL SERVICE INFORMATION BULLETIN

TSIB 16-01 rev A

TO:	All Operators
TITLE:	Rework existing exhaust tube support bracket for updated Cummins EGR cooler installation
APPLICABILITY:	All New Flyer Diesel Low Floor Buses built before Sept 2010 with engines meeting the 2007 or 2010 EPA emissions certification

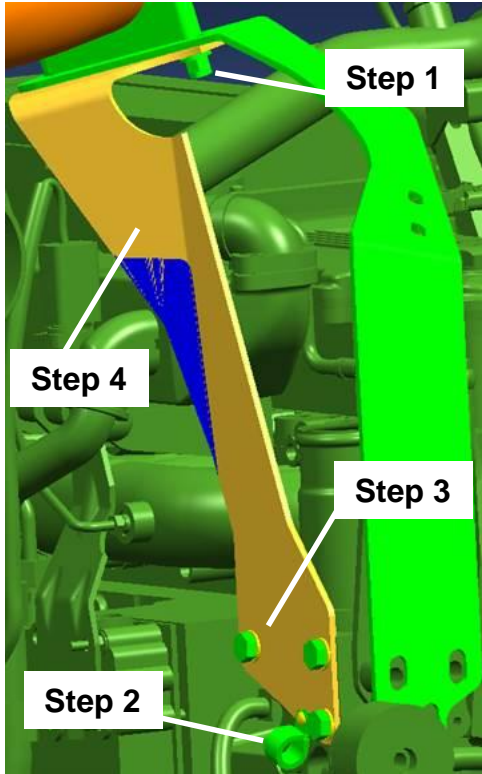
It has come to the attention of New Flyer (NF) Customer Service that when installing the new Cummins field replacement EGR cooler (Cummins PN 5343328) into a New Flyer Low Floor (LF) style bus, the EGR cooler makes contact with the existing exhaust tube support bracket (NF PN 315247). This affects LF buses built before Sept 2010 with diesel engines meeting the 2007 or 2010 EPA emissions certification.

1. Remove and save the existing U-bolt hardware. See Figure 1 on page 2.
2. Remove and save any hose and/or cable support p-clips and mounting hardware. Tie back any loose hose and/or cables that may interfere with the bracket removal. See Figure 1 on page 2.
3. Remove and save the existing bracket mounting hardware. See Figure 1 on page 2.
4. Bracket must be removed to be reworked. Using a band saw or die grinder rework the existing bracket by removing the area, as shown in Figure 2 on page 2. Using a zinc rich primer, prime any bare metal left from the removal process before reinstallation to prevent corrosion.
5. Install reworked bracket using existing hardware, removed in Step 3. See Figure 3 on page 2. Torque hardware to 35 ft-lb.
6. Install the U-bolt hardware, removed in Step 1.
7. Re-install the hose and/or cable support p-clips and mounting hardware, removed in Step 2.

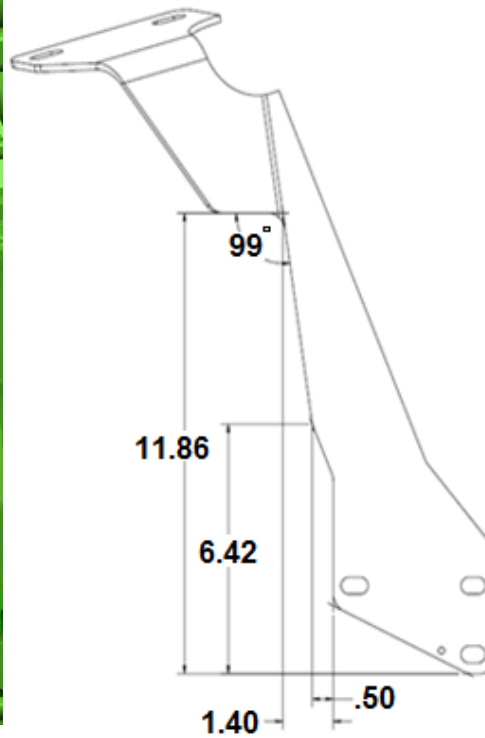
Figure 2

**Existing Bracket
with cut outs shown**

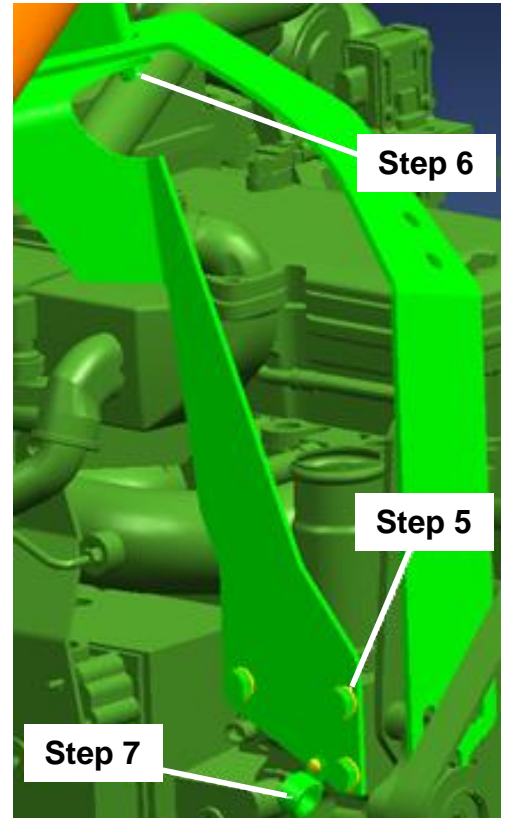
Figure 3

P/N 315247 Modified

Reworked Bracket
