TECHNICAL BULLETIN
K432 UPS7116-2bNAS1
16 SEP 2016

Update Prior to Sale: Vacuum Pipe and Exhaust Gas Recirculation Pipe Contact

XF (X260)

XE (X760)

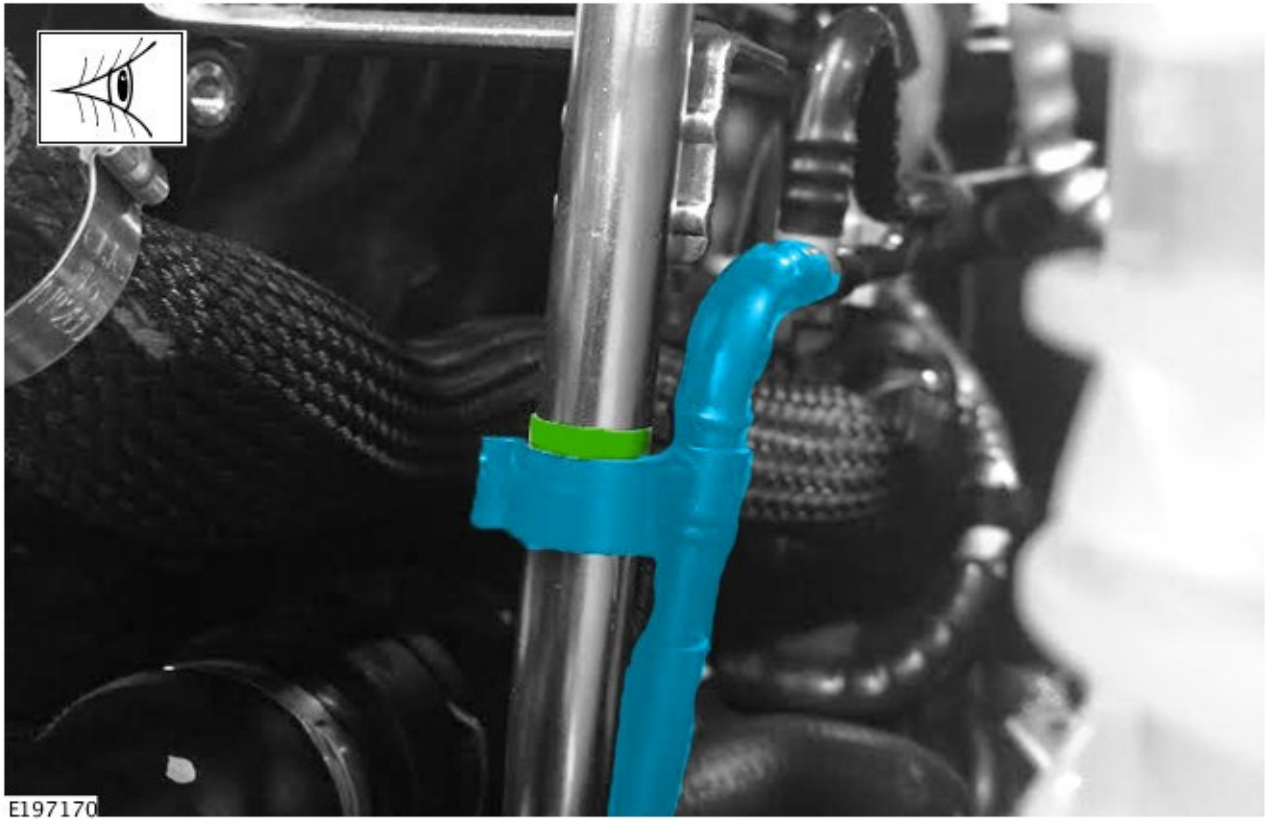
1. Visually inspect the vacuum pipe to Exhaust Gas Recirculation (EGR).
 - If the clip is in line with the white tape (shown in green) as shown, continue to SERVICE INSTRUCTION B.
 - If the clip is not in line with the white tape (shown in green) as shown, continue to Step 2.

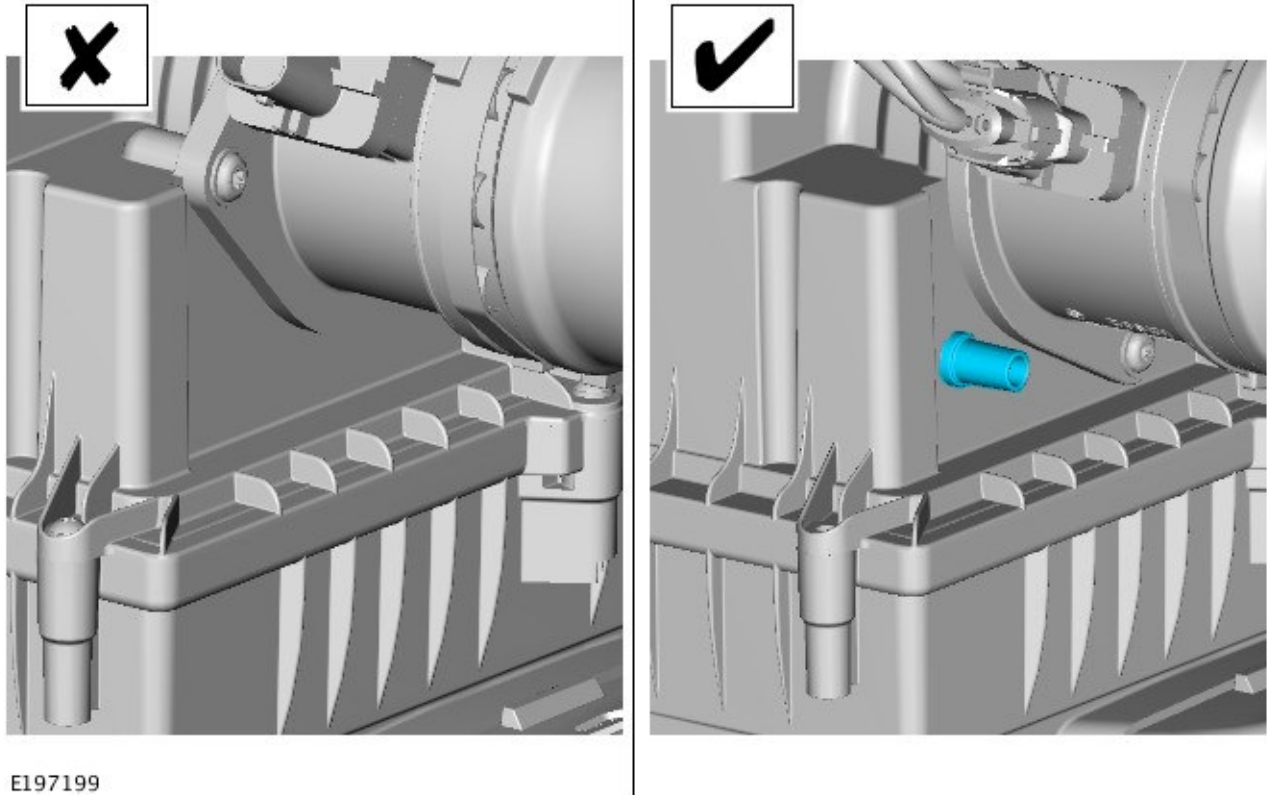
1. Visually check the air cleaner.

- If the air cleaner does have the outlet installed (✓), continue to Step 3.
- If the air cleaner does not have the outlet installed (✗), continue to Step 2.

2. Replace the air cleaner (see TOPIx Workshop Manual section 303-12: Intake Air Distribution and Filtering), making sure to attach the air cleaner pipe as shown (✓) in Step 3.

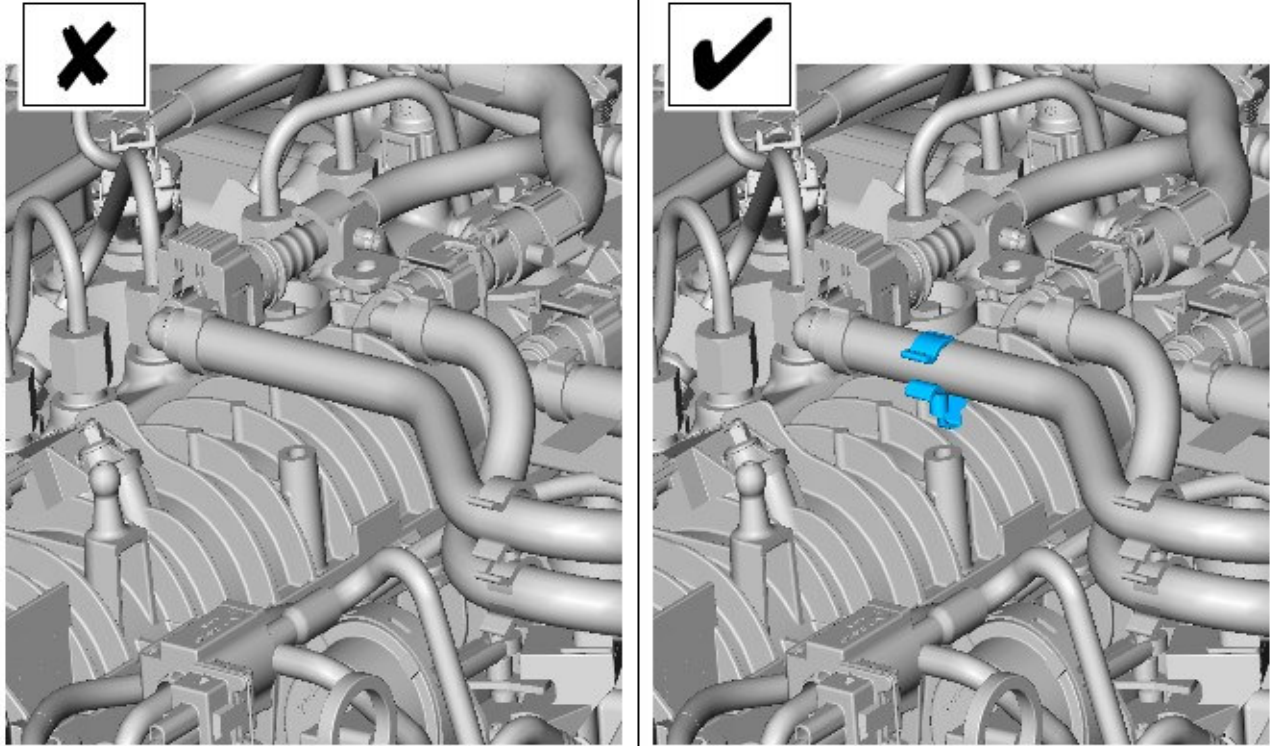
E197186

1. Visually check the fuel line and clip are installed correctly.

- If the fuel pipe and clip are installed correctly (✓) and all the other SERVICE INSTRUCTIONS are complete, release the vehicle.
- If the fuel line and clip are not installed correctly (✗), continue to Step 2.

2. Refer to **Special NOTE on supply of Fuel Line Clips** in Parts section to obtain a fuel line clip.

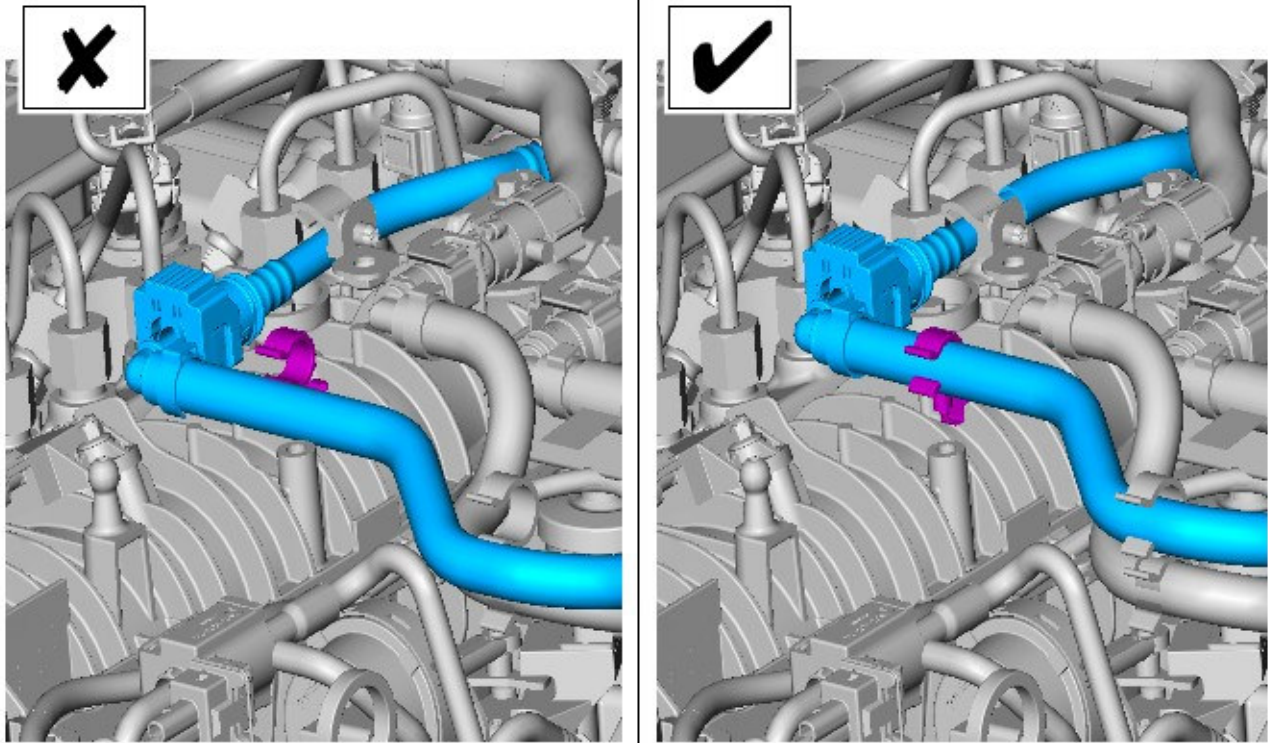
E197185

3. Visually check the fuel line is installed correctly as shown.

- If the fuel line is installed (✓), continue to Step 5.
- If the fuel line is not installed correctly (✗), continue to Step 4.

4. Install the fuel line correctly (✓) as shown in Step 3.
