Technical Service Bulletin

91 MMI3G+ Audi connect only reaches 2G service - Telephone module replacement instructions for A6 & A7

91 16 69 2039515/7 September 7, 2016. Supersedes Technical Service Bulletin Group 91 number 16-30 dated February 25, 2016 for reasons listed below.

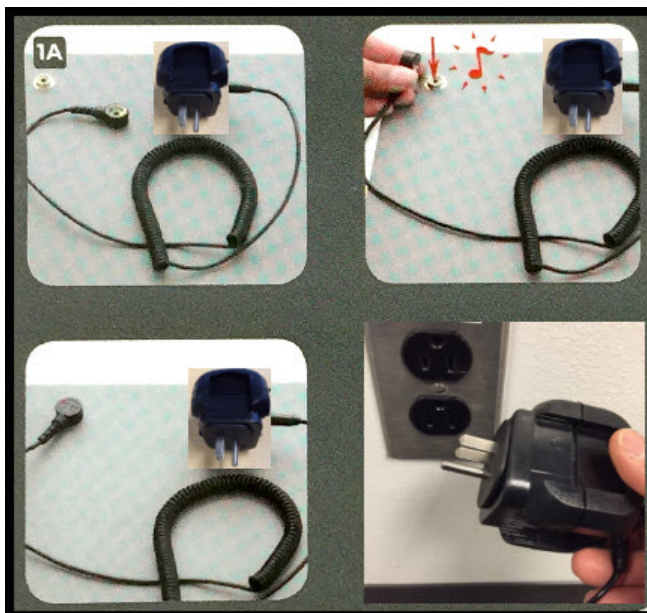
Figure 2. VAS6613 ESD work surface grounding plug.

3. Place the ESD anti-static mat onto the surface. Ensure that all three grounding straps are securely strapped to the ESD mat.
4. Ground the ESD mat by plugging the 110V grounding strap into a wall socket or power strip (Figure 2). If a power strip is used, it must be plugged into a grounded wall outlet. (See attached user instructions for VAS6613 titled "VAS6613 ESD Workspace Guide.pdf".)

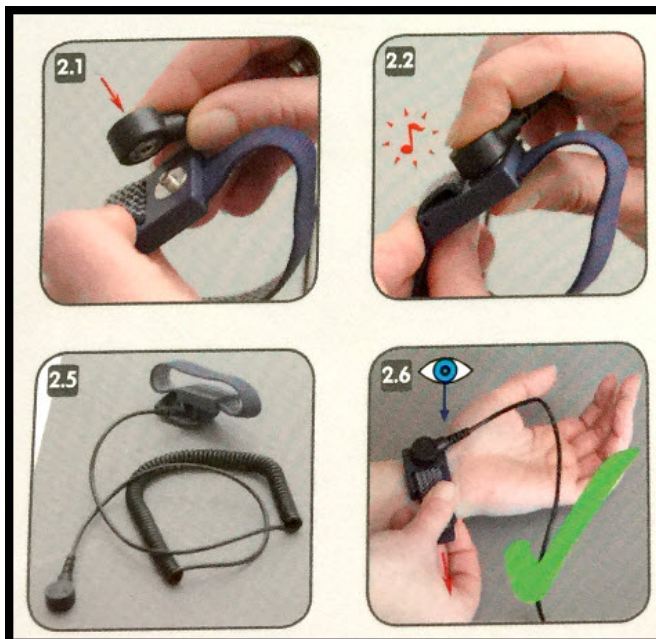
Figure 3. VAS6613 ESD work surface grounding wrist strap.

5. Ground yourself by placing the elastic strap around your wrist. Make sure it is securely touching your skin. It cannot be loose-fitting or over your shirt cuff (Figure 3).

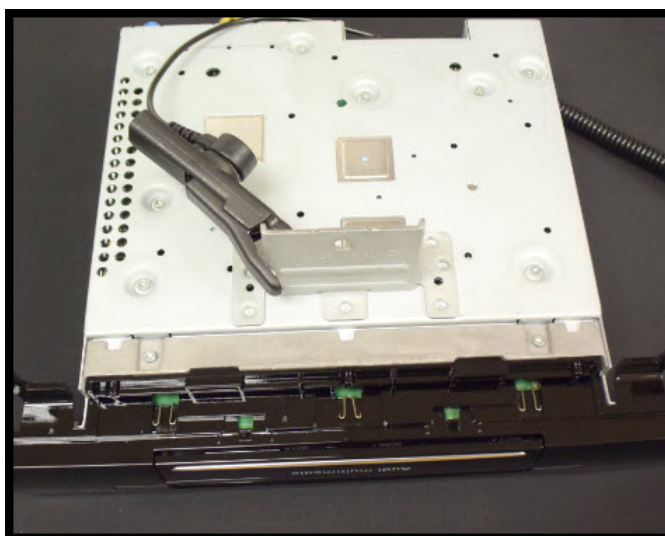
Figure 4. VAS6613 ESD work surface grounding device clip.

6. Ground the MMI main unit by placing an alligator clip on the back, ensuring that it makes contact with the metal housing of the main unit. The most secure location is at the bottom of the metal bracket (Figure 4).

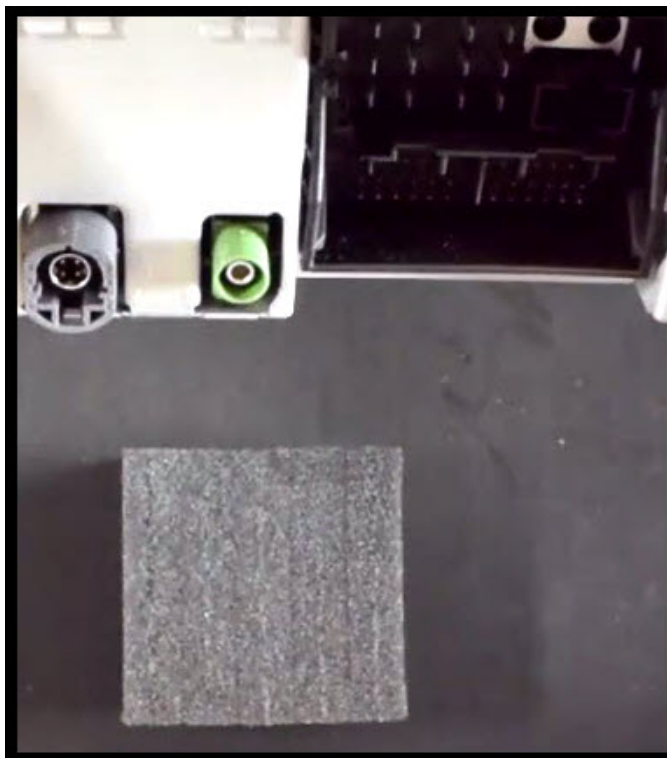
Figure 5. Foam block used as a spacer under the main unit.

A foam block can be used as a spacer under the main unit to keep the grounding strap connected (Figure 5).

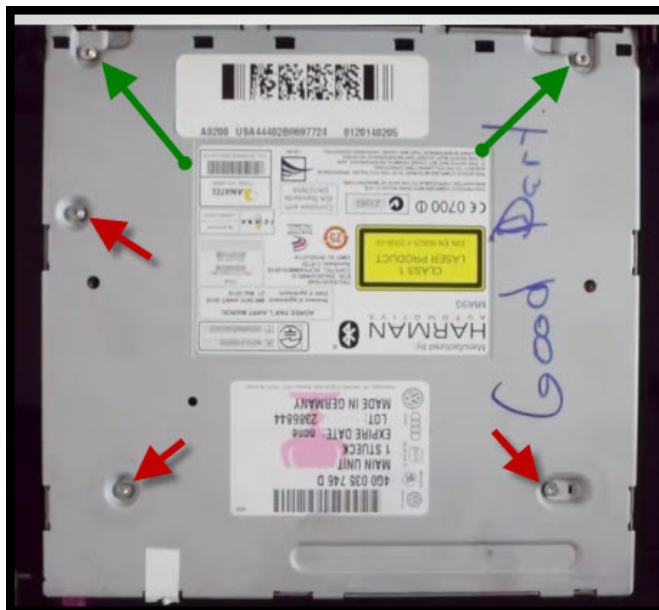
Figure 6. MMI main unit with screw locations for top cover.

7. Start by touching the screw driver to the ESD mat to discharge any static that may be built up in the tool. Next, remove the five screws that are holding the MMI top cover in place. The two screws near the faceplate (Figure 6, green arrows) are longer than the others, have thread lock on them, and may require extra effort to remove. Keep these screws separated from the others at all times.

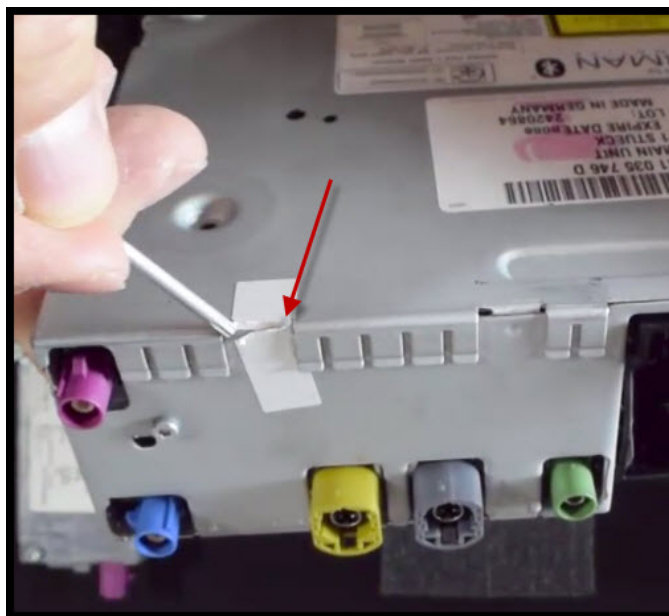
Figure 7. Break the white warranty seal.

8. Break the white warranty seal on the back of the main unit (Figure 7).

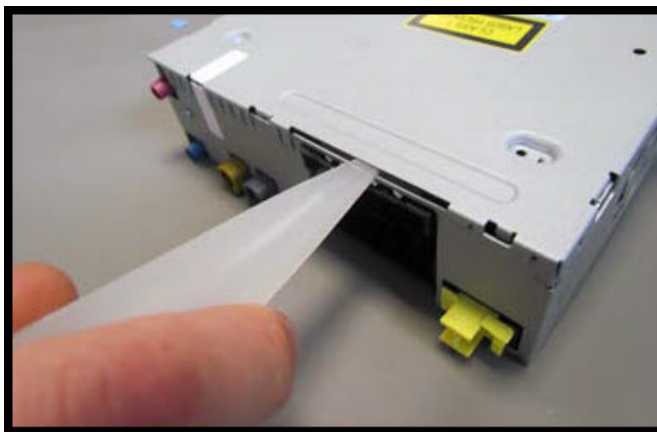
Figure 8. Pry to cover off using plastic trim wedge tool.

9. Using a flat head screw driver, your fingers or a plastic wedge trim tool, remove the top cover by prying it from the back of the cover at the location seen in Figure 8. If a flat head screw driver is used then touch the tool to the ESD mat to discharge the tool prior to touching the main unit.

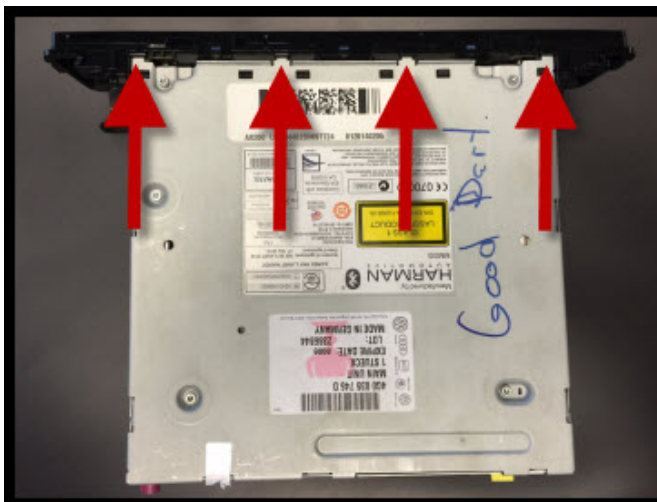
Figure 9. Top cover metal tabs indicated by the red arrows.

The top cover of the main unit has four metal tabs that are slotted into the plastic front face plate (Figure 9). Slightly lift on the rear of the cover and pull back on the cover until the metal tabs are released. Lift up on the cover and pull it away from the face plate at the same time to prevent bending the top cover's metal tabs (Figure 10). If the metal tabs bend during this process, straighten them with a pair of pliers.

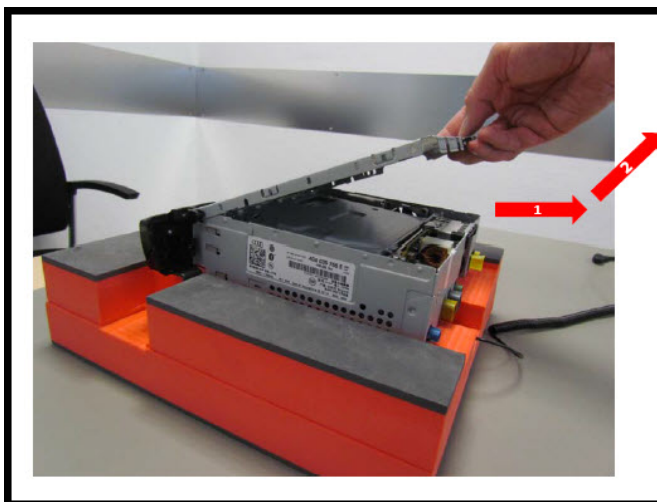
Figure 10. Pull up and back to prevent damaging the faceplate slots (Note: the orange/black holder is not required).

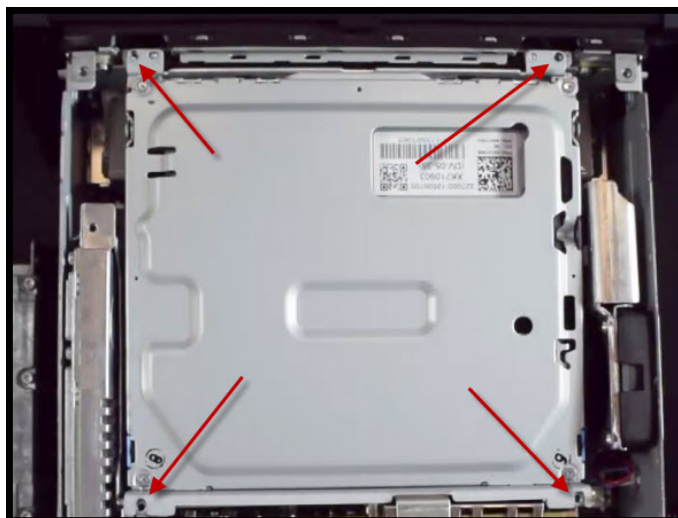
Do not flip the main unit over at this point. The CD drive, which was held in place by the top cover screws, is no longer secured. If the CD drive moves significantly, the ribbon cable can detach from the circuit board and disable the CD drive's functionality (Figure 11).

Figure 11. CD drive mounting points are now free.

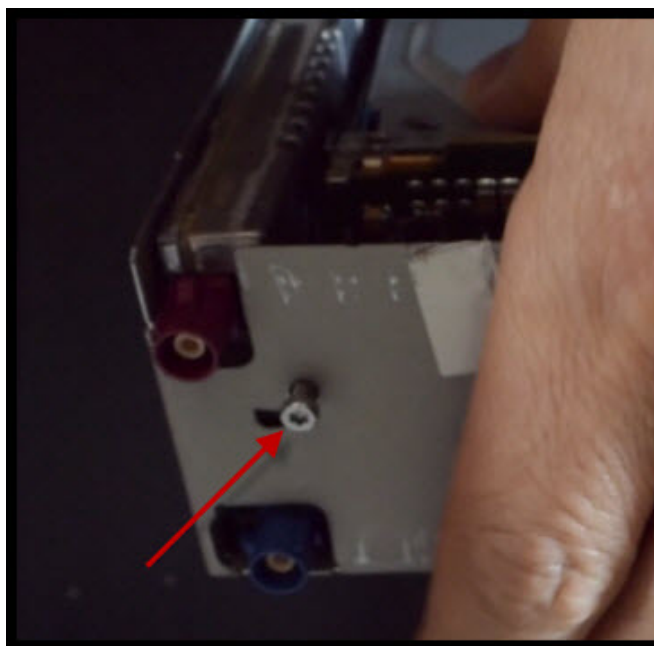
Figure 12. Telephone module retaining screw indicated by the red arrow.

10. On the back of the main unit, remove the retaining screw that holds the telephone module in place (Figure 12).

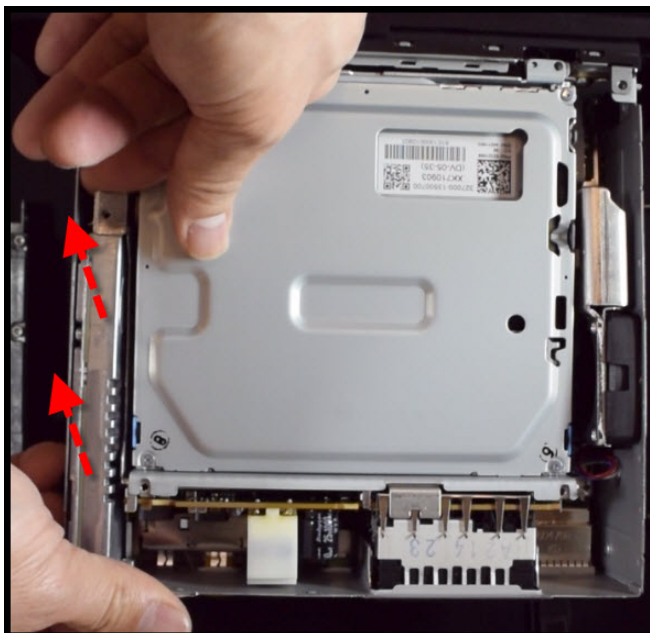
Figure 13. Lift up on both ends of the telephone module as indicated by the red arrows.

11. Carefully lift up the telephone module, using both ends as points of contact when pulling up (Figure 13). The module is held in place with a computer socket-type attachment and will release when enough force is used.

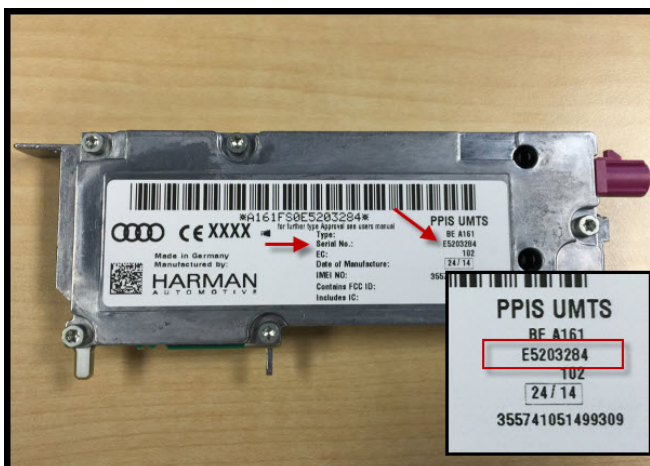
Figure 14. Serial number of the PPIS UMTS telephone module indicated by the red arrows and red box.

12. Before proceeding, write down the serial number of the new replacement UMTS telephone module (Figure 14).

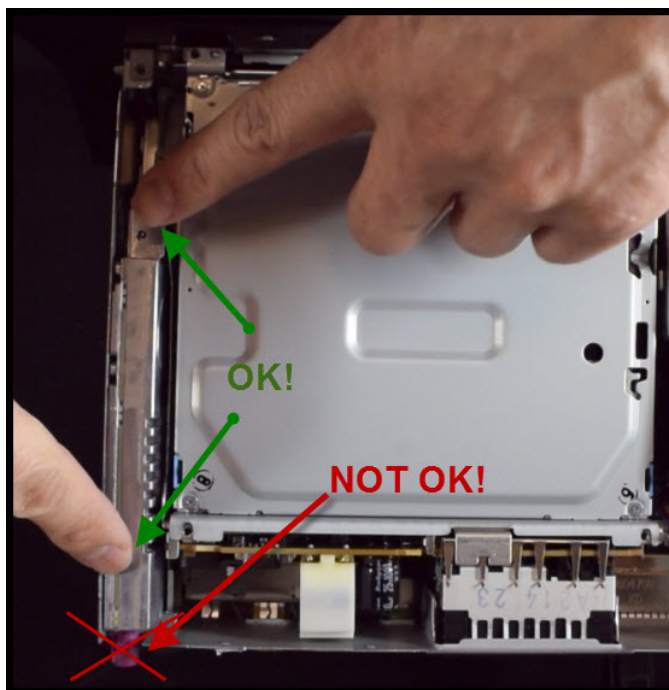
Figure 15. Do not press down using the purple FAKRA connector.

13. Place the new UMTS telephone module into the socket, making sure it is level before snapping it into place. Use both ends of the telephone module when pressing it into place. Do not press down using the purple FAKRA connector (Figure 15).

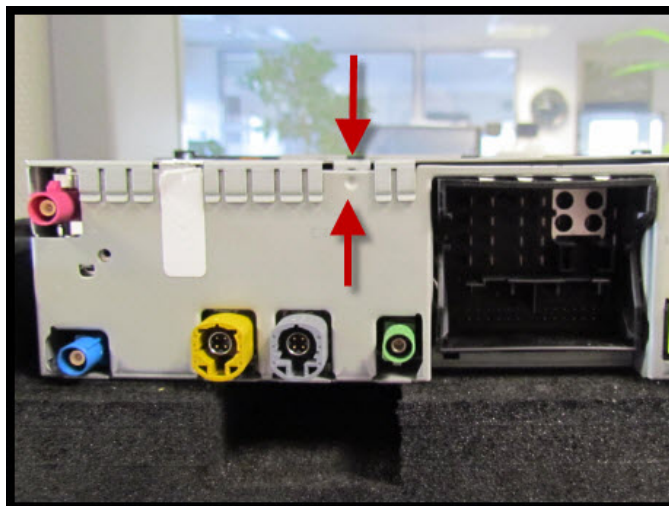
Figure 14. Place the new warranty seal over the location indicated by the red arrows.

17. Place the new warranty seal from the retrofit kit next to the original warranty seal (Figure 14).

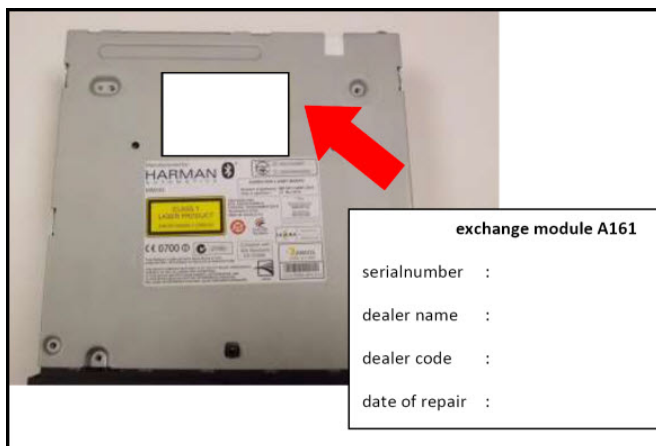
Figure 15. The white area indicates the suggested location for the repair label on the top cover of the main unit. Do not cover any existing part number labels or the laser warning.

18. Place the repair label on the top of the main unit cover. Do not cover any part number label and do not cover the yellow laser warning (Figure 15). Fill out all fields on the repair label.

Do not cover the yellow laser warning label. The repair label may need to be placed on sideways due to space limitations
