Technical Service Bulletin

91 MMI3G+ Audi connect only reaches 2G service - Telephone module replacement instructions for A4,A5,A5 cab,Q5,Q7,A8

91 16 70 2039476/7 September 7, 2016. Supersedes Technical Service Bulletin Group 91 number 16-31 dated February 25, 2016 for reasons listed below.

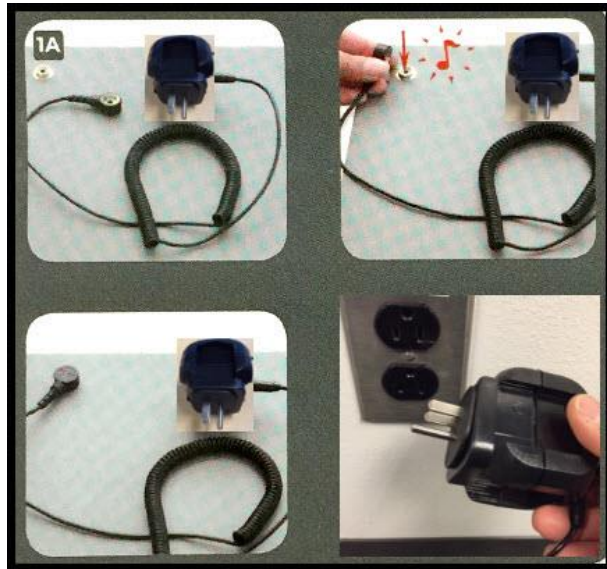
Figure 2. VAS6613 ESD work surface grounding plug.

4. Ground the ESD mat by plugging the 110V grounding strap into a wall socket or power strip (Figure 2). If a power strip is used, it must be plugged into a grounded wall outlet. (See attached user instructions for VAS6613 titled “VAS6613 ESD Workspace Guide.pdf”.)

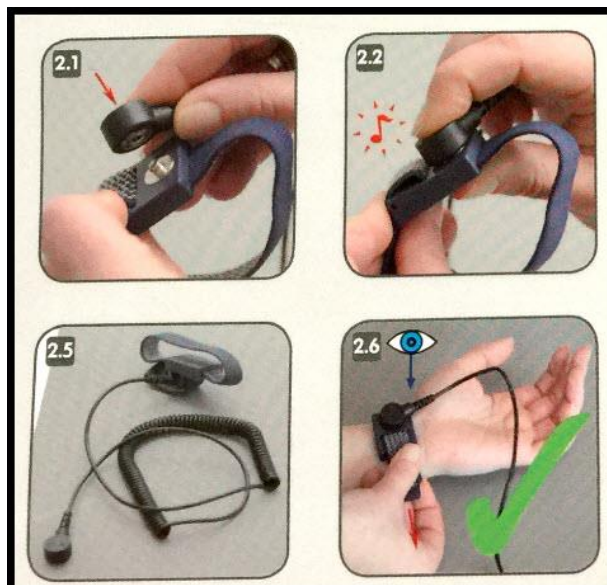
Figure 3. VAS6613 ESD work surface grounding wrist strap.

5. Ground yourself by placing the elastic strap around your wrist. Make sure it is securely touching your skin. It cannot be loose-fitting or over your shirt cuff (Figure 3).

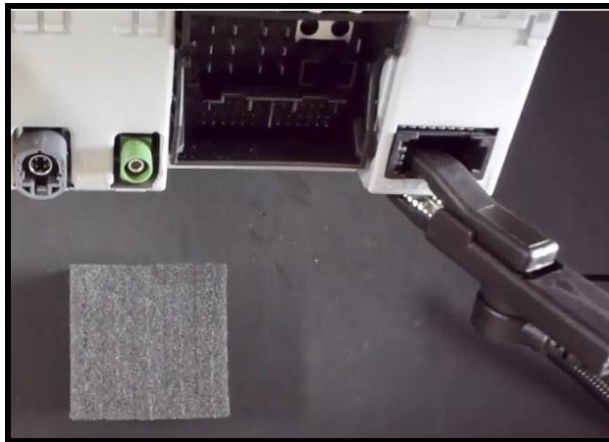
Figure 4. VAS6613 ESD work surface grounding device clip.

6. Ground the MMI main unit by placing an alligator clip on the back, ensuring that it makes contact with the metal housing of the main unit. The most secure location is at the MOST connector (Figure 4).

A foam block can be used as a spacer under the main unit to keep the grounding strap connected.

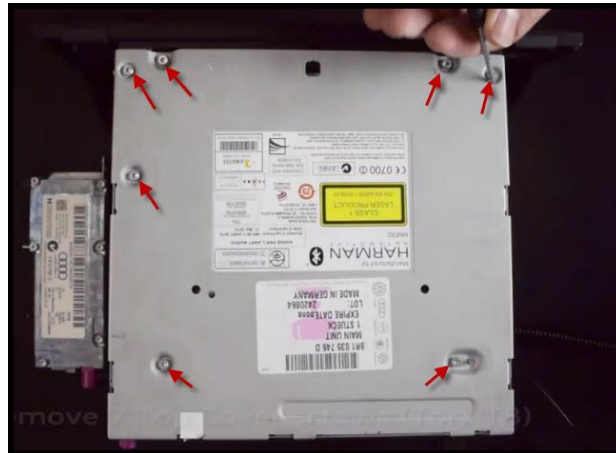
Figure 5. MMI main unit with screw locations for top cover indicated by the red arrows.

7. Remove the seven screws that are holding the MMI top cover in place (Figure 5).

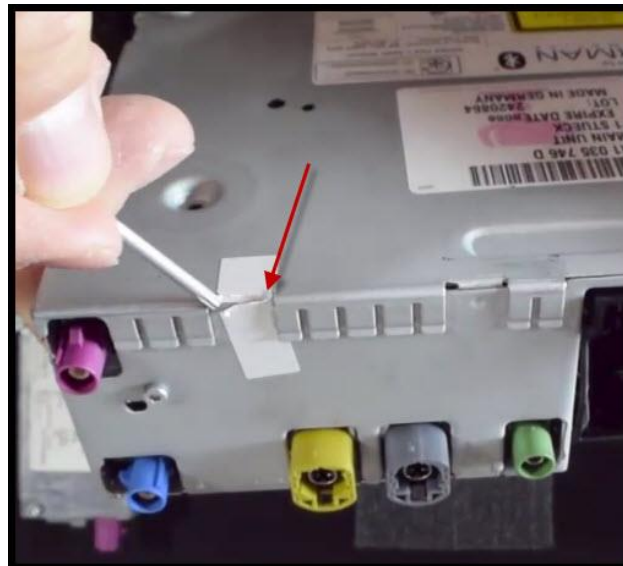
Figure 6. Break white warranty seal.

8. Break the white warranty seal on the back of the main unit (Figure 6).

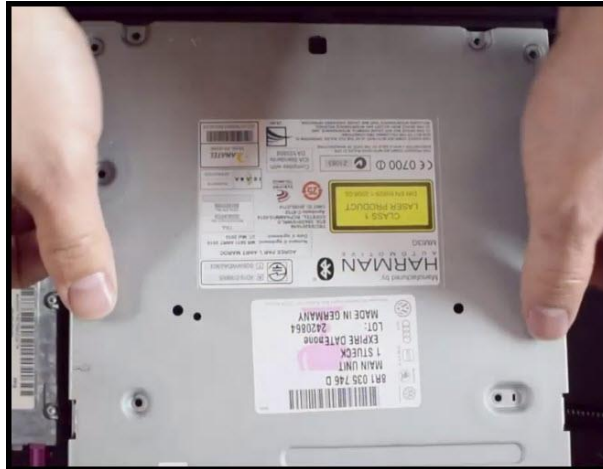
Figure 7. Pry top cover off with fingers.

9. Using a flat head screw driver, your fingers or a plastic wedge trim tool, remove the top cover by prying it from the back of the cover at the location seen in Figure 8. If a flat head screw driver is used then touch the tool to the ESD mat to discharge the tool prior to touching the main unit.

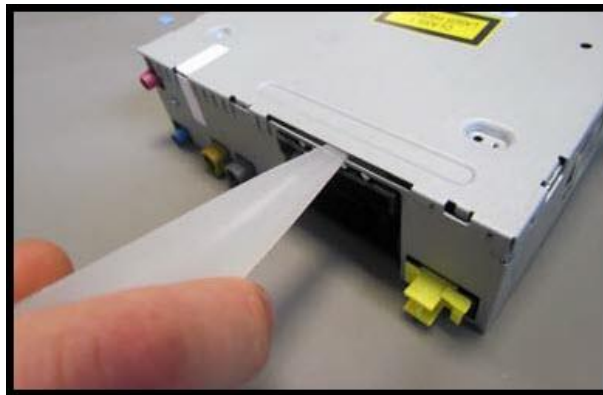
Figure 8. Pry top cover off using plastic trim wedge tool.

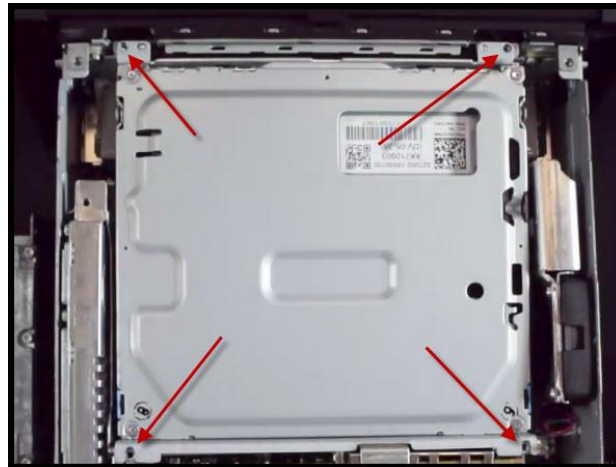
Do not flip the main unit over at this point. The CD drive, which was held in place by the top cover screws, is no longer secured. If it moves significantly, the ribbon cable can detach from the circuit board and disable the CD drive's functionality (Figure 9).

Figure 9. CD drive mounting points are free to move.

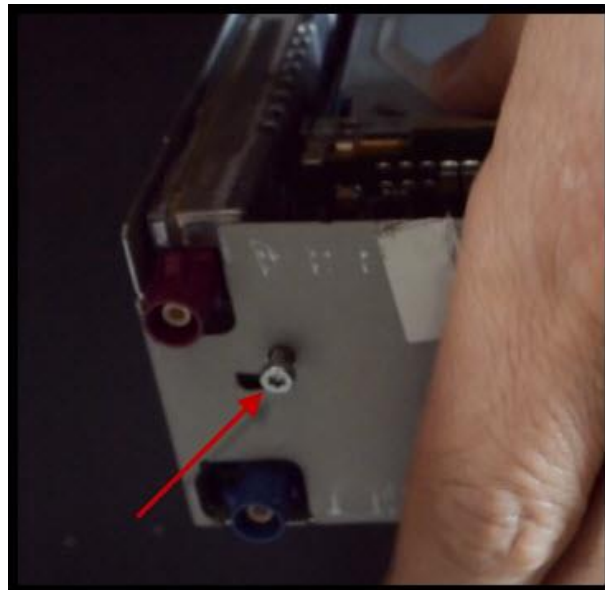
Figure 10. Telephone module retaining screw indicated by the red arrow.

10. On the back of the main unit, remove the retaining screw that holds the telephone module in place (Figure 10).

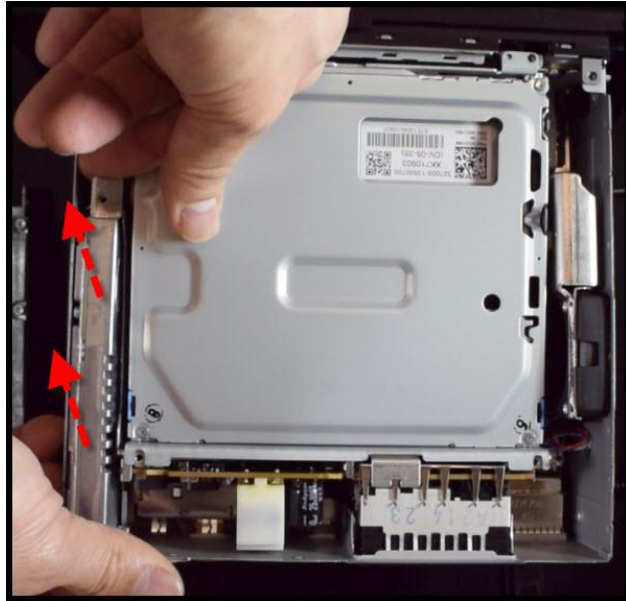
Figure 11. Lift up on both ends of the telephone module as indicated by the red arrows.

- Carefully lift up the telephone module, using both ends as points of contact when pulling up (Figure 11). The module is held in place with a computer socket-type attachment and will release when enough force is used.

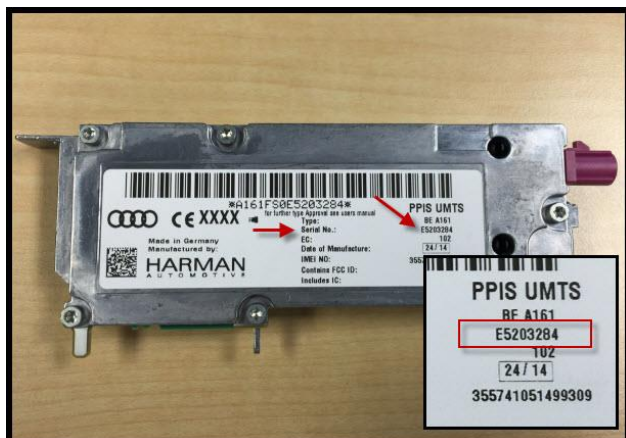
Figure 12. Serial number of the PPIS UMTS telephone module indicated by the red arrows and red box.

- Before proceeding, write the serial number of the new replacement UMTS telephone module on the rework label (Figure 12).

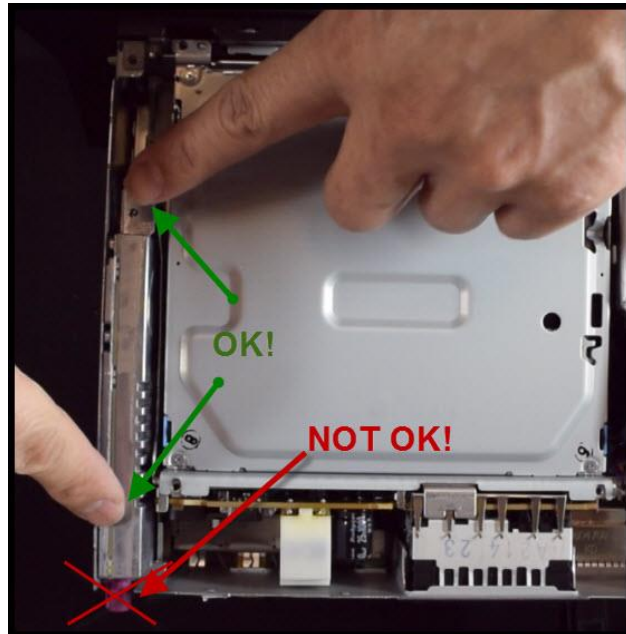
Figure 13. Do not press down using the purple FAKRA connector.

13. Place the new UMTS telephone module into the socket, making sure it is level before snapping it into place. Use both ends of the telephone module when pressing it into place. Do not press down using the purple FAKRA connector (Figure 13).

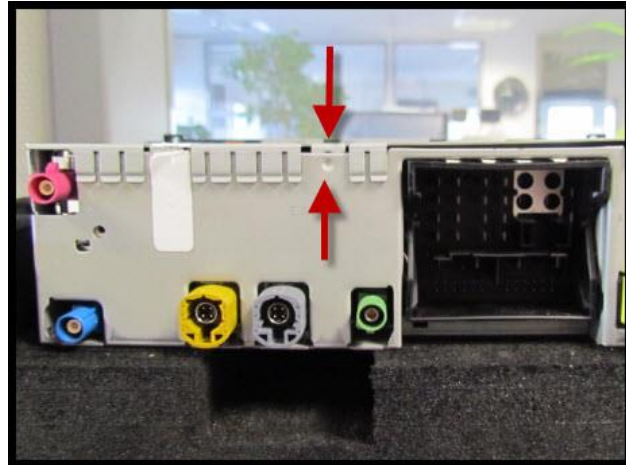
Figure 14. Place the new warranty seal over the location indicated by the red arrows.

17. Place the new warranty seal from the retrofit kit next to the original warranty seal (Figure 14).

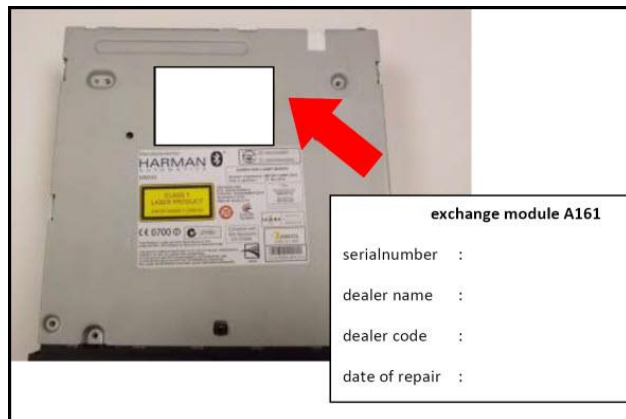
Figure 15. The white area indicates the “suggested” location for the repair label on the top cover of the main unit. Do not cover any existing part number labels.

18. Place the rework label on the top of the main unit cover. Do not cover any part number labels (Figure 15). Fill out all fields on the repair label.

Do not cover the yellow laser warning label. The repair label may need to be placed on sideways due to space limitations.
