Technical Service Bulletin

91 MMI3G+ GPS navigation location inaccurate or navigation takes a very long time to acquire location

91 16 71 2040406/6 September 8, 2016. Supersedes Technical Service Bulletin Group 91 number 16-56 dated July 7, 2016 for reasons listed below.

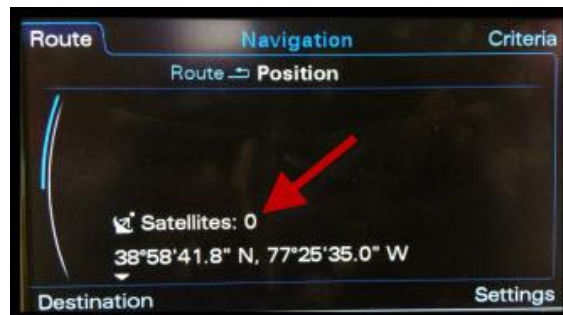
Figure 1. No satellite reception.

- When the issue occurs, the GPS navigation system satellite reception shows 0 satellites. Due to the infrequency of the issue, this might not be verifiable. (To view the number of satellites being received, go to *Nav >> Route >> Select Current Position* (first item in list) and scroll up (Figure 1)).

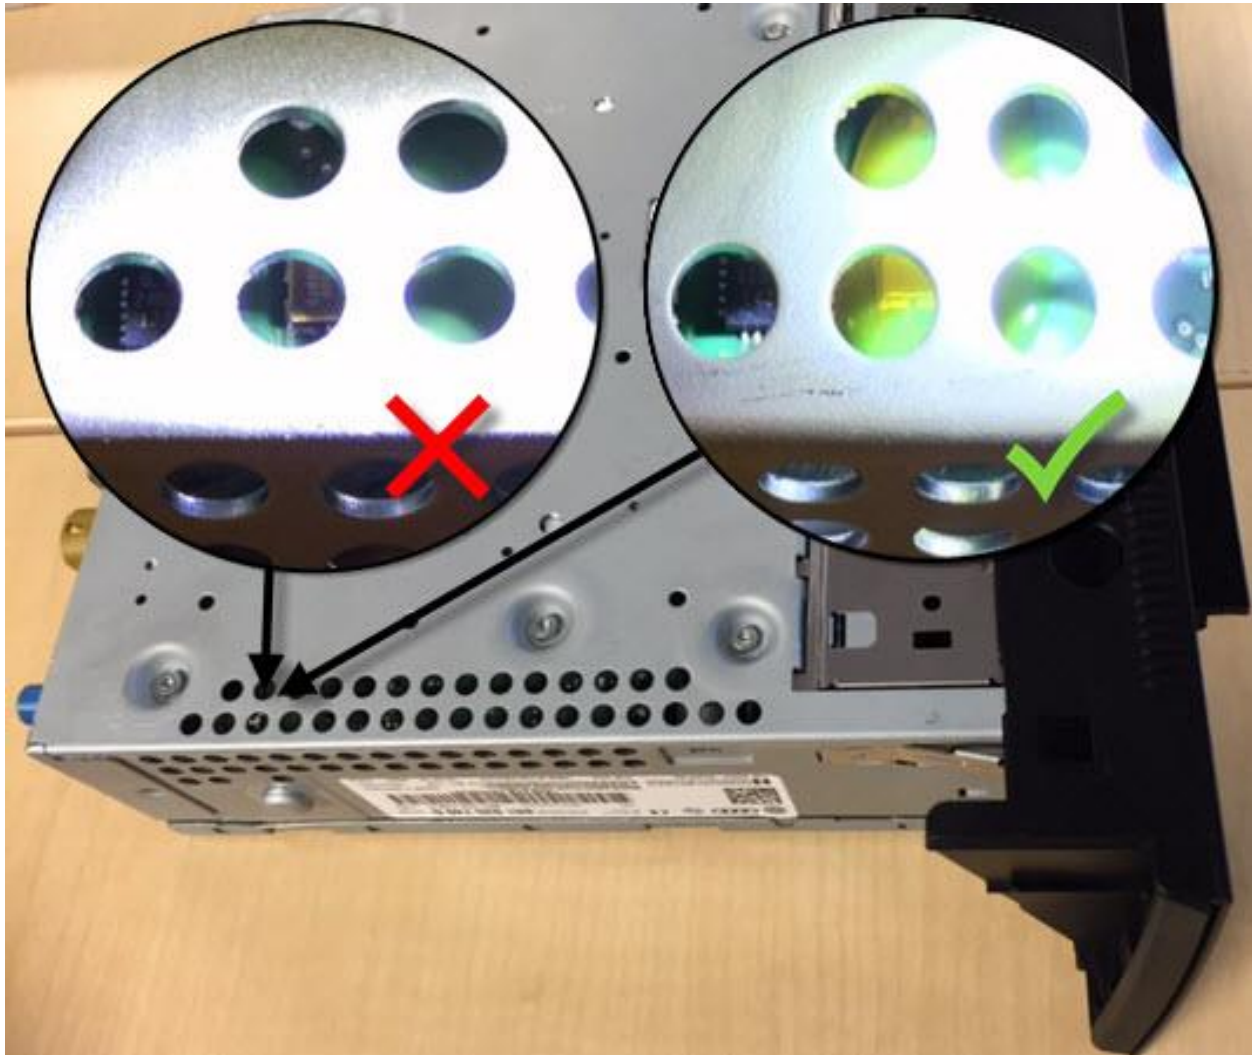
Figure 2. Example of integrated circuit chip without coating (left) and with coating (right). Parts without the coating over the integrated circuit chip are not okay and should be replaced.

3. Order a replacement MMI main unit using the applicable part number listed in the parts table below. There are different variants of main units that have support for a SIM card slot and some variants that do not. Once the new part arrives, check the integrated circuit chip of the GPS oscillator on the internal circuit board. The chip should have a translucent yellow coating (Figure 2).

Some early service parts did not have the coating despite the updated hardware part number (G suffix) and build date. All parts built after November 08, 2014 should have the coating over the integrated circuit chip. If the part does not have the coating over the integrated circuit chip, return the part and order a replacement.

If the parts department has problems getting updated parts with the integrated circuit chip coating, contact TAC. A small amount of specially modified parts are available for shipping directly from Audi of America.

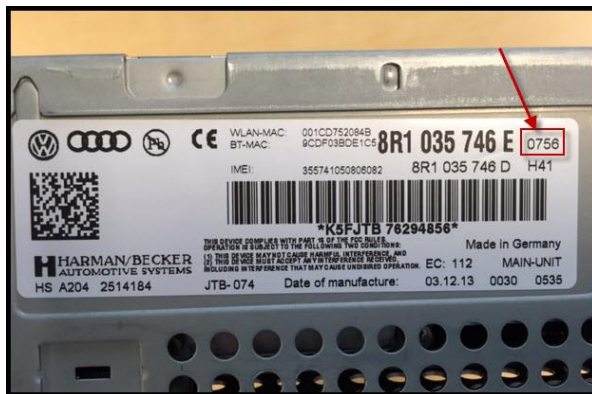
Figure 3. Main unit part label.

4. Check the label (Figure 3) on the side of the new part to verify that it contains software at level 0901 or higher. Install the replacement MMI main unit (information electronics control module 1, J794 (address word 5F)).

5.
 - If the software level is less than 0901, perform component protection removal, **repeat steps 1 and 2** and then move to step 6.
 - If the software is at 0901 or above (A6, A7, and A8 can have 0902), perform component protection removal and **repeat step 2**, then move to Step 6. Repeating step 2 will allow SVM to accept the new control unit with the updated part number.
6. Complete the GFF replacement test plan for the information electronics control module 1, J794 (address word 5F) with only the new MMI main unit installed in the vehicle (the original MMI main unit is not needed).
