Technical Service Bulletin

91 Rear Seat Entertainment software update for potential vehicle battery draw concern and improved functionality

91 16 73 2043660/3 September 14, 2016. Supersedes Technical Service Bulletin Group 91 number 16-41 dated April 27, 2016 for reasons listed below.

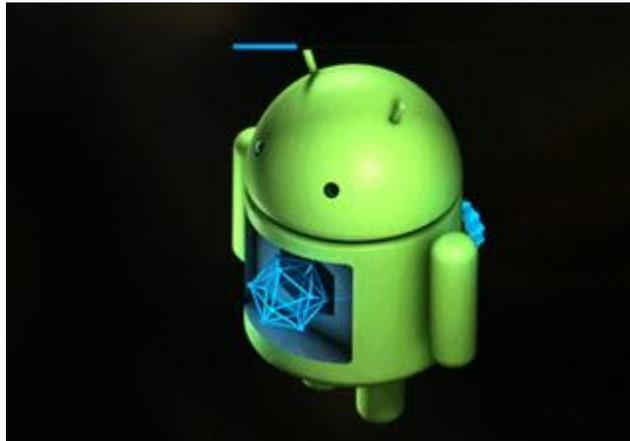
- A system update has been initiated but the system freezes at the Android update screen for many hours (Figure 1).

Figure 1. Android System Update Screen.

Tip: Most system updates include updates to the critical firmware including boot or recovery software. As a result the firmware may freeze during the update (Figure 1). This is completely normal and is no cause for replacement. If the system freezes during the update, then a full battery discharge is required to allow the firmware update to be completed.

**Note:** If the installation freezes at “Andy the Android” and does not progress (Figure 12), then unplug the tablet from its power source. If the tablet is docked in the vehicle, then carefully undock the tablet and turn off the vehicle. Then, ***allow the tablet to fully discharge (keep screen on)***. Test to see if the tablet has fully discharged by pressing the power button. If the tablet has fully discharged, the white LED light under the tablet will turn on and off briefly and the screen will remain blank. After discharging, plug the tablet back into the wall or dock it back into the vehicle (turn ignition on). Then turn the tablet back on and allow the installation to start again. Keep the tablet connected to the charger or vehicle while the

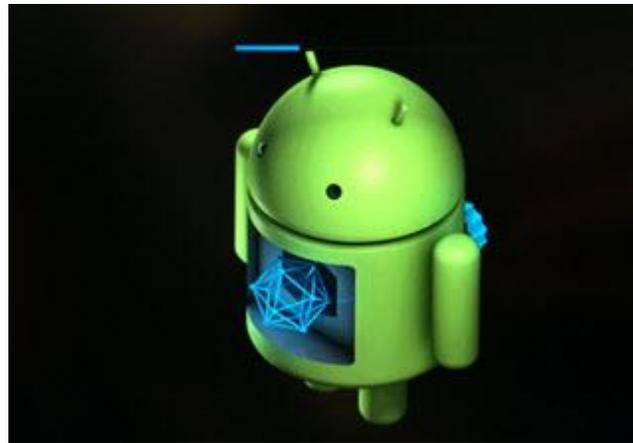
Figure 12. Android System Update Screen

installation completes. Repeat this process if the installation fails or freezes a second time.
