TECHNICAL BULLETIN

JTB00518NAS1

SECTION: 303-03

Engine Coolant Expansion Tank Leak

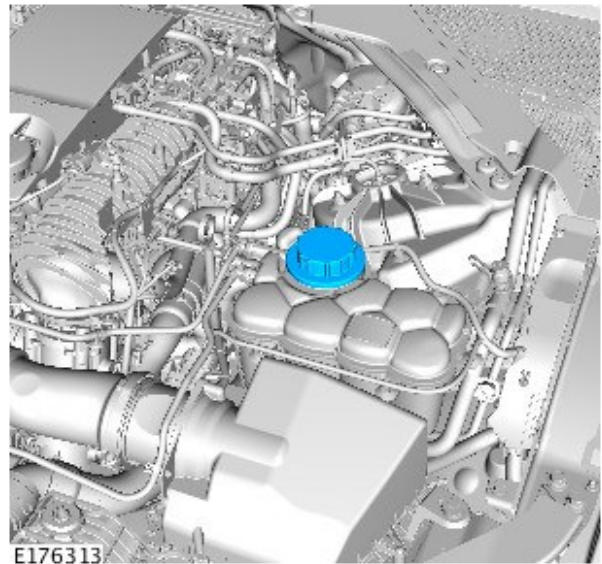
1. Remove the engine coolant expansion tank pressure cap.

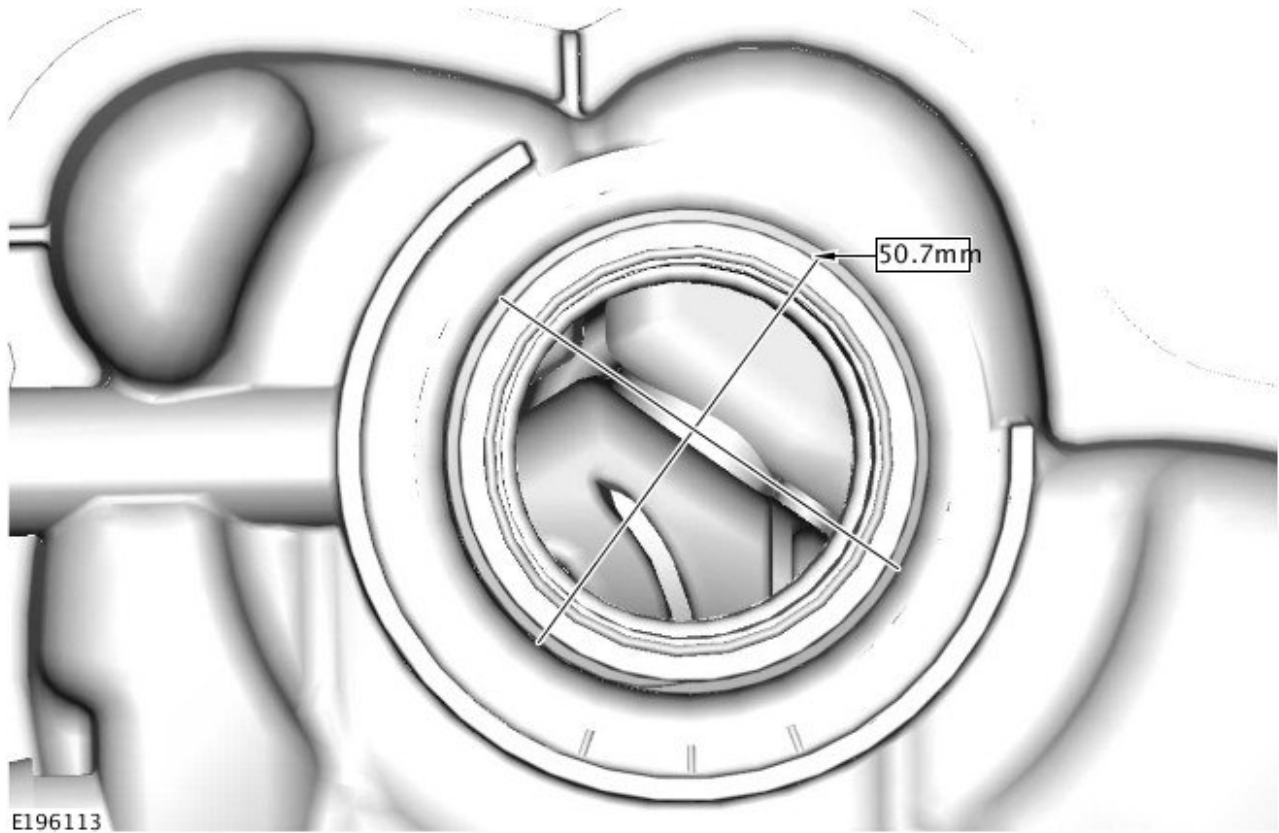
4. Visually inspect the sealing bead on the engine coolant expansion tank neck to check for damage.

- If the sealing bead is damaged, go to Step 5.
- If no damage is found:
 - Install a new engine coolant expansion tank pressure cap.
 - Top up the engine coolant to the MAX level mark.
 - Run the engine up to normal operating temperature, allowing the electric cooling fan to operate at least once without problem before releasing the vehicle.
 - Switch the engine OFF.
