# Technical Service Bulletin

## 01 MIL on; small EVAP leak (DTC P045600)

01 16 74 2044156/3 August 18, 2016. Supersedes Technical Service Bulletin Group 01 number 16-72 dated August 10, 2016 for reasons listed below.

Model(s)	Year	VIN Range	Vehicle-Specific Equipment
A6	2016	000001 - 111348	3.0 TFSI

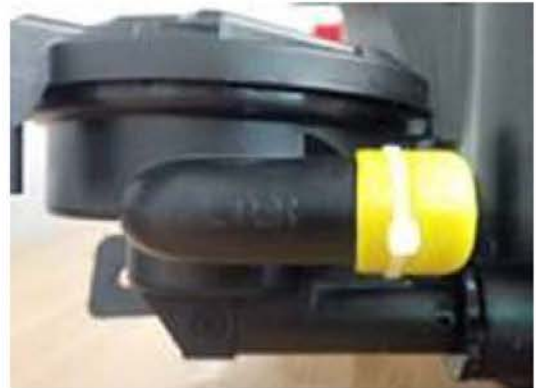
**Figure 1.** Block the filter port on the NVLD sensor.

3. Block off the filter port on the NVLD sensor (Figure 1).

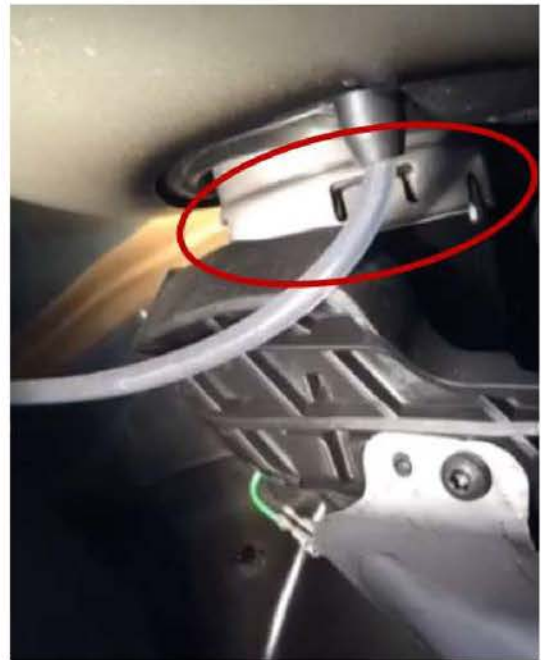
Rubber O-ring at tank filler neck is out of position.

**Figure 2.** Check for smoke escaping around the filler neck.

4. Connect the tester to the vehicle and pressurize the system (3–5 minutes).
5. Take a picture of the flow meter.
6. Remove the purge line from the N80 valve.
7. Generate smoke with the smoke function of the KLI9210 tester until smoke comes out of the purge line on the N80 side.
8. Smoke EVAP system under pressure.
9.
  - If smoke is escaping around the filler neck of the fuel tank (wheel liner removed) replace fuel tank (Figure 2).
  - If no leak can be found, contact TAC.
