Technical Service Bulletin

20 Noises from fuel tank area

20 16 77 2035591/3 August 31, 2016. Supersedes Technical Service Bulletin Group 20 number 14-42 dated December 19, 2014 for reasons listed below.

Model(s)	Year	VIN Range	Vehicle-Specific Equipment
Q7	2011 - 2014	All	3.0 TFSI

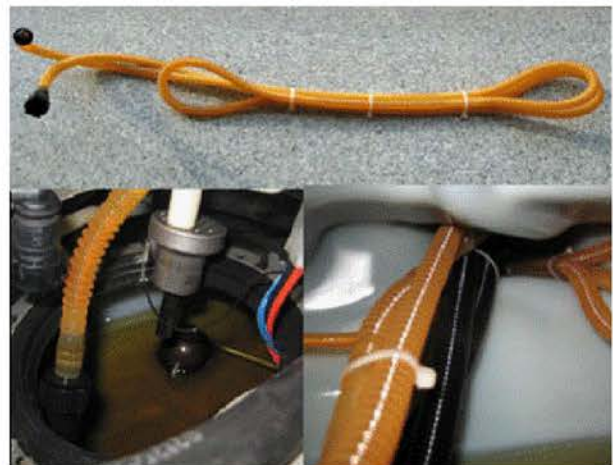
Normal fuel system pulsation can cause slight vibrations in the pressure regulator on the flange located on the right side of the fuel tank. This pulsation also causes the long, curved fuel lines (Figure 1) to vibrate and make a jarring noise in the tank.

Figure 1. The long, curved fuel lines that run across the fuel tank from right to left.

Long, curved fuel lines fastened with a tie wrap.

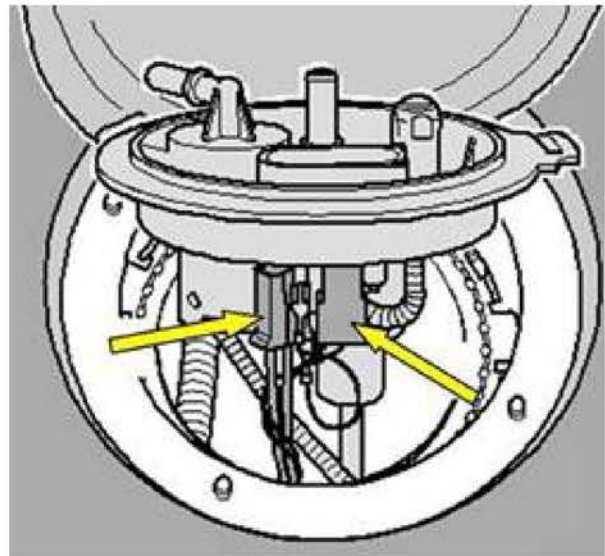
Figure 2. Two electrical connectors on the right locking flange to be disconnected.

1. Open the flange lock on the right side of the fuel tank according to the instructions in *Repair Manual >> Engine >> Fuel Supply System >> 20 Fuel Supply >> Removal and Installation*.
2. Slightly pull the right locking flange with seal out of the fuel tank.
3. Disconnect two electrical connectors on the underside of the right locking flange (Figure 2).

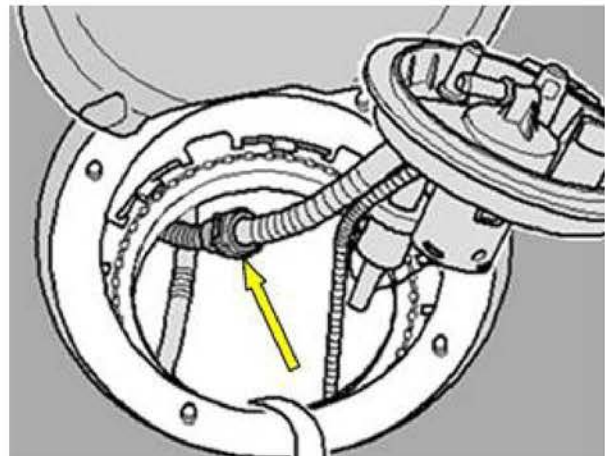
Figure 3. Fuel line connected to the locking flange.

4. Disconnect fuel line (Figure 3) by pressing release button.

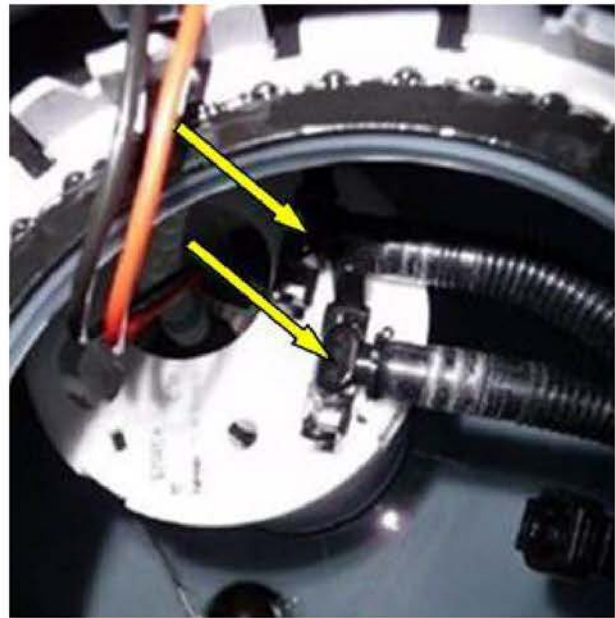
Figure 4. Black corrugated lines leading from the suction jets to be moved.

5. Disconnect the two black corrugated lines leading from the suction jets and move them to the left in order to create space for working on other fuel lines (Figure 4).

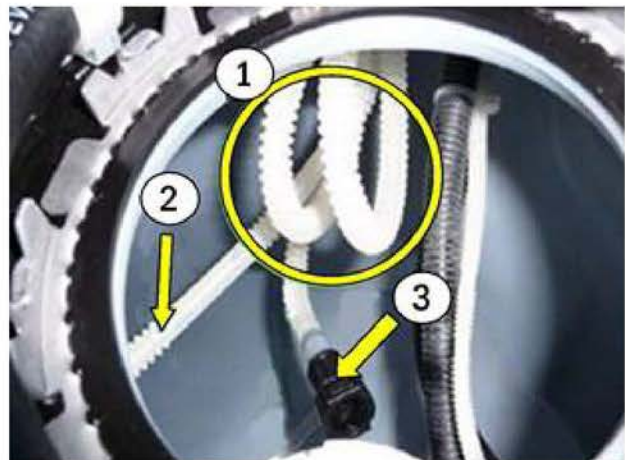
Figure 5. Curved fuel lines (1), fuel supply pipe (2), and fuel line.

6. Pull the curved fuel lines (Figure 5) as far to the right of the vehicle as possible without using force.

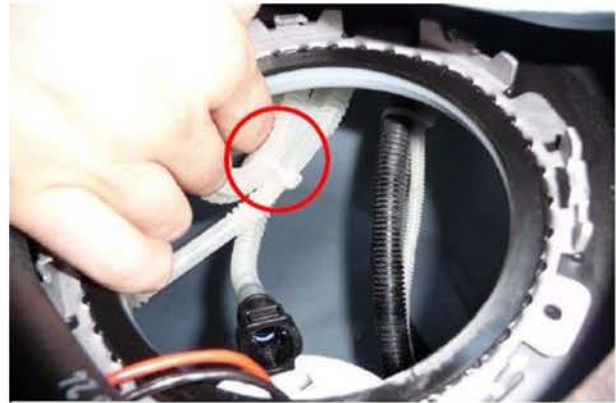
Figure 6. Curved fuel lines, fuels supply pipe, and fuel line tied together with tie wrap.

7. Tie the curved fuel lines, fuels supply pipe, and fuel line together with a tie wrap (Figure 6).

The tie wrap must be close to the lower section of the curve of the curved fuel lines to prevent any contact with the suction jet pipes.

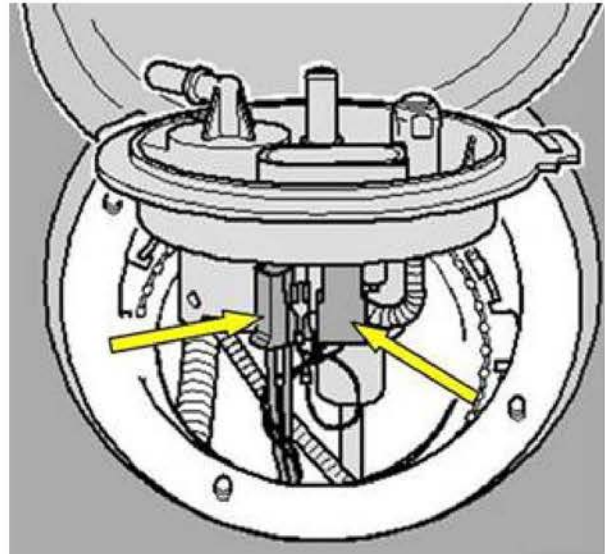
Figure 7. Two electrical connectors on the right locking flange to be reconnected.

8. Refit the two black corrugated lines leading from the suction jets. Reconnect the rest of the lines and reconnect the two electric connectors to the flange.
Reinstall the flange according to the instructions in Elsa, and ensure that the flange seal is positioned correctly.
