**LINCOLN:**  
2017 MKC

This article supersedes TSB **16-0148** to remove the production fix date.

### **ISSUE**

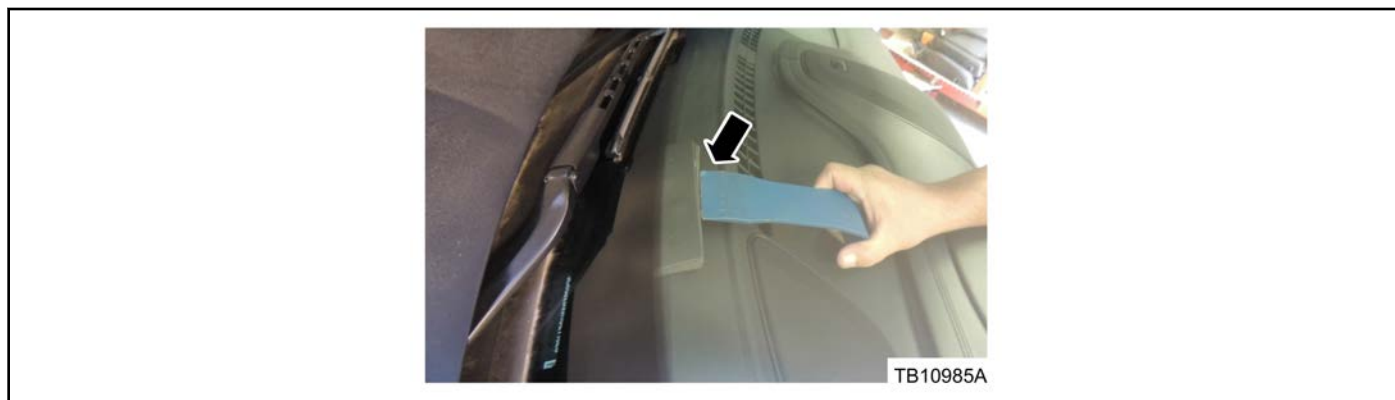
Figure 1 - Article 16-0156

Some 2017 MKC vehicles may exhibit a buzz/rattle noise from the left side of the defrost vent trim panel. This is due to the defrost vent trim panel contacting bare metal on top of the cowl close to the windshield.

1. With the protective backing removed, uniformly stack together 3 pieces of polyvinyl chloride (PVC) soft foam tape 164-R4901 from the Rotunda Squeak and Rattle repair Kit 164-R4900 to create a thickness of 9.5 mm (3/8 inch).
2. Insert the PVC soft foam tape lengthwise at the forward edge of the defrost trim panel where it meets the windshield. Position the tape between left speaker grille and defrost air vent opening as shown. (Figure 1)

3. Using a plastic trim tool wedge the piece of PVC soft foam tape down until the tape is no longer visible and will not show in the reflection of the glass.
