Bulletin No.: PIT5291B

Service Bulletin

Subject: Wind Whistle Noise At Highway Speeds From Left Or Right Rear Quarter Glass Area

Models: 2015-2016 Chevrolet Suburban, Tahoe

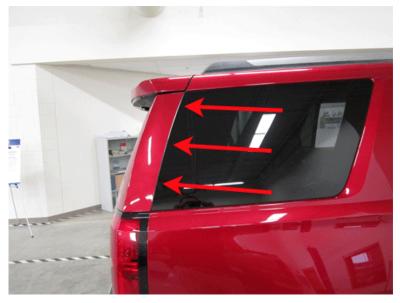
1. The fit between the exterior "D" pillar trim and the rear quarter glass in the area shown below.

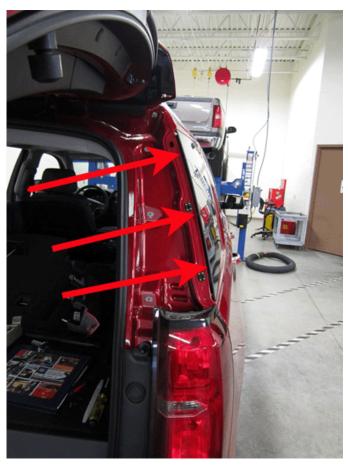
Excessive urethane from the quarter glass installation may not allow the exterior "D" pillar trim to fit properly against the rear quarter glass, as shown below.

1. Use a sharp knife and cut off the excessive urethane, as shown below. In most cases the urethane will need to be cut sub-flush to the sheet metal. This will allow the exterior "D" pillar trim to fit correctly against the rear quarter glass.

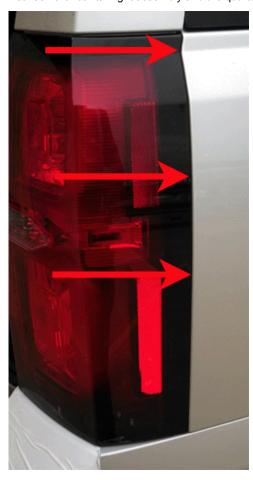
2. Between the rear tail light assembly and the quarter panel, as shown below.

2. Install a 5mm X 5mm (3/16 X 3/16) piece of closed cell foam tape along the entire length of the tail light assembly, as shown below.
