Bulletin No.: PIT5364B

Subject: SES Lamp On With DTC P151E

Models: 2015 Chevrolet Colorado

2015 GMC Canyon

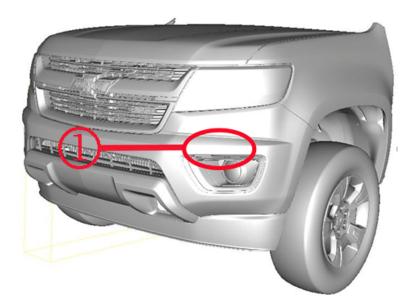
This jumper will be installed between the connector halves of X105 which is attached to the tie bar behind the left side of the fascia. The picture (1) below indicates its position but the fascia does not need to be removed for this procedure.

Separate the connector halves, install jumper harness PN 23390136 between them, and ensure they snap together.
