TECHNICAL BULLETIN
JTB00507NAS1
15 JUL 2016

SECTION: 417-01

Hood May Contact Headlamp(s)

XF (X250)

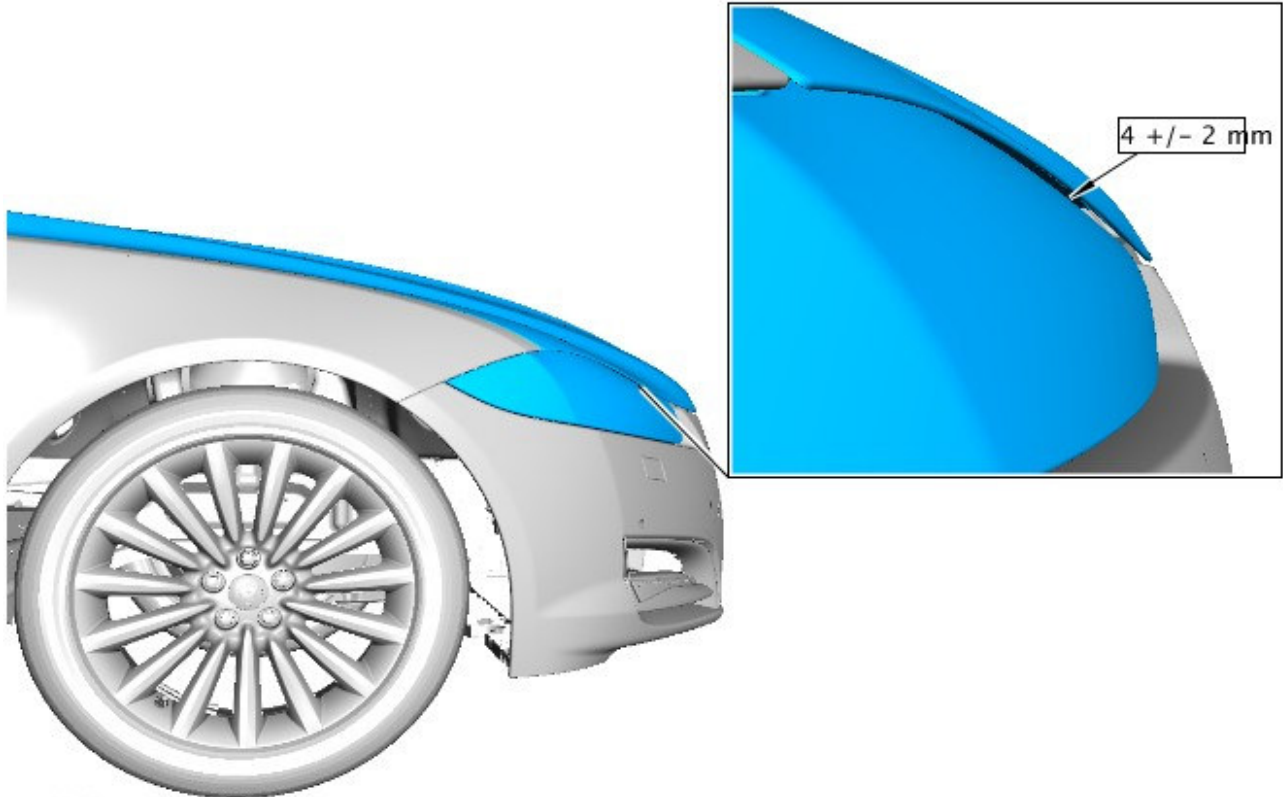
E193784

**NOTE: Gap specification: $4 \pm 2\text{mm}$.**

Using a suitable tool, measure the headlamp-to-hood gap.

- If the headlamp-to-hood gaps are not within specification ($4 \pm 2\text{mm}$), continue to Step 2
- If the headlamp-to-hood gaps are within specification ($4 \pm 2\text{mm}$), this is not the cause of the customer concern. Do not continue with this Technical Bulletin.

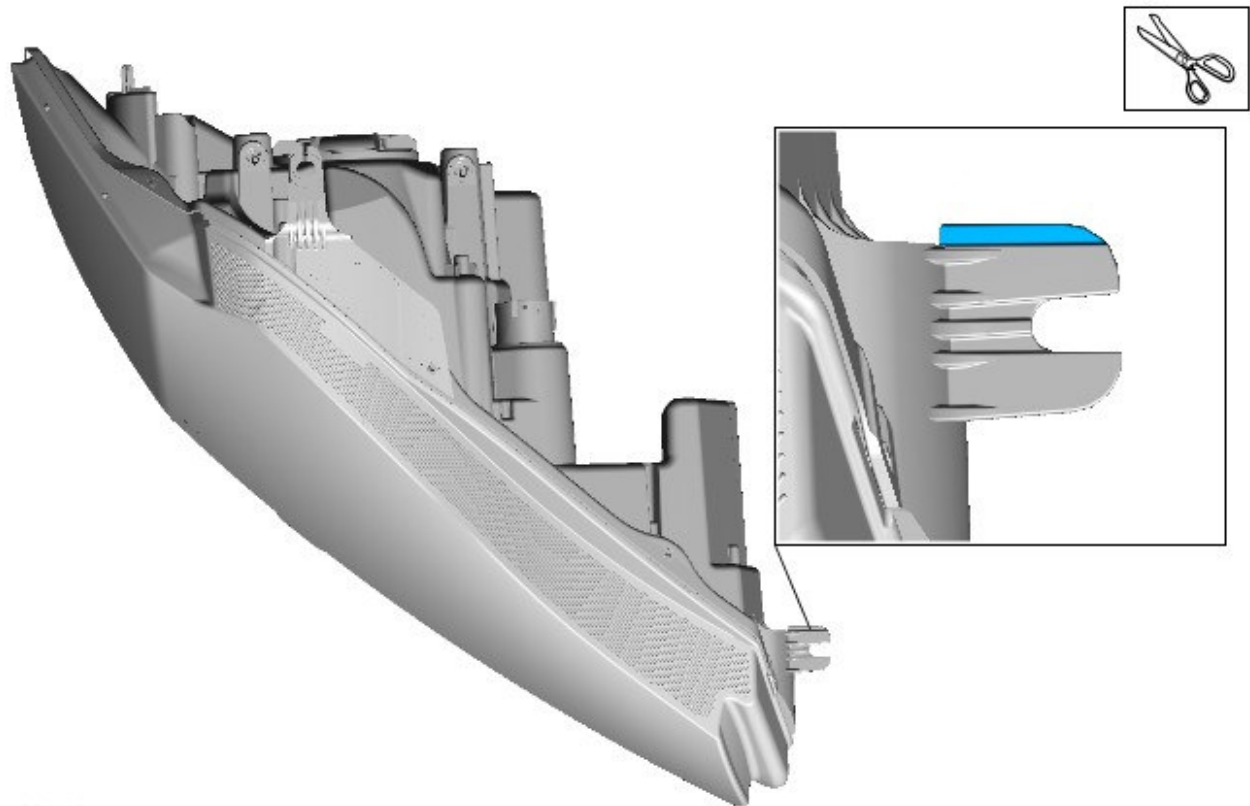
E193519

**NOTE: Right hand-lamp shown; left-hand lamp similar.**

Trim the tab off the new headlamp(s) before installation as shown.

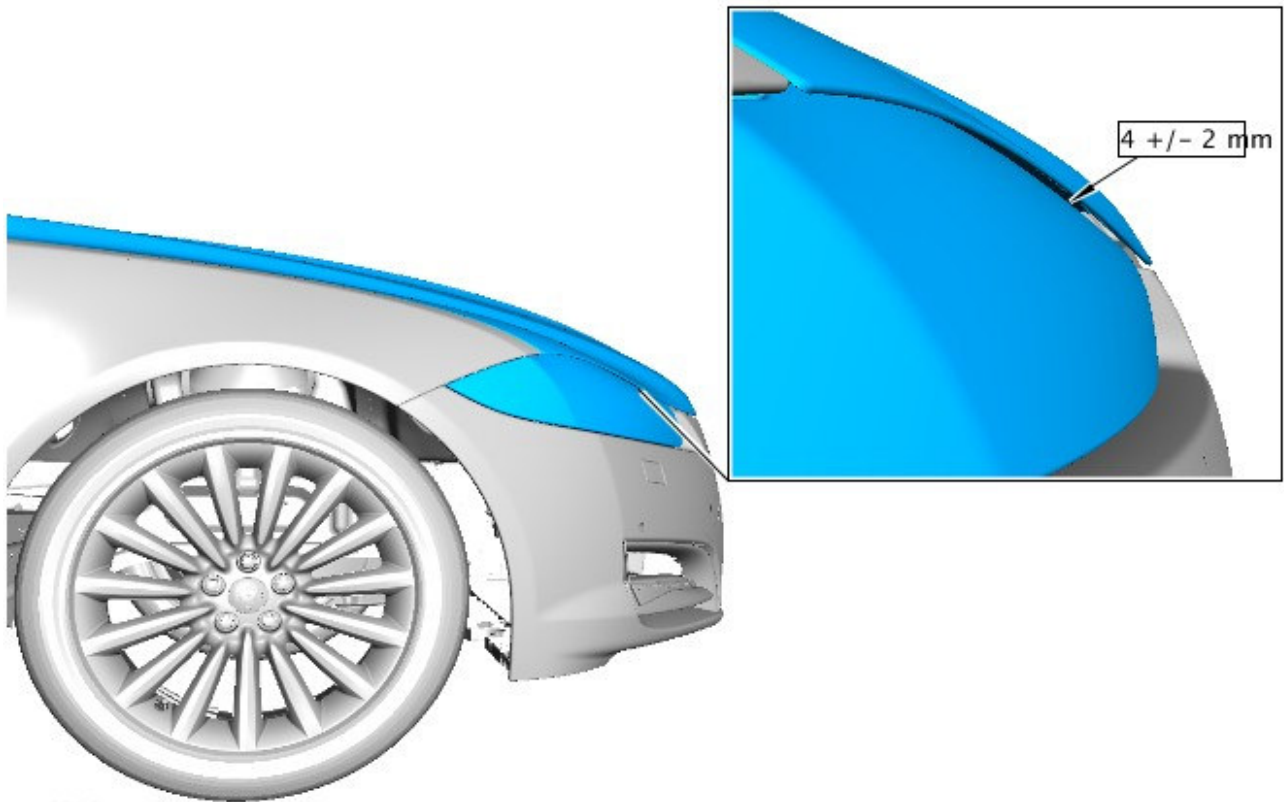
E193784

**NOTE: Gap specification: $4 \pm 2\text{mm}$.**

Using a suitable tool, measure the headlamp-to-hood gap.

- If the headlamp-to-hood gaps are not within specification ($4 \pm 2\text{mm}$), continue to Step 8.
- If the headlamp-to-hood gaps are within specification ($4 \pm 2\text{mm}$), continue to Step 10.
