Technical Service Bulletin

90 Night vision system inoperative; DTC: B201000 (no basic settings)

90 16 70 2045020/1 August 31, 2016.

Model(s)	Year	VIN Range	Vehicle-Specific Equipment
A6, A7	2015 -2017	All	With night vision system

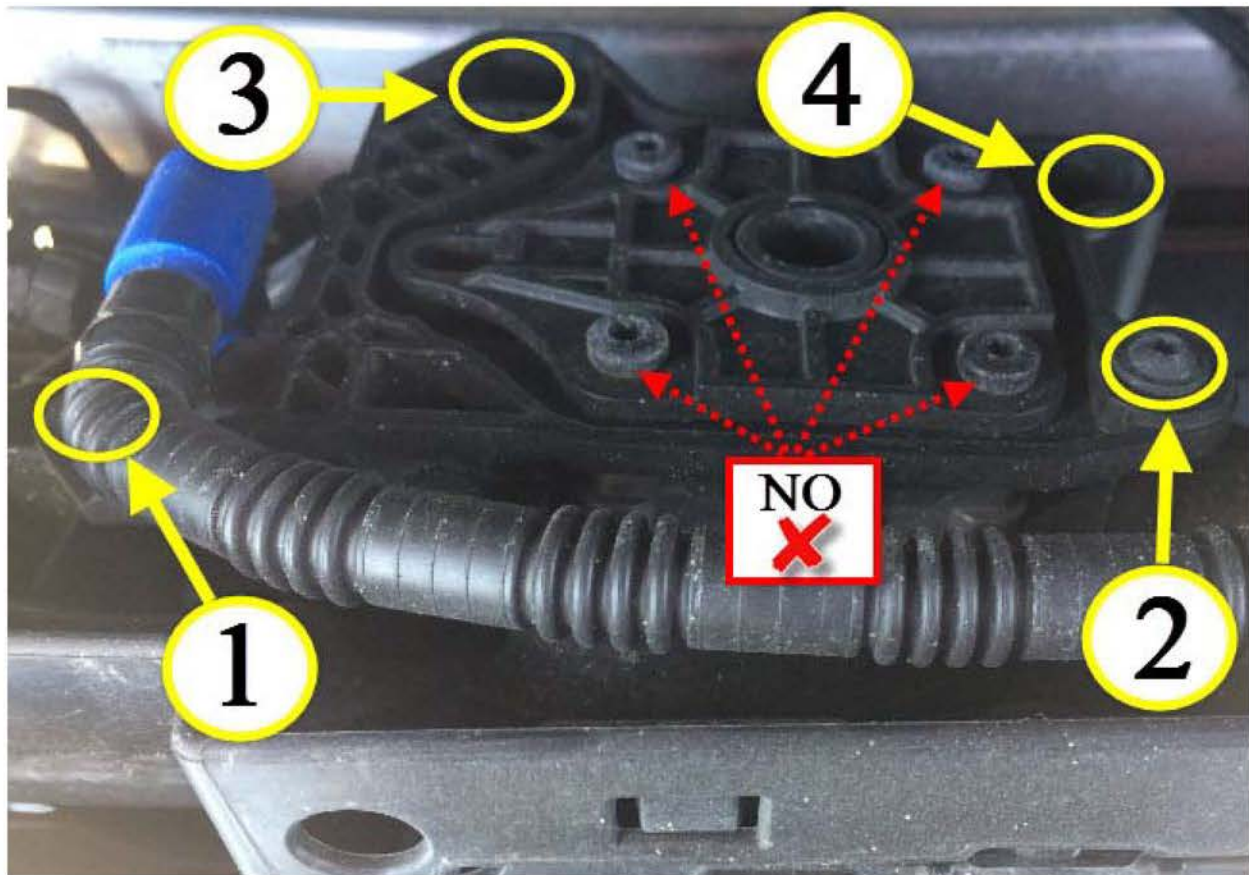
Figure 1. Night Vision Camera Mounting Bracket Screw Retainer Locations 1,2,3,4. Loosen Screws 1,2,3,4. Do not remove or loosen the four screws holding the camera to the bracket.

6. Loosen the night vision camera mounting bracket by loosening the four mounting screws that hold the mounting bracket to the radiator grill. Mounting screws are shown in the image below (Figure 1) by numbered arrows 1,2,3, and 4. Do not remove or loosen the four screws that hold the camera onto the camera mounting bracket, these are shown in the image with red dotted arrows.

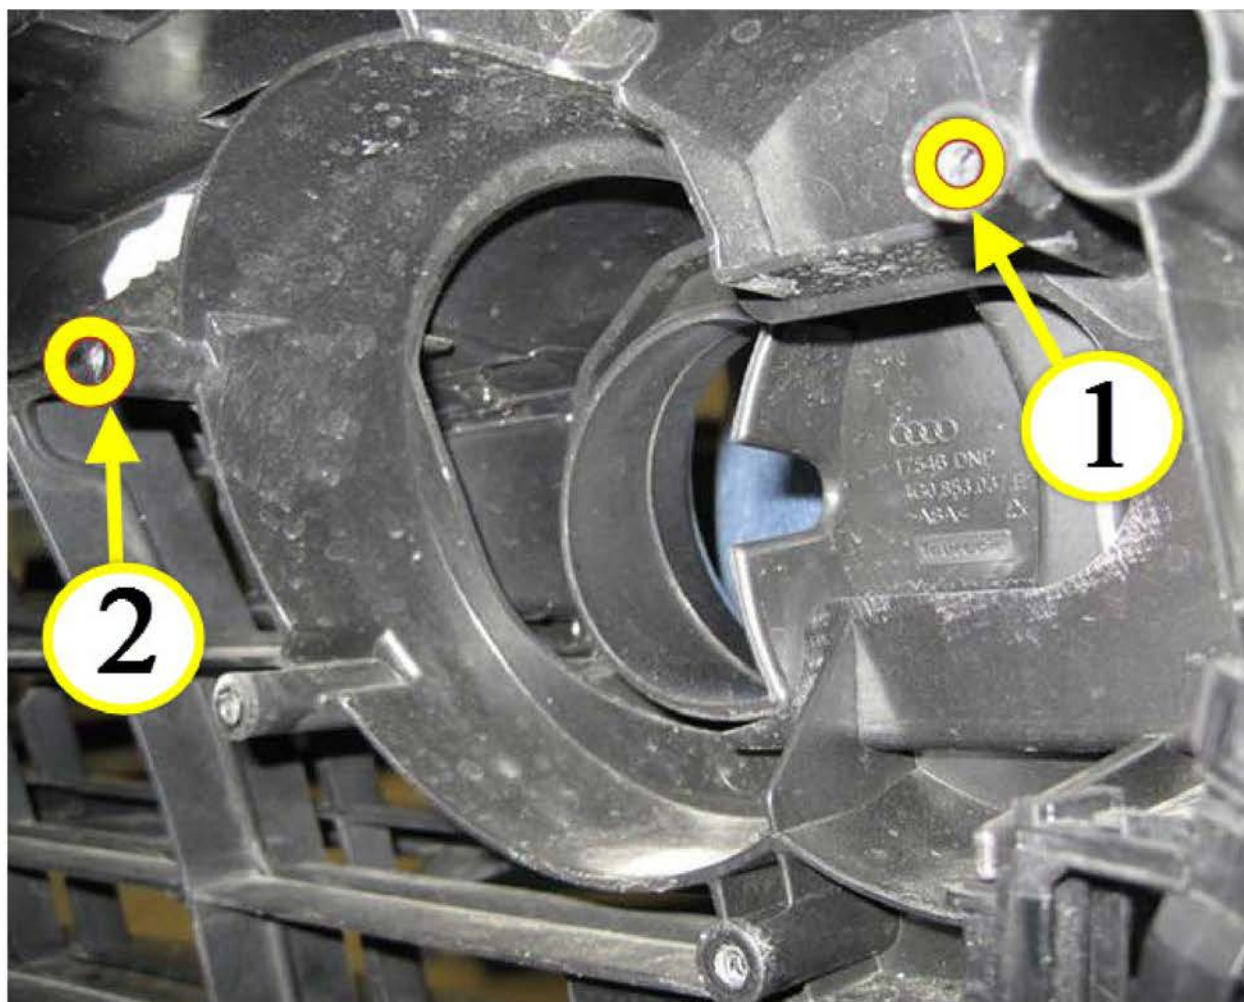
Figure 2. Radiator grill screw retainer locations with camera removed for reference. Spacer (N01152322) will be placed at locations 1 and 2.

7. Place a single spacer, part number N01152322, between each of the two upper mounting points that secure the night vision camera bracket to the radiator grill. These screws are shown in the above image as points 1 and 2 (Figure 1). The image below (Figure 2) references these points on the radiator grill as 1 and 2. The next image (Figure 3) shows placement of the spacer on the camera as points 1 and 2, the camera has been removed for clarity.

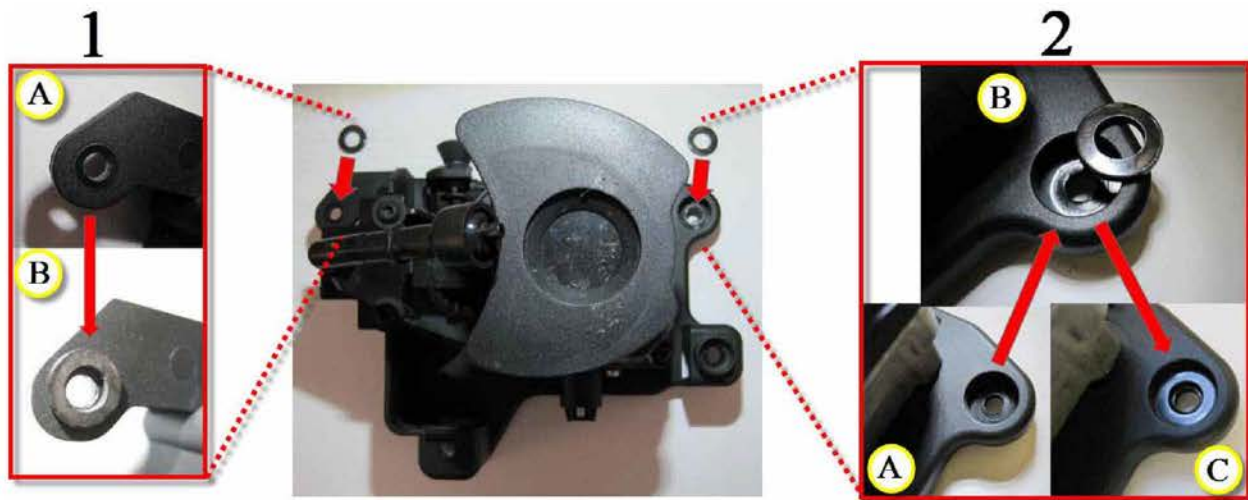
Figure 3. Additional photo showing spacer placement with the camera removed for reference. Place spacer on the grill facing side of the camera's upper mounting surface in positions 1 and 2.

8. After positioning the two spacers between the night vision cameras upper mount points and the radiator grill, torque all four screws to 2.5Nm.
9. Perform the calibration of the night vision system once again. Following the calibration, the new final pitch angles displayed by the tester should be between 0.3° and 1° less than the original values recorded. A final pitch value between $+0.5^{\circ}$ and $+1.1^{\circ}$ is acceptable.
10. If this is an RS 7 model, additional systems must also be calibrated due to removal of the front bumper. Consult the Elsa repair manual for these procedures.
