TECHNICAL BULLETIN

K415 UPS5616-5bNAS1

Update Prior to Sale: Water Ingress - Left Hand A Post

XE (X760)

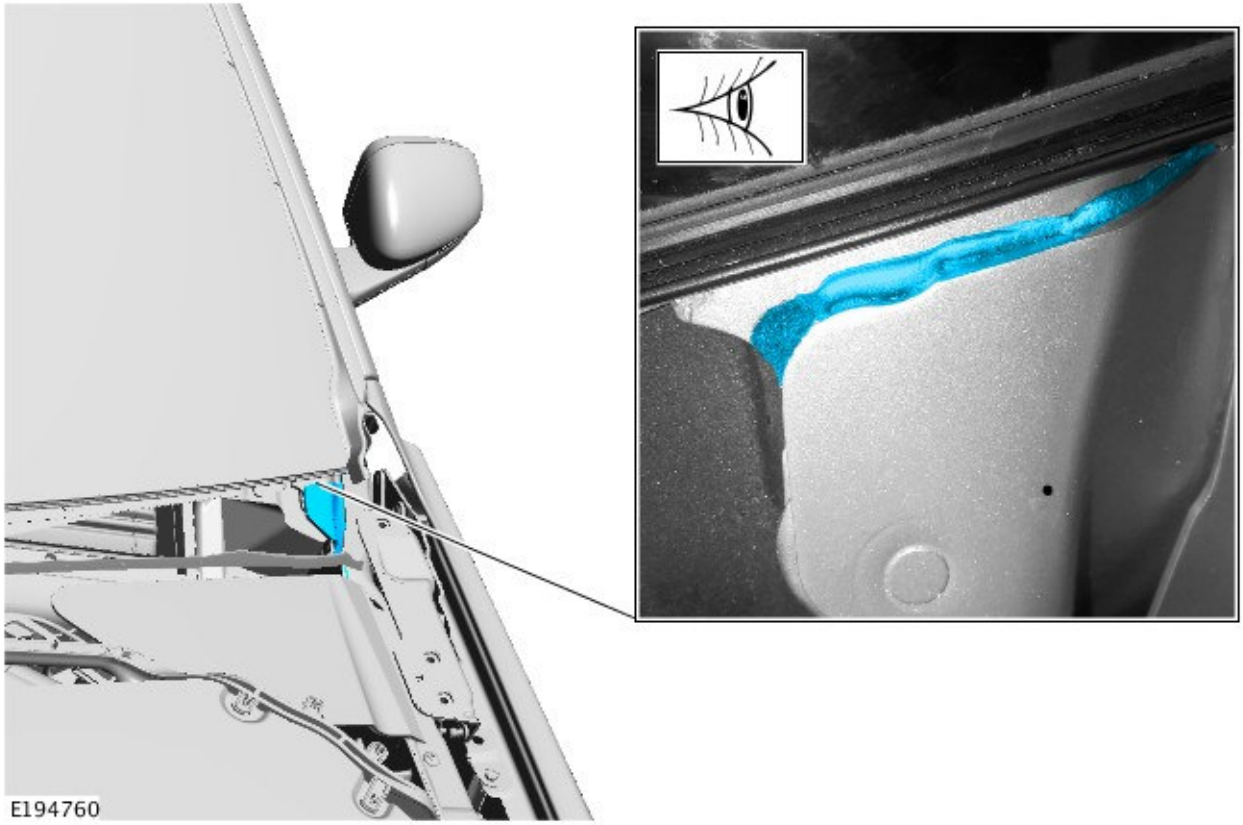
Visually check to see if the sealant is applied in the area shown.

- If the sealant is applied, no corrective action is required.
 - Install the cowl panel vent screen (see TOPIX Workshop Manual section 501-02: Front End Body Panels).
 - Release the vehicle for onward distribution or sale.
- If the sealant is not applied, continue to Step 3.

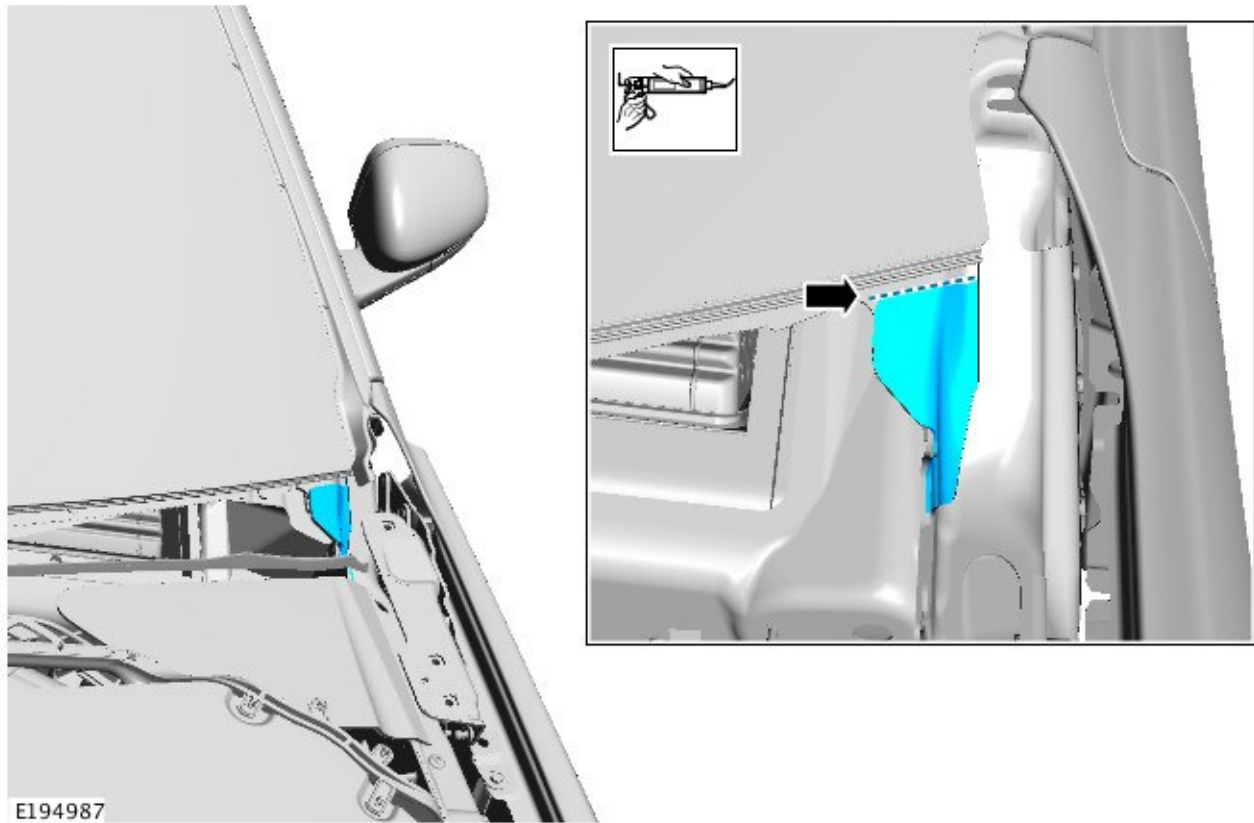
Situation: An issue has been identified on a limited number of vehicles within the listed Affected Vehicle Range where a change to the robotic sealing process occurred which led to a small area of sealant in the vicinity of the cowl panel being omitted only on the left-hand side of the vehicle. Consequently, water may run through the 'A' Pillar into the footwell area of the vehicle.

3. Apply sealant to the area shown.

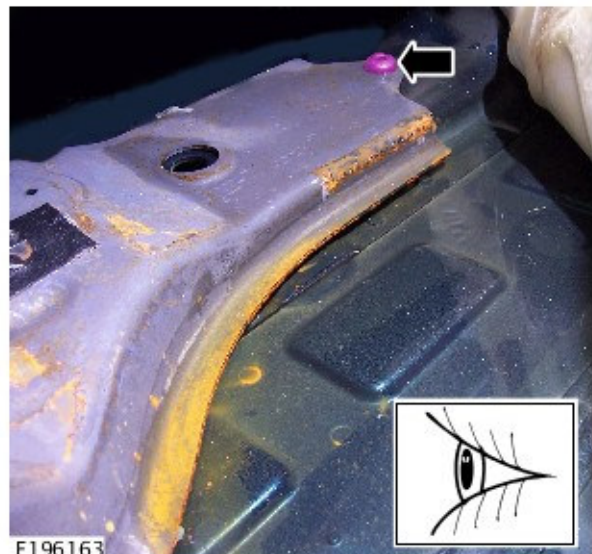
17. Visually inspect the body brace for corrosion.

18. Remove corrosion and paint body brace.

1. Remove the body brace fixing.
2. Remove the body brace.
3. Remove any corrosion with a wire brush or similar tool.
4. Clean both sides of the body brace with a spirit wipe cloth.
5. Paint both sides of the body brace with etch primer.
6. Allow to dry.
7. Paint both sides of the body brace with finish coat.
8. Allow to dry.
9. Install the body brace and fixing.

- Torque: **40 Nm**.

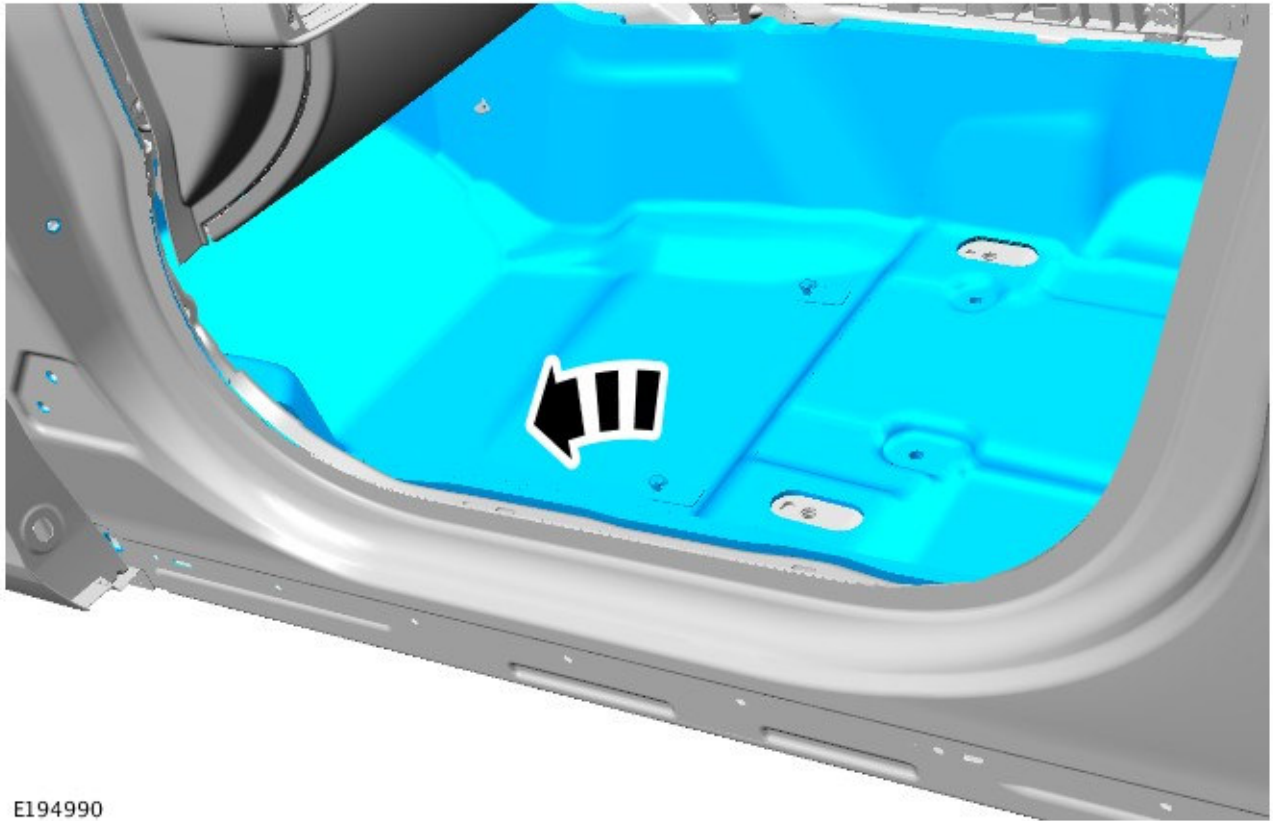
E194990

Check if the front and/or rear left-hand carpets are wet and if they can be dried to an acceptable standard.

Remove the front and/or rear left-hand carpets and continue to hold the vehicle.
