Reference	SSM72778
Models	F-PACE / X761
Title	X761 - F Pace Diesel Exhaust Fluid Leakage from filler bowl area
Category	Engine
Last modified	18-May-2016 00:00:00
Symptom	404000 Fuel System Concerns
Attachments	Image 1.jpg (Image 1.jpg) Image 2.JPG (Image 2.JPG) Image 4.JPG (Image 4.JPG) image3.JPG (image3.JPG)

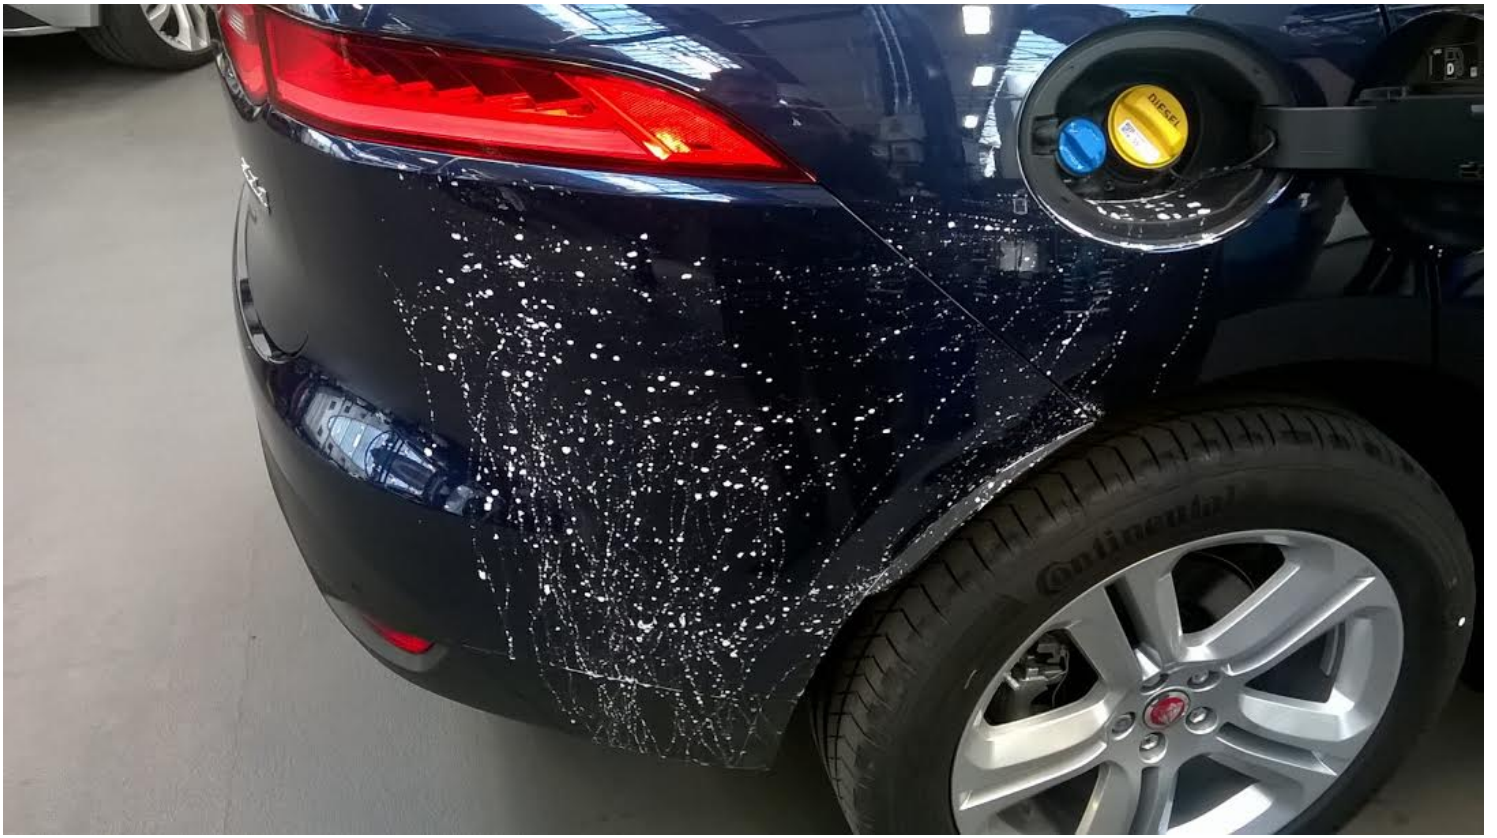
Issue:
Diesel Exhaust Fluid (DEF) leakage from Fuel Filler bowl area – This will be identified as white fluid staining on the right hand side of vehicle towards the rear. (See image 1)

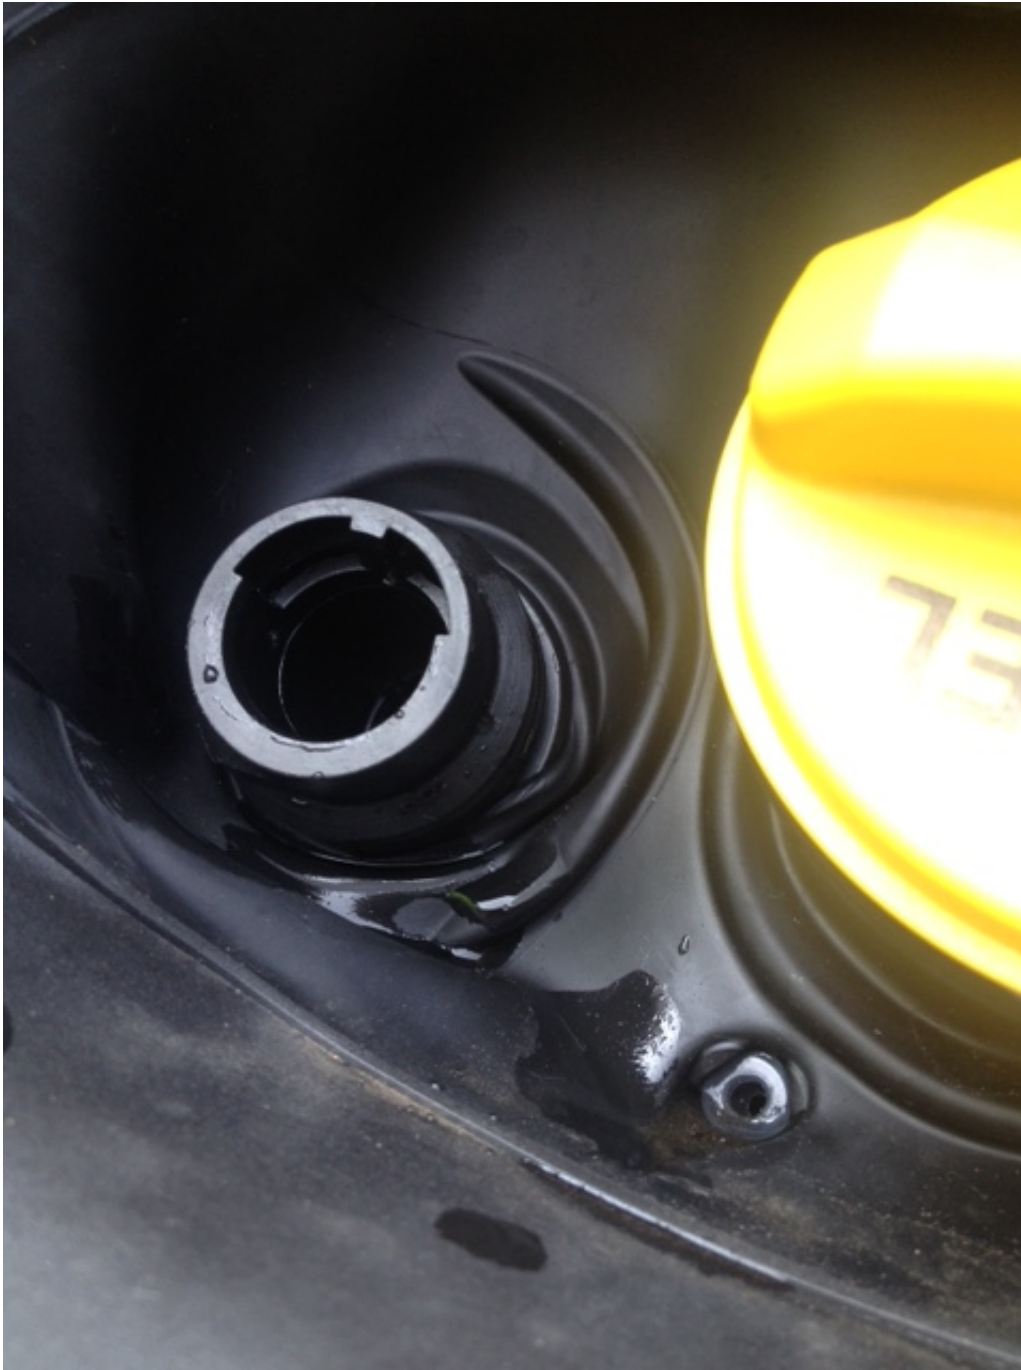
Cause:
Incorrect fitment of DEF/Fuel filler bowl causing insufficient tightening of DEF filler cap. (See image 2)
