Reference	SSM72625
Models	XJ / X351
Title	SIM Card Replacement 16MY XJ InControl Touch Pro
Category	Electrical
Last modified	18-Feb-2016 00:00:00
Symptom	207000 Entertainment Systems
Attachments	1ICCID.jpg (1ICCID.jpg)

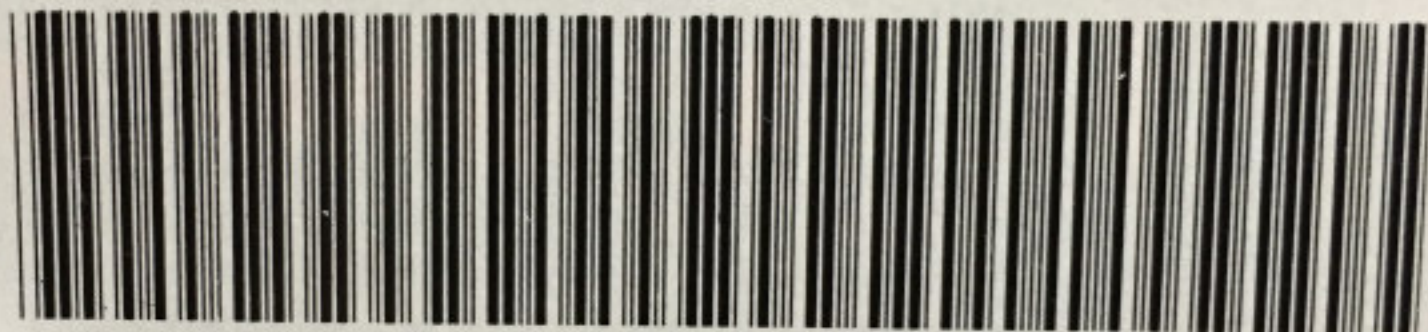
Once a new SIM card has been received, it must be paired with the vehicle. To pair the SIM card with the vehicle, a request for Technical Assistance (TA) will have to be opened with the Technical Helpline. To help the Technical Helpline process your request faster, please have a clear photo of the SIM card packaging showing the ICCID attached to the TA. The Technical Helpline will then forward the case to the Telematics Hub to have the new SIM paired with the vehicle.
