TECHNICAL BULLETIN

Q614NAS1

Service Action: Missing Grommet

Discovery Sport (LC)

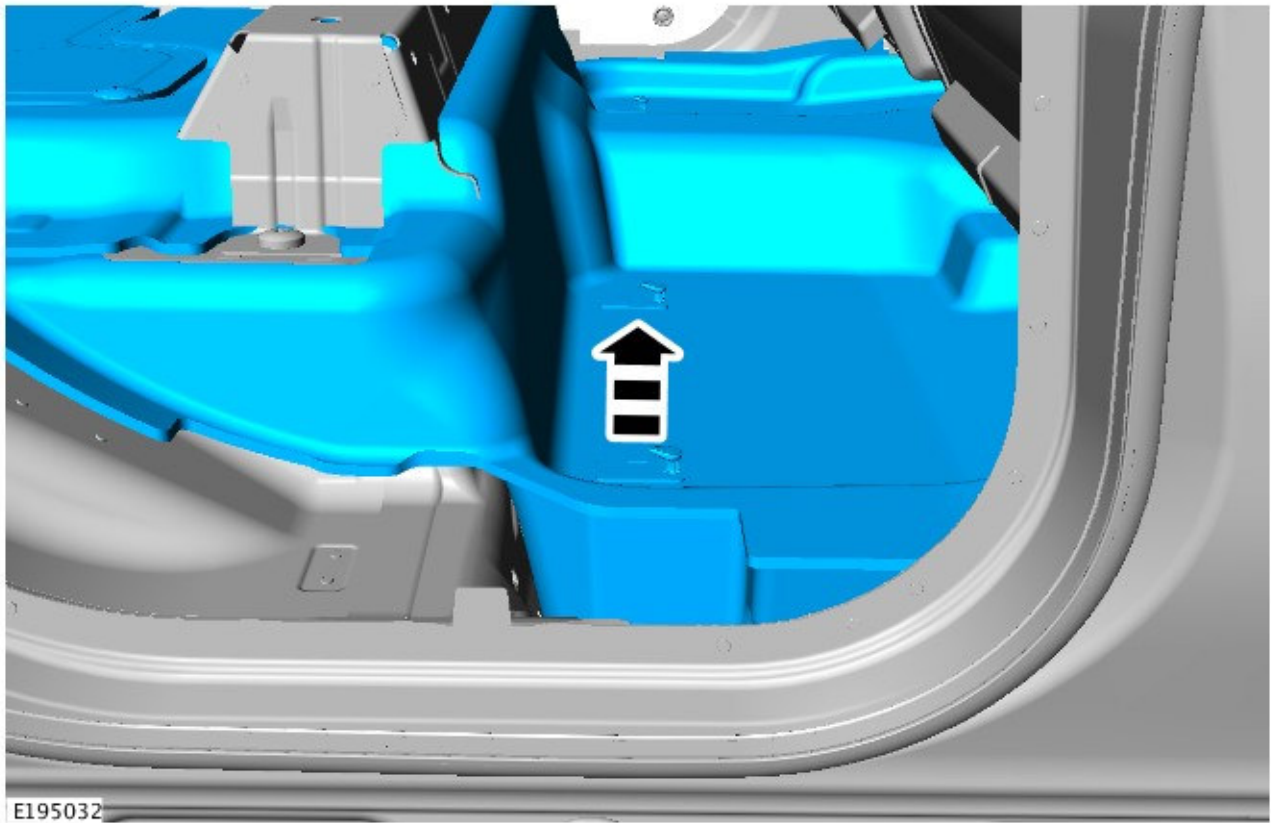
**NOTE: Take care when positioning the carpet to one side as this can damage the Noise, Vibration and Harshness (NVH) material.**

Position the rear right-hand carpet to one side to access the grommets.

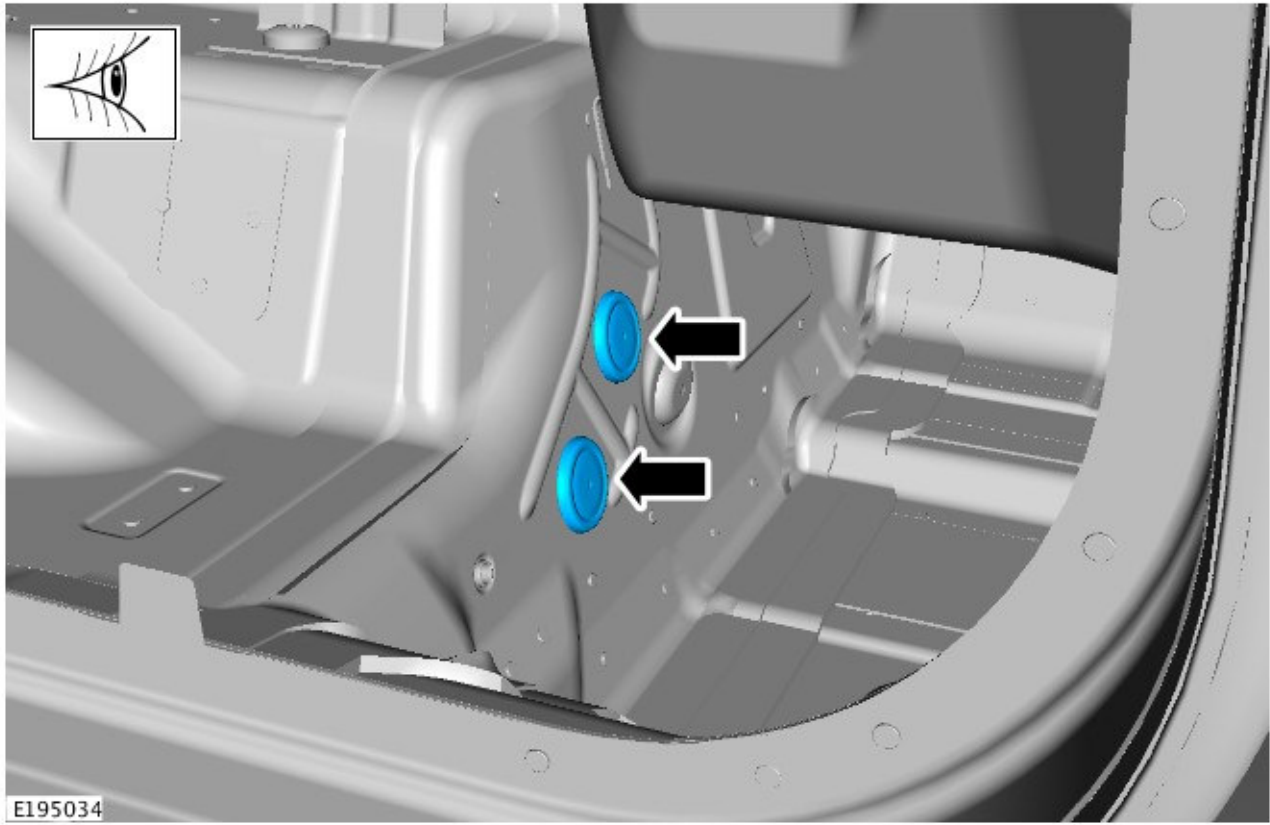
4. Visually check to see if the grommets are installed.

- If the grommets are installed, go to Step 6.
- If the grommets are not installed, go to Step 5.
