TECHNICAL BULLETIN

LTB01001NAS1

SECTION: 303-14

Engine Speed Drops During Windshield Wiper Operation

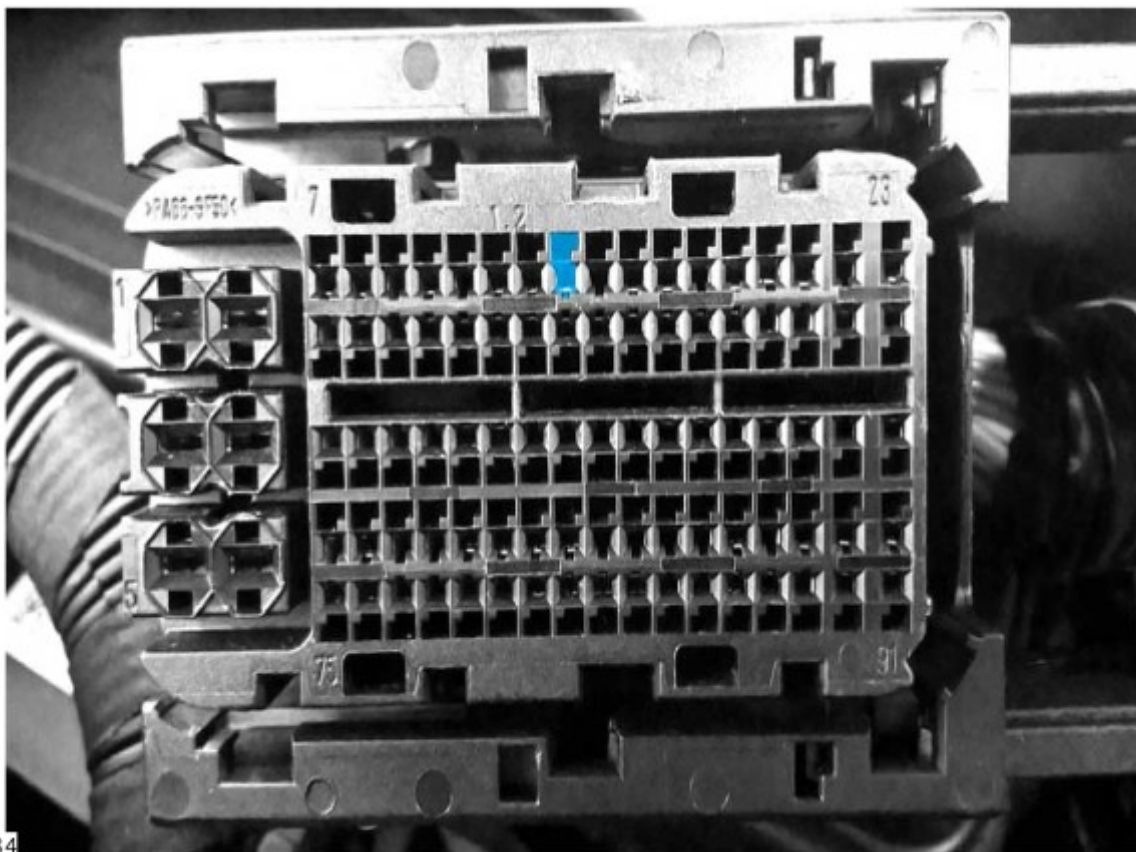
E196934

**NOTE: The pin to be removed is a green/orange 0.5mm wire.**

Using tool JLR-418-595 from tool kit JLR-418-684, remove the pin from location 14.
