TECHNICAL BULLETIN
Q637 UPS7716-4bNAS1
13 OCT 2016

Update Prior to Sale: USA Battery Legal Label

Discovery Sport (LC)

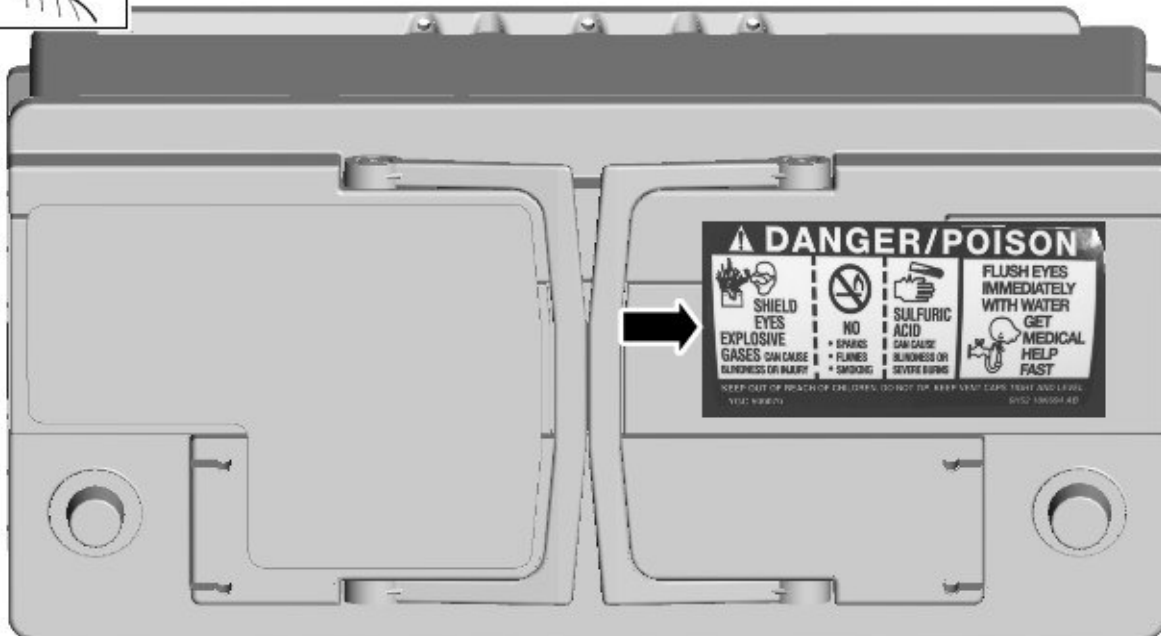
E198776

Situation: An issue has been identified on the one vehicle within the listed Affected Vehicle Range where a replacement battery has been fitted without the required USA legal label.

1. Visually check if the battery warning label is installed as shown.
 - If the battery warning label is installed, release the vehicle.
 - If the battery warning label is not installed, install a new battery warning label as shown.
