Reference	SSM72995
Models	Range Rover / L405 Range Rover Sport / L494
Title	Differential Axle Tube Assembly Noise
Category	Driveline
Last modified	11-Oct-2016 00:00:00
Symptom	597997 Driveline Noise Concerns
Attachments	Halfshaft Journal Finish1.pdf (Halfshaft Journal Finish1.pdf) Needle Roller Bearing - Extension Tube.pdf (Needle Roller Bearing - Extension Tube.pdf)

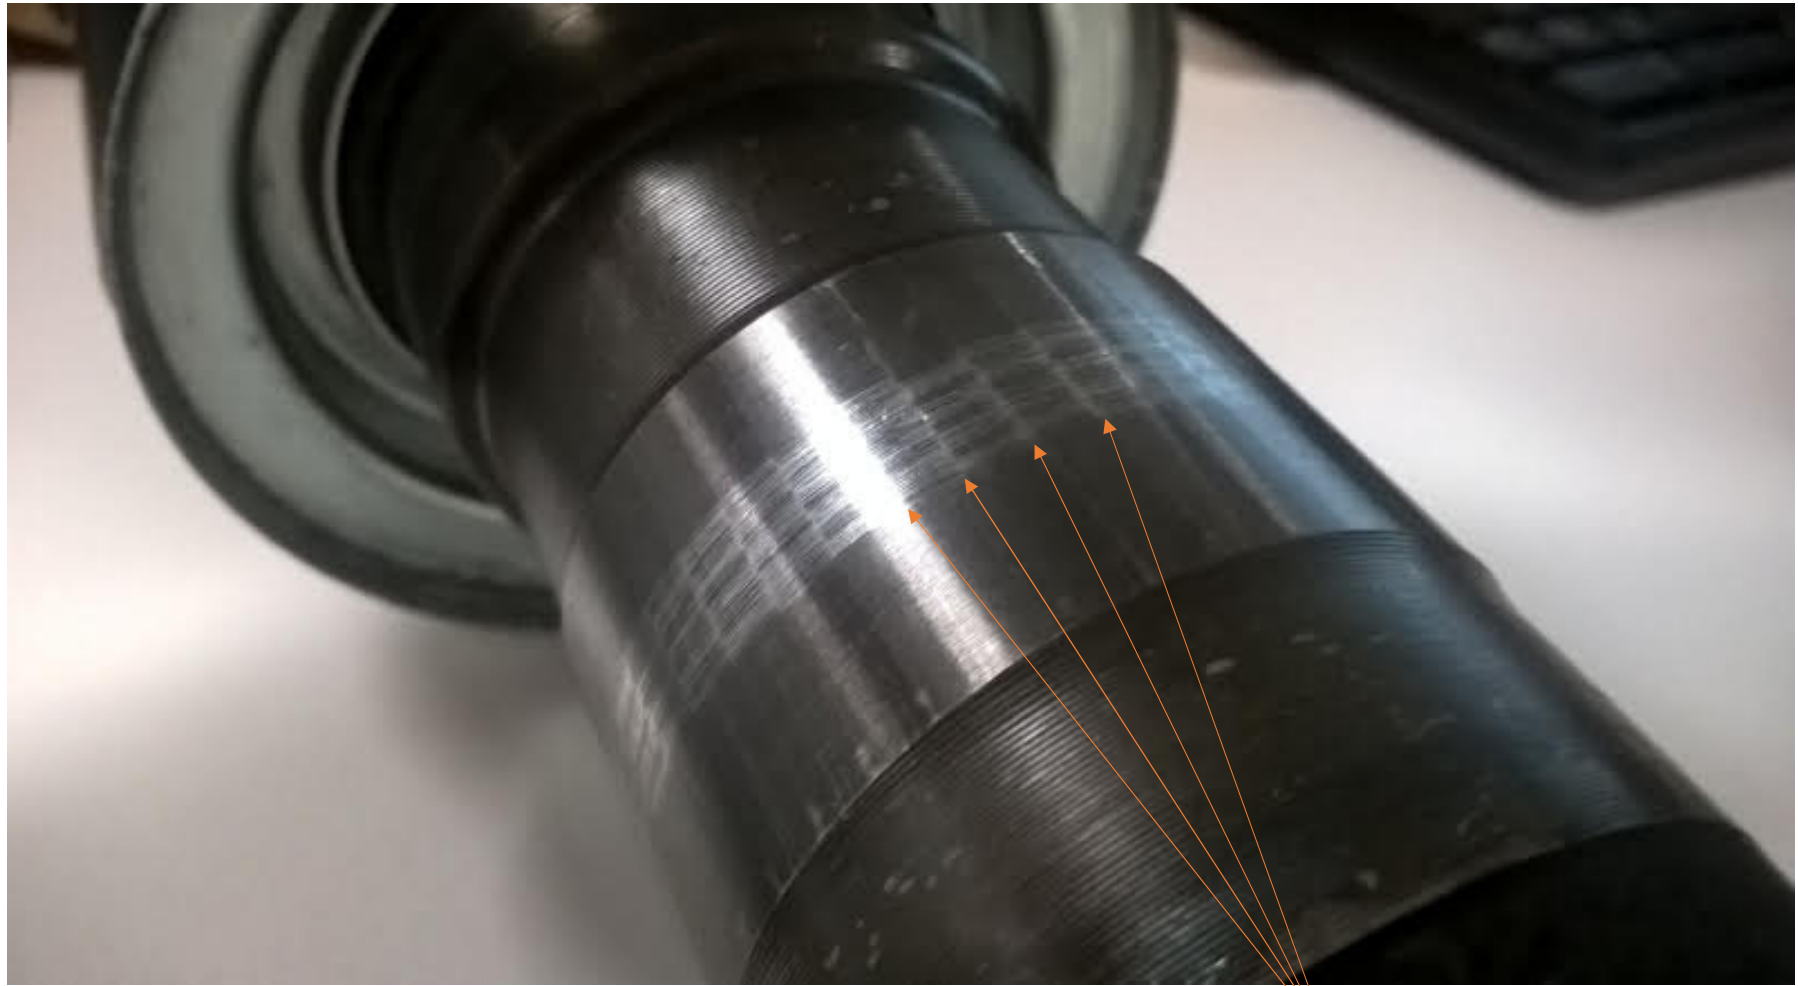
A poor finish of the front right halfshaft journal diameter can produce a vibration and rumbling noise through the vehicle when it rotates directly against the needle rollers in the differential extension tube bearing.

- **If journal diameter shows evidence of facets (refer to attached file), replace the halfshaft.**

Facets

Remove the front right halfshaft to confirm poor finish on journal diameter.

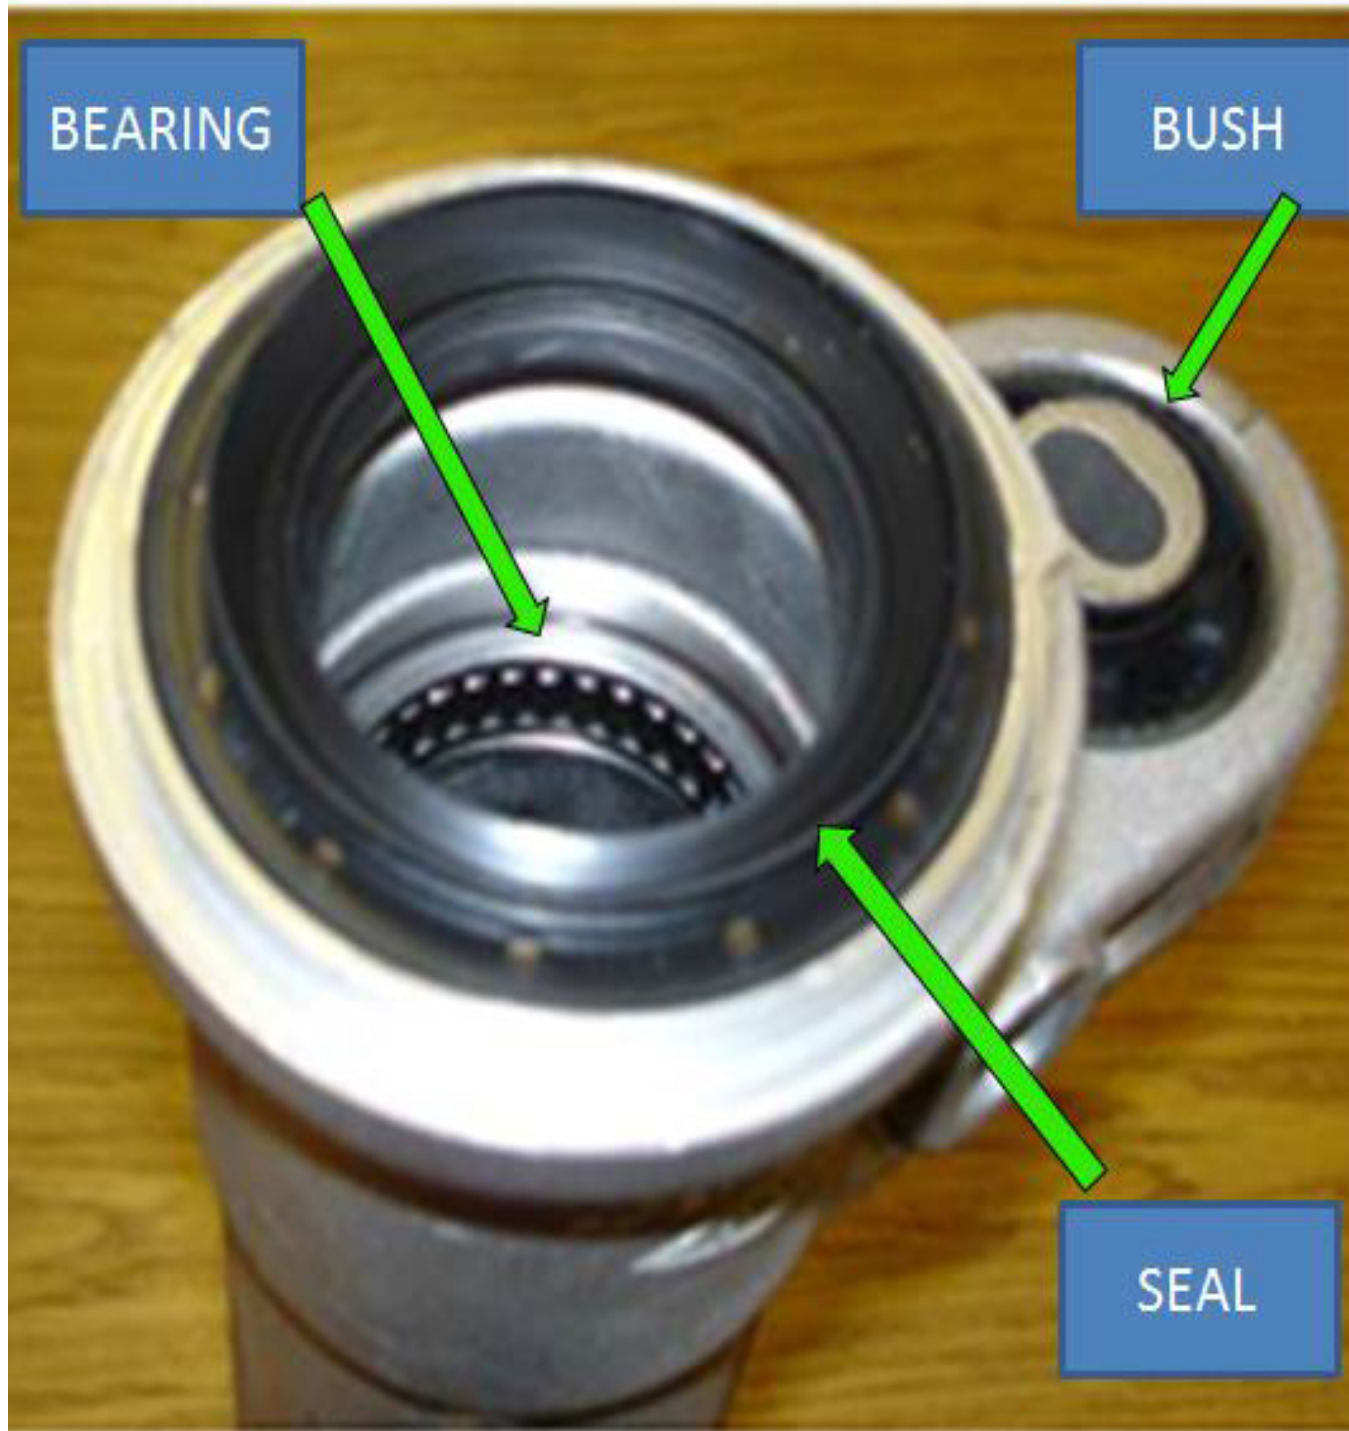
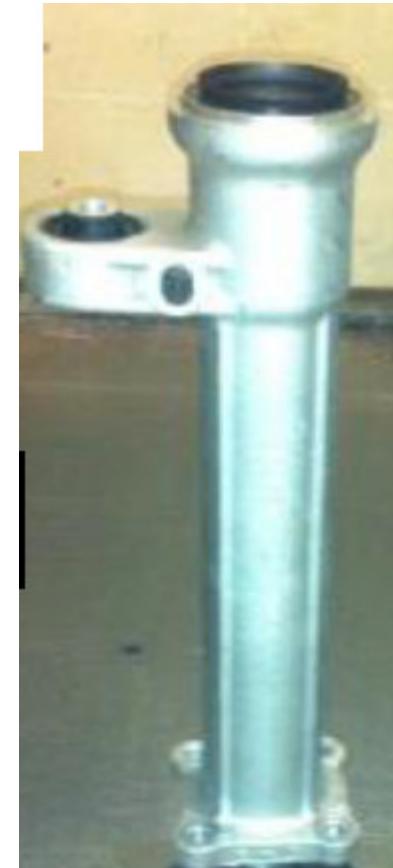
Inspect the needle rollers in the differential extension tube bearing for flat surface (damage).

- **If the bearing rollers are damaged, replace the differential extension tube assembly.**
