Reference	SSM72703
Models	Range Rover Evoque / L538 (149928 \rightarrow 600000)
Title	L538 Range Rover Tailgate Drop
Category	Body
Last modified	17-Oct-2016 00:00:00
Symptom	111000 Body Panel(s)/Unibody
Attachments	11SSM detail.pdf (11SSM detail.pdf)
Content	 <u>Issue:</u> Customer may express concern with the tailgate: Functionality – difficult to open/close. Contact between the tailgate and other panels resulting in paint rub. Damaged tailgate latch cover and/or striker.
	 Symptoms can be similar to: Fig. 1 - Damage to the tailgate latch cover. This is caused by interference with the Striker as shown in Fig. 2.
	 Note: Powered tailgate variants may lose calibration and will require manual intervention. Fig. 3 - Visual differences of the tailgate aperture gaps – the customer will experience styling lines out of alignment. This can be measured to reinforce the customer's concern.
	 Fig. 4 - Visual differences with tailgate flush to body. Fig. 5 - Touch conditions with various areas such as the tailgate touching the rear lamps.

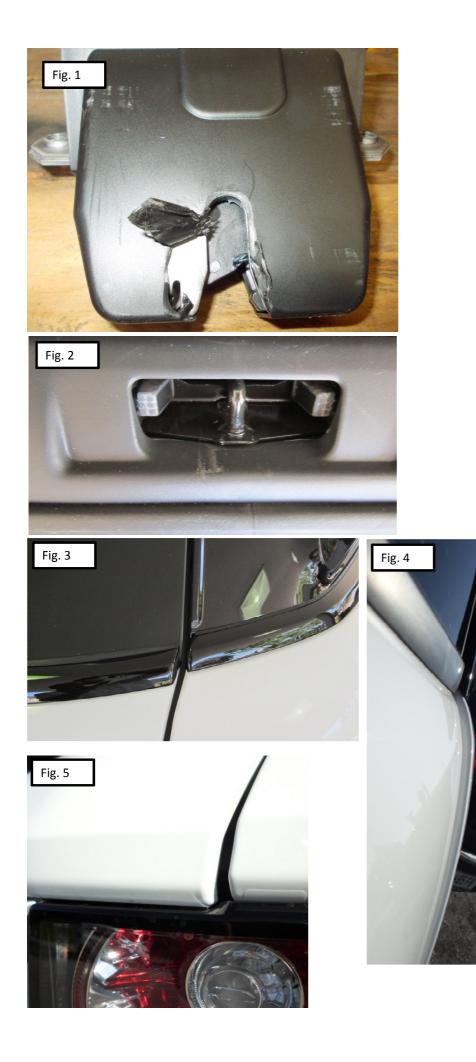
<u>Cause:</u> The tailgate has dropped due to torque relaxation at the tailgate hinge – to – body mounting.
	<u>Action:</u> TOPIx references: • 501-03 Body Closures. • 501-14 Handles, Locks, Latches and Entry Systems.

1. Re-align the tailgate as per TOPIx section above.
	Check the gaps and flush measurements of the tailgate and make sure that the tailgate is central to the aperture. Tailgate latch covers can now be ordered separately to the latch. Service part number is: • LR094065
