Service Bulletin

Bulletin No.: 16-NA-014

Subject: Delayed Engagement After Sitting With Engine Off

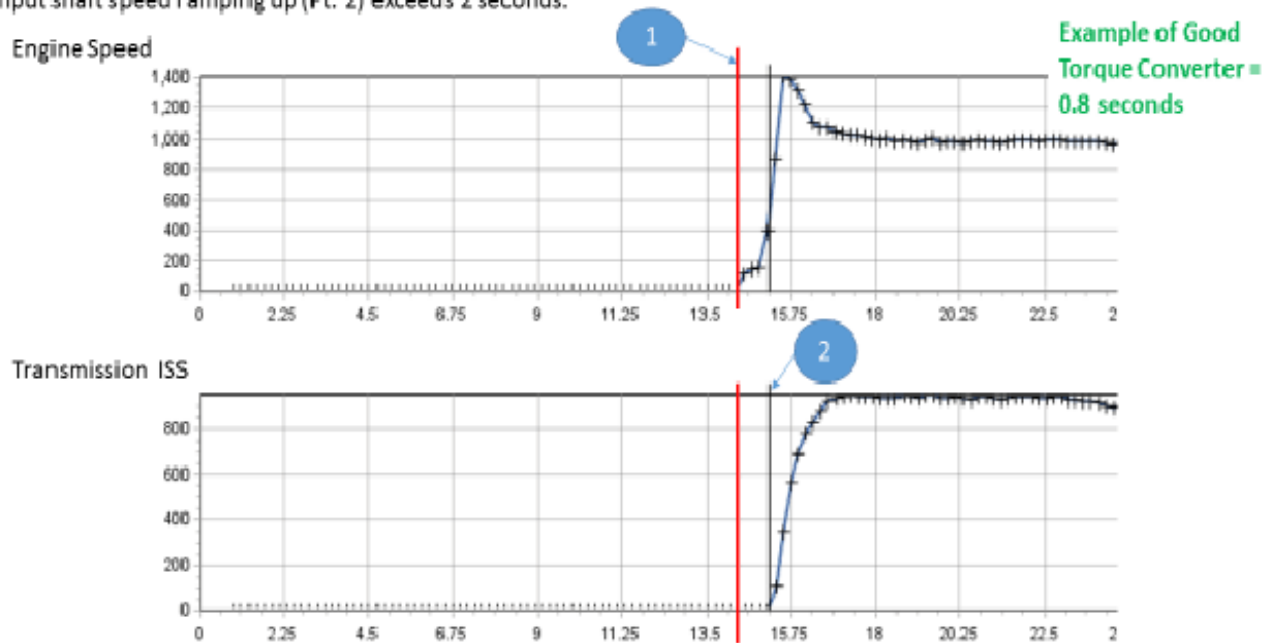
Torque Converter Drain Down is present if the time difference between engine speed ramping up (Pt. 1) and transmission input shaft speed ramping up (Pt. 2) exceeds 2 seconds.

The slide bar on the bottom of GDS 2 screen can be used to aid in discerning time.

Example of acceptable torque converter fill time.

If the customer describes the condition as a long engagement with a slip/soft engagement feel and/or the vehicle not wanting to move, the condition should be considered drain back and the following procedure should be followed.

1. Using GDS and monitor engine RPM and transmission Input Speed Sensor (ISS) prior to starting the engine.
2. Start the engine with the transmission in park.
 - ISS should be equal to engine RPM in 3 seconds or less.
 - If ISS takes more than 3 seconds to equal engine RPM than follow the procedure for replacing the stator shaft support described in the service procedure below.
 - **DO NOT** replace the stator shaft support on vehicles taking 3 seconds or less for turbine shaft speed to equal engine RPM.

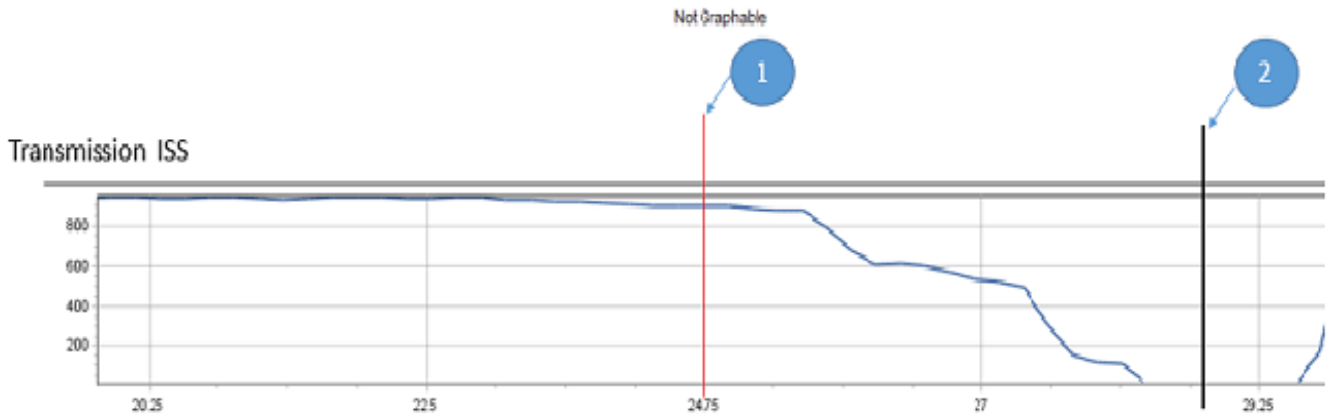
Delayed Engagement into Reverse is present if the time difference between Gear Command (Pt. 1) and transmission input shaft speed reaching 0 rpms (Pt. 2) exceeds 1.5 seconds.

Example of C5 Needing to complete Adaptive Learn and several garage shifts in the temperature range of 20 – 30 deg C. = 3.34 seconds.

Example of C5 clutch needing to complete Adaptive Learn on a 2016 MY vehicle or a C5 Clutch that is slow to learn on 2015 and 2016 fill.

For 2016 MY vehicle attempt to learn the C5 Clutch using the following procedure:

1. Allow the transmission sump temperature to rise between 20 and 30 degrees C (68 and 86 degrees F).

2. Perform 20 Park to Reverse shifts releasing the brake with each shift.

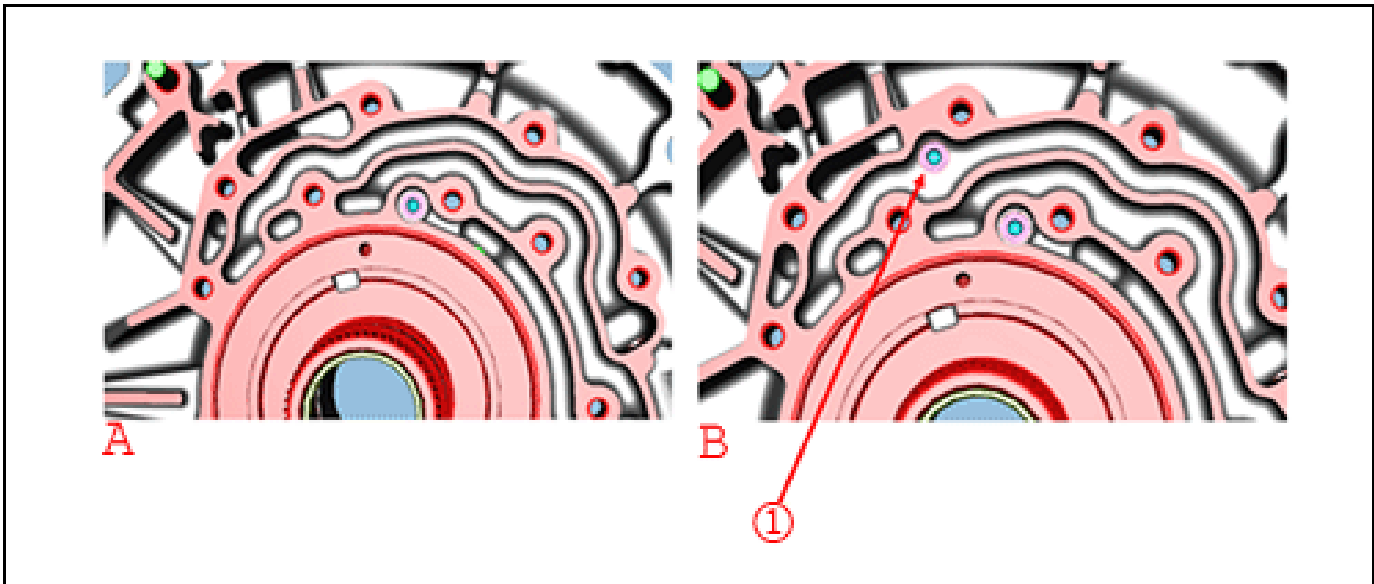
4358775

Note: The new stator shaft support assembly has a second check ball (1) added (see illustrations).

Install a new stator shaft support assembly that includes an additional check ball. Follow the instructions below to replace the stator shaft support assembly.
