Reference	SSM72957
Models	Range Rover / L405 Range Rover Sport / L494
Title	L405 & L494 Fuel Filling Difficult Gasoline Models Only
Category	Engine
Last modified	12-Sep-2016 00:00:00
Symptom	404000 Fuel System Concerns
Attachments	Example of vapour line restriction1.jpg (Example of vapour line restriction1.jpg) L405 & L494 fuel fill.pdf (L405 & L494 fuel fill.pdf) L405 & L494 fuel tank check valve2.pdf (L405 & L494 fuel tank check valve2.pdf)
Content	<p><u>Issue:</u></p> <p>The customer may complain of fuel filling difficulties (gas station pump premature cut off).</p> <p><u>Cause:</u></p> <p>There are a number of possible causes for fuel filling difficulties.</p> <p>Please refer to TOPIx workshop manual section '303-13: Evaporative Emissions, Diagnosis and Testing' in the first instance for advice on system checks. An example of the type of restriction which may be found in the vapour line between the fuel tank and the carbon canister is shown on the file attached "Example of vapour line restriction.jpg".</p> <p>Other Possible Causes:</p> <ol style="list-style-type: none"> 1. Debris may be lodged in the fuel filler. See page 2 of 'L405 & L494 fuel fill information.pdf' for further

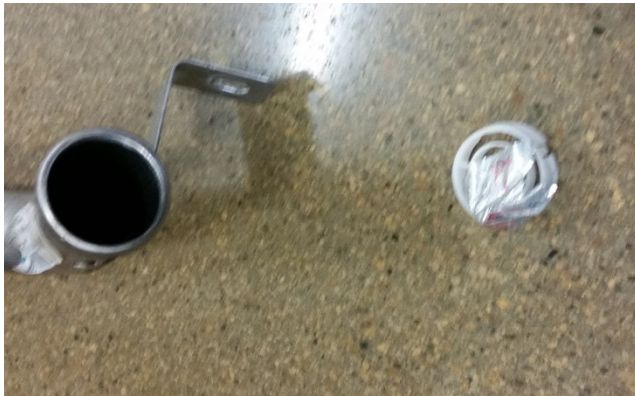
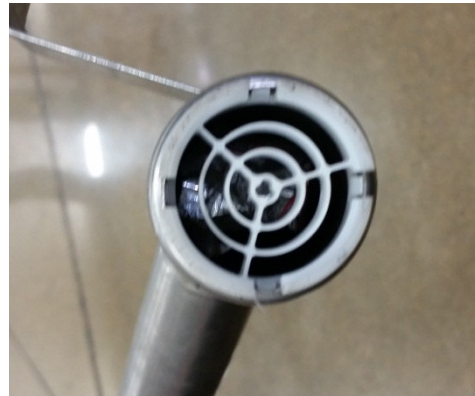
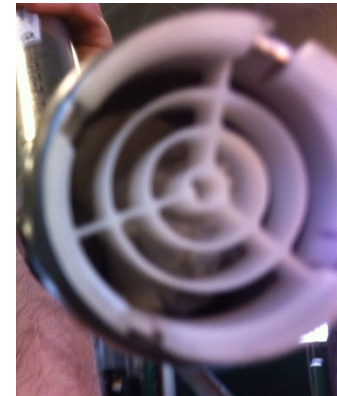
Reports have been submitted showing debris in the filler pipe was causing an obstruction and fuel filling problems.

Debris can be identified using a borescope (no need to remove the fuel filler pipe).

See the examples below:

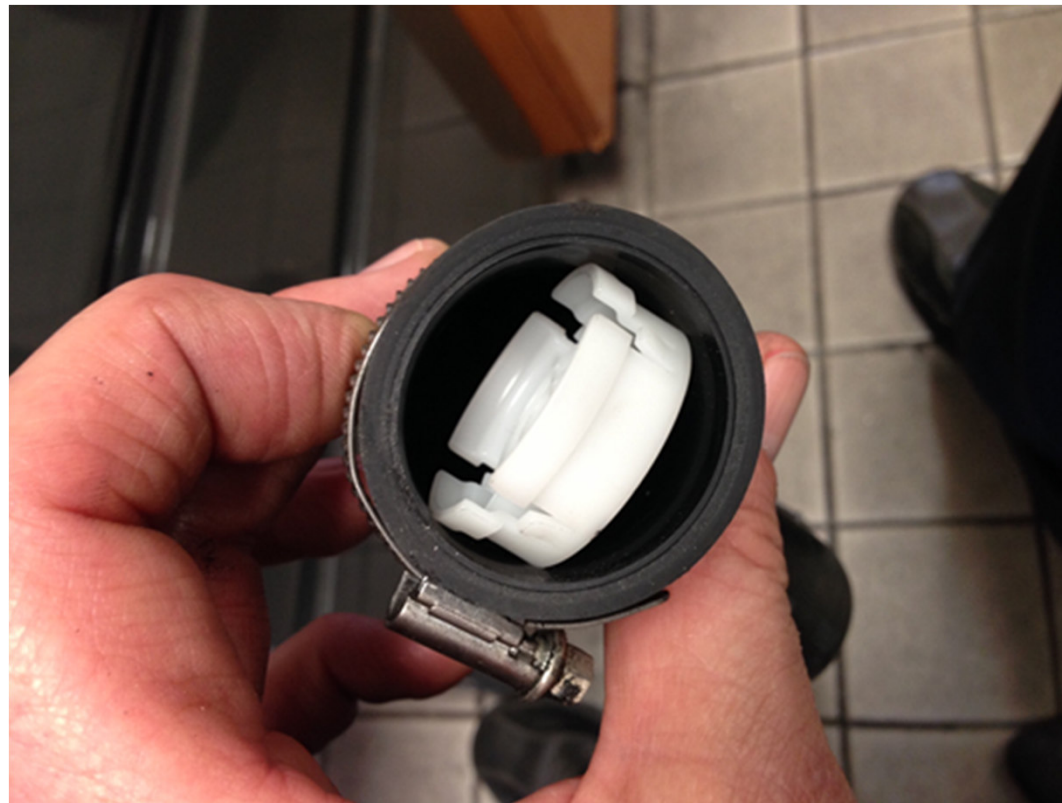
If the anti syphon device is dislodged it will cause the fuel flow to be disrupted and can cause shut off problems (as per the example below):

- ONLY REPLACE THE FUEL FILLER IF A CLEAR FAULT IS OBSERVED. REPORT THE FAULT FOUND ON AN EPQR.
- If cause 1 is identified, correctly install the anti-siphon device.
- If cause 2 is identified, replace the fuel filler pipe (ensure the filler head is in the correct orientation on the new part).
- If cause 3 is identified, reroute the fuel pipe in the tank to prevent the check valve from being obstructed. Also take care to ensure the fuel sender is not obstructed.
- Fill with fuel and to confirm if the issue is repaired.

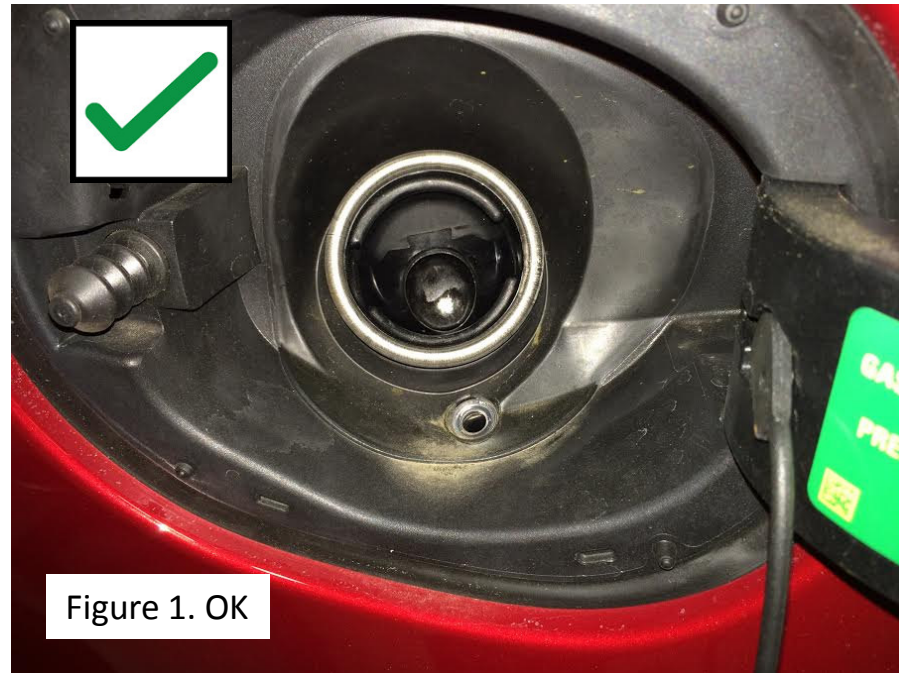
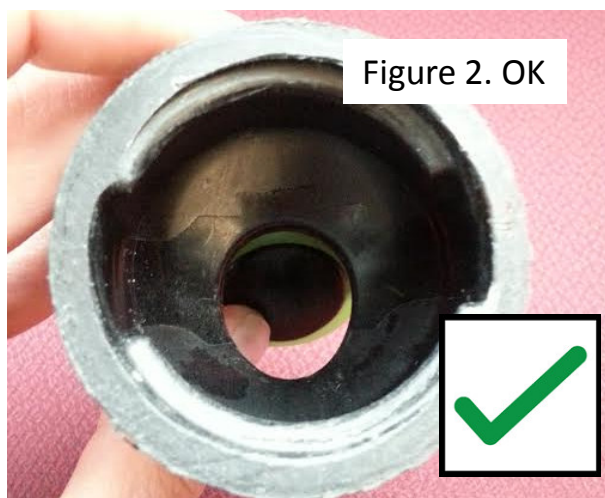
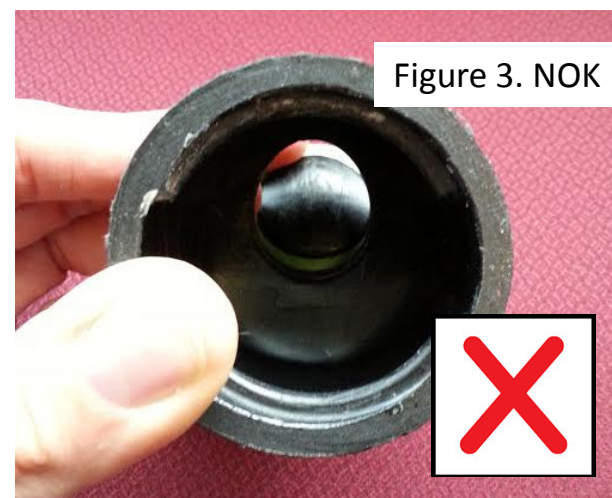
1. Flap should appear as per figure 1 and 2.
2. It must hinge from the top as per figure 2.
3. If it hinges from the bottom (as per figure 3.), the filler pipe must be replaced.

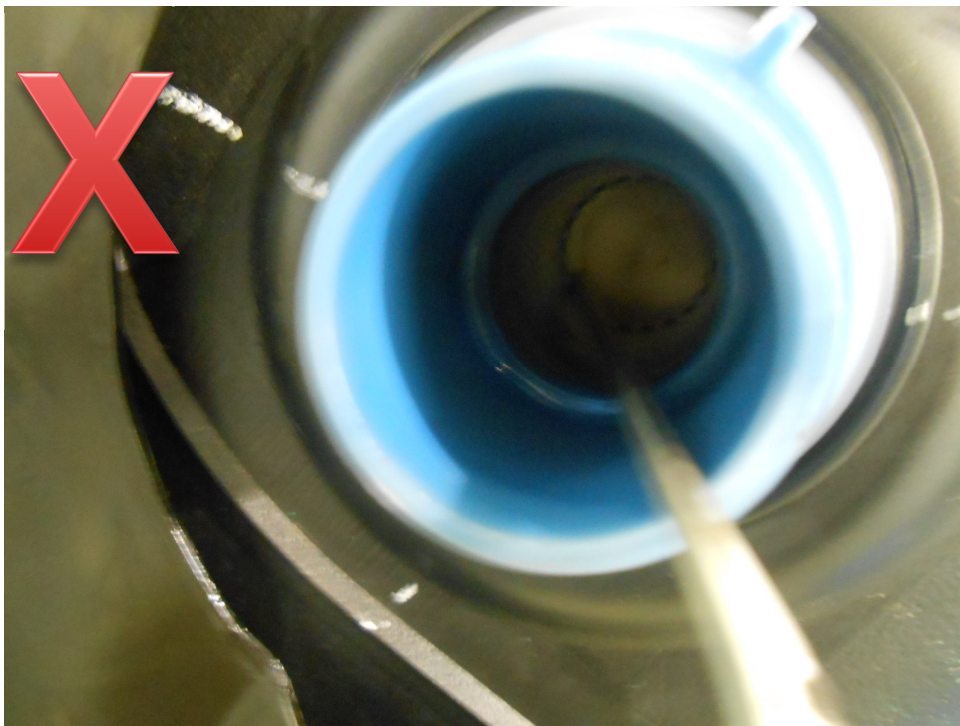
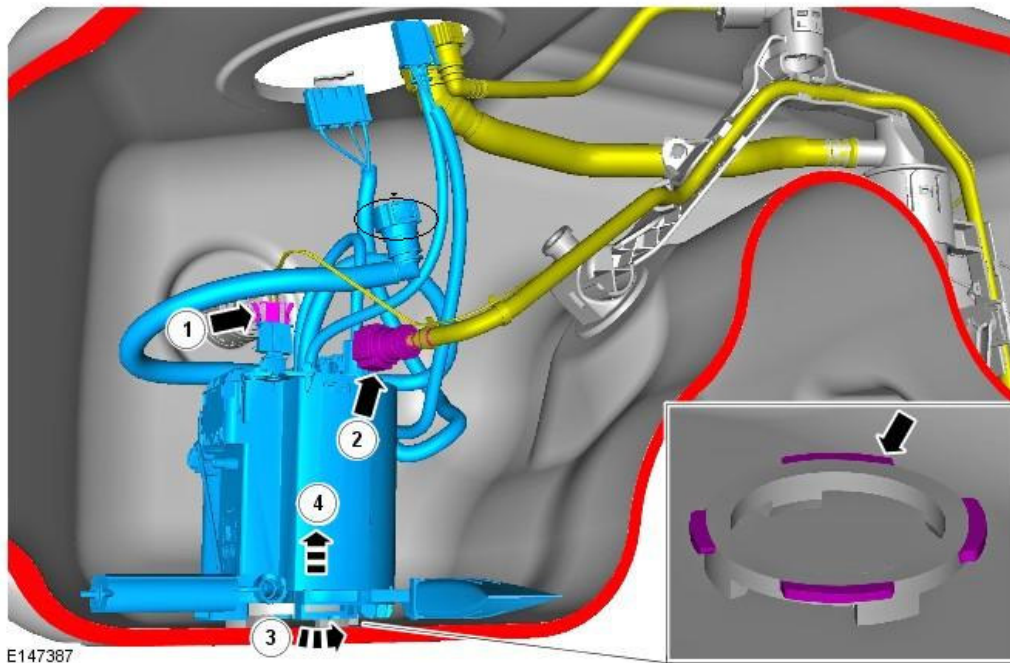
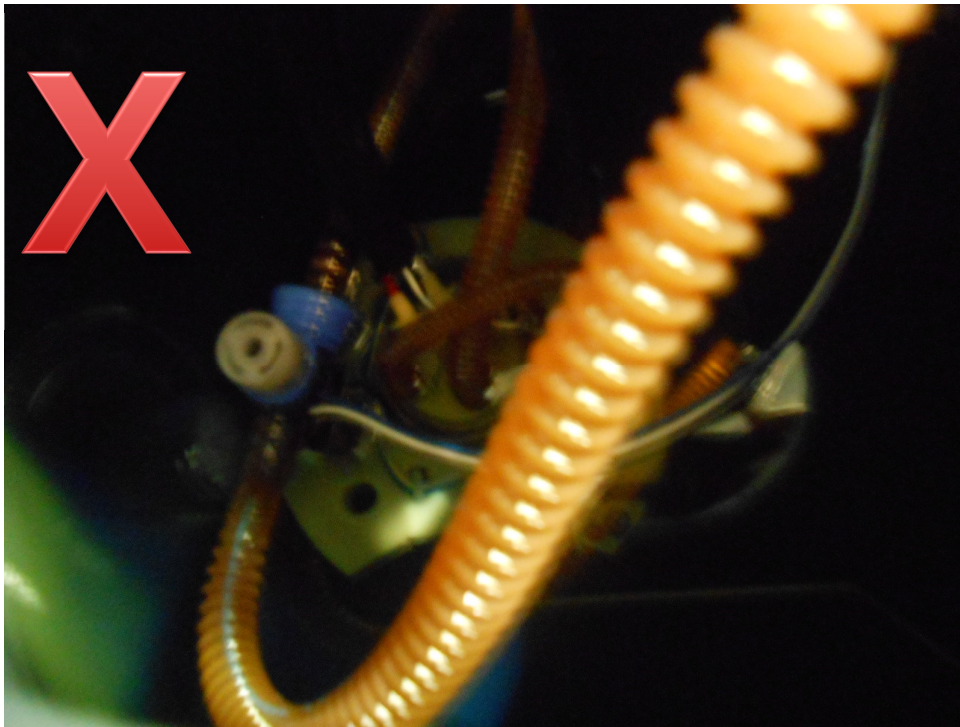
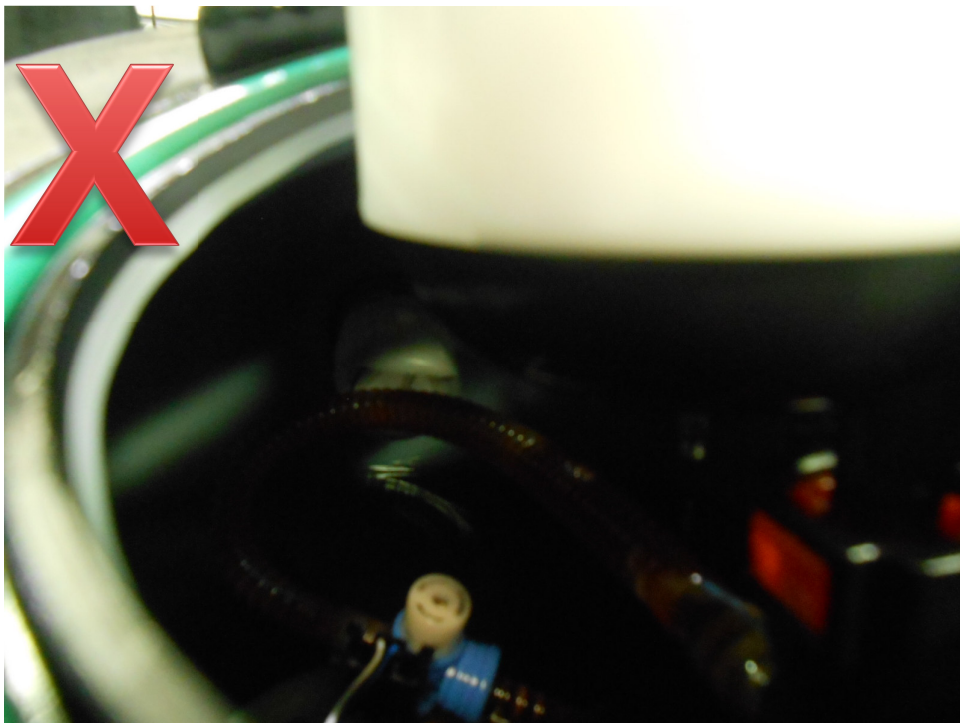
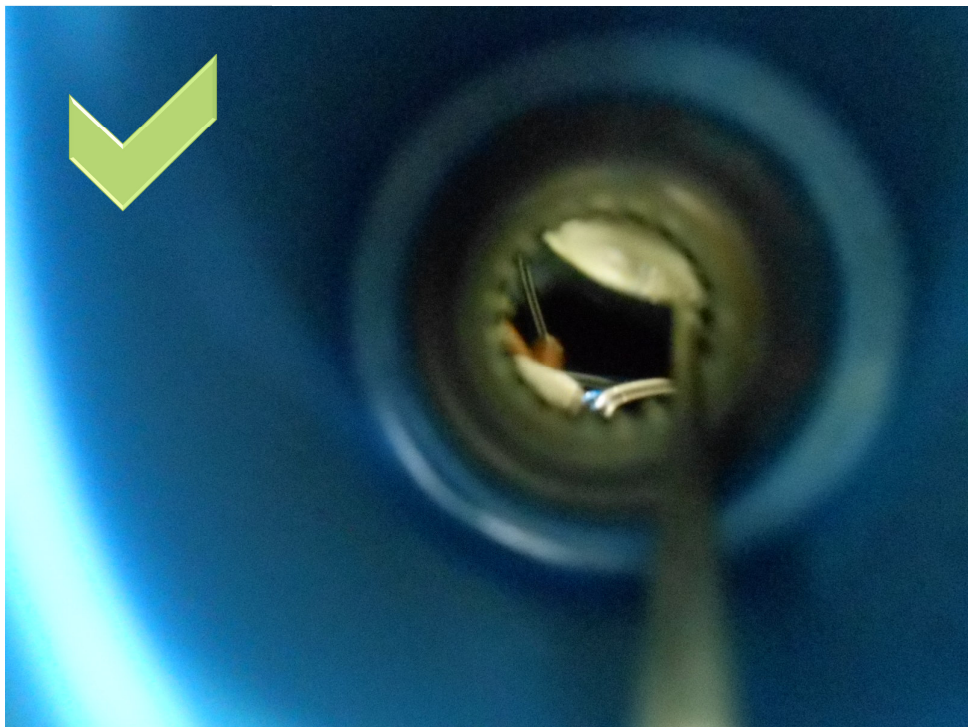
2. Press against the check valve. It should move easily through it's full range.
3. If it does not, refer to 'Removal and Installation' instructions for the fuel filter in workshop manual section 310-01: Fuel Tank and Lines
4. Do not remove the fuel filter, but carefully lift it and visually inspect for any obstruction of the check valve.
5. If obstruction is observed, reroute the fuel pipe in the tank to prevent the check valve from being obstructed. Also take care to ensure the fuel sender is not obstructed.

1. With the fuel tank as close to empty as possible, remove the rubber section of filler pipe from the fuel tank to gain access to the check valve.
