Denali 2.0 Leveling

GROUND CONTROL® 2.0 LANDING GEAR REPAIR PROCEDURE

SF-066

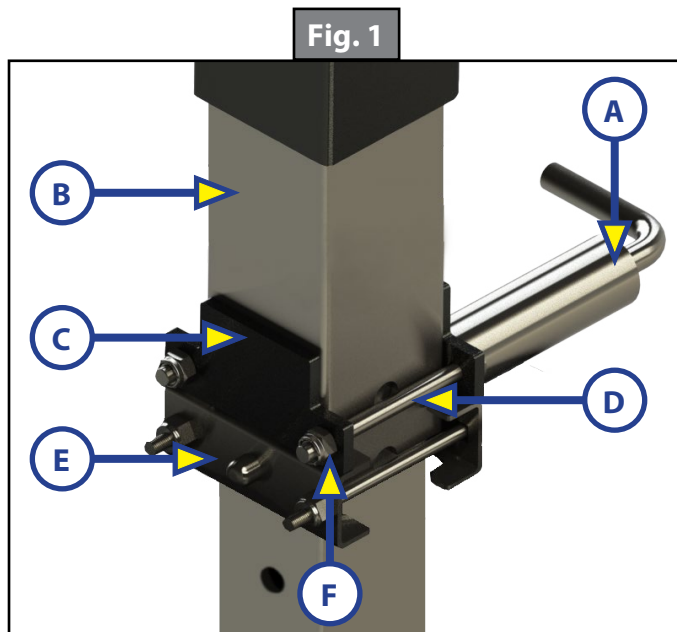
Lippert Components, Inc. has discovered a conflict occurring between the Ground Control® 2.0 Landing Gear and some Dutchmen 5th wheels. When the "Auto Retract" sequence is initiated, the outer legs of the landing gear retract too far up into the chassis and the pull pins collide with the frame. As a result, the pull pins of the landing gear are bending. To remedy this situation, LCI has created a service kit (Part Number - 656030) that can easily be installed by any dealer or potential end user.

1. Locate the pull pin (Fig. 1A) at the bottom of the outer leg (Fig. 1B) of the landing gear.
2. Place the provided 3 1/4" x 1 1/2" x .1790 plates (Fig. 1C) flush with the top edge of the existing brackets (Fig. 1E) of the pull pin: one plate on each side of the outer leg (Fig. 1B).

3. Insert the provided 1/4" - 20 x 3 hex cap bolt (Fig. 1D) through the holes on the plates and thread with the provided 1/4" - 20 nylock nuts (Fig. 1F).
4. Using a 7/16" wrench, hold the bolt (Fig. 1D) in place while using a 7/16" socket with ratchet to tighten the nut (Fig. 1F).
5. Repeat Steps 1-4 on the other landing gear leg.
