**SERVICE ADVISORY # 16-256**

Voltage Epic Series Quiet Cool

Keystone RV Company has determined that certain air conditioners installed in the main living area may not have been installed over the opening correctly resulting in a possible roof leak. This advisory explains the process to properly diagnose and remedy this concern.

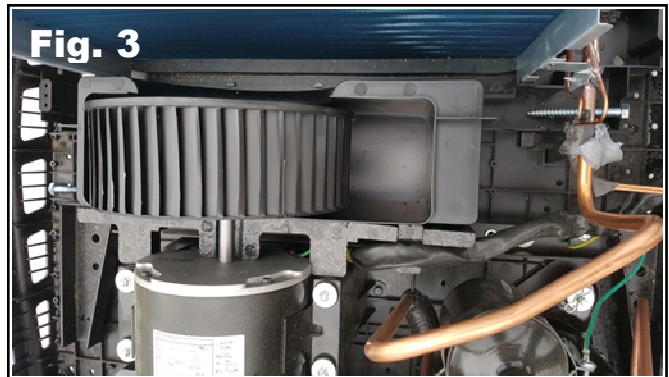
- A. Locate the interior fan and reach into the duct to the rear of the A/C. See Fig. 3.
- B. Feel the rear gasket and determine if it is sealing against the roof membrane. You may feel a gap between the 1 ½” gasket and the roof opening, feel the entire length of the gasket from door side to off door side, and front to back.
- C. If there is not a gap proceed to step 8.
- D. If there is a gap proceed to step 4.

**Step 3.** Inspect the gasket seal.
