TECHNICAL BULLETIN

LTB00977NAS1

Rear Door Interior Trim Panel Loose

Range Rover Evoque (LV)

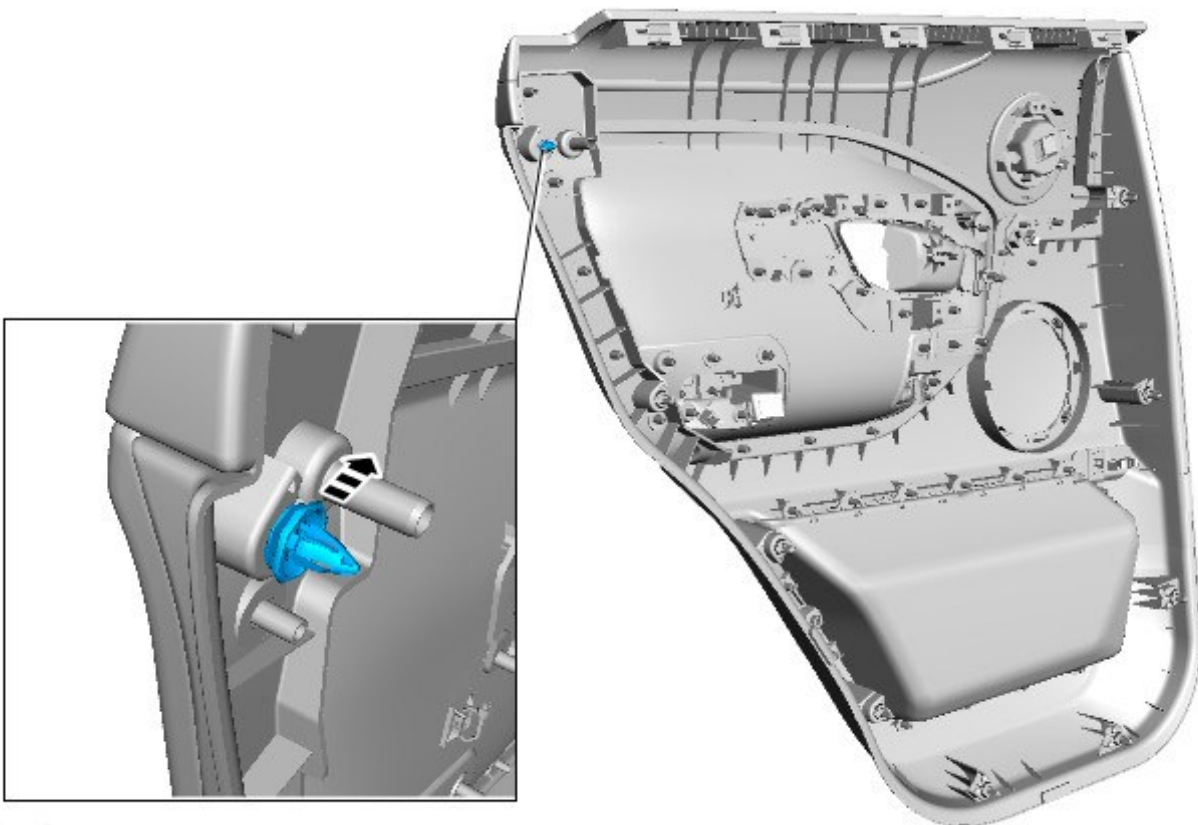
E194143

**NOTE:** Rear right door trim panel shown; rear left similar.

Remove and discard the indicated interior door trim clip.

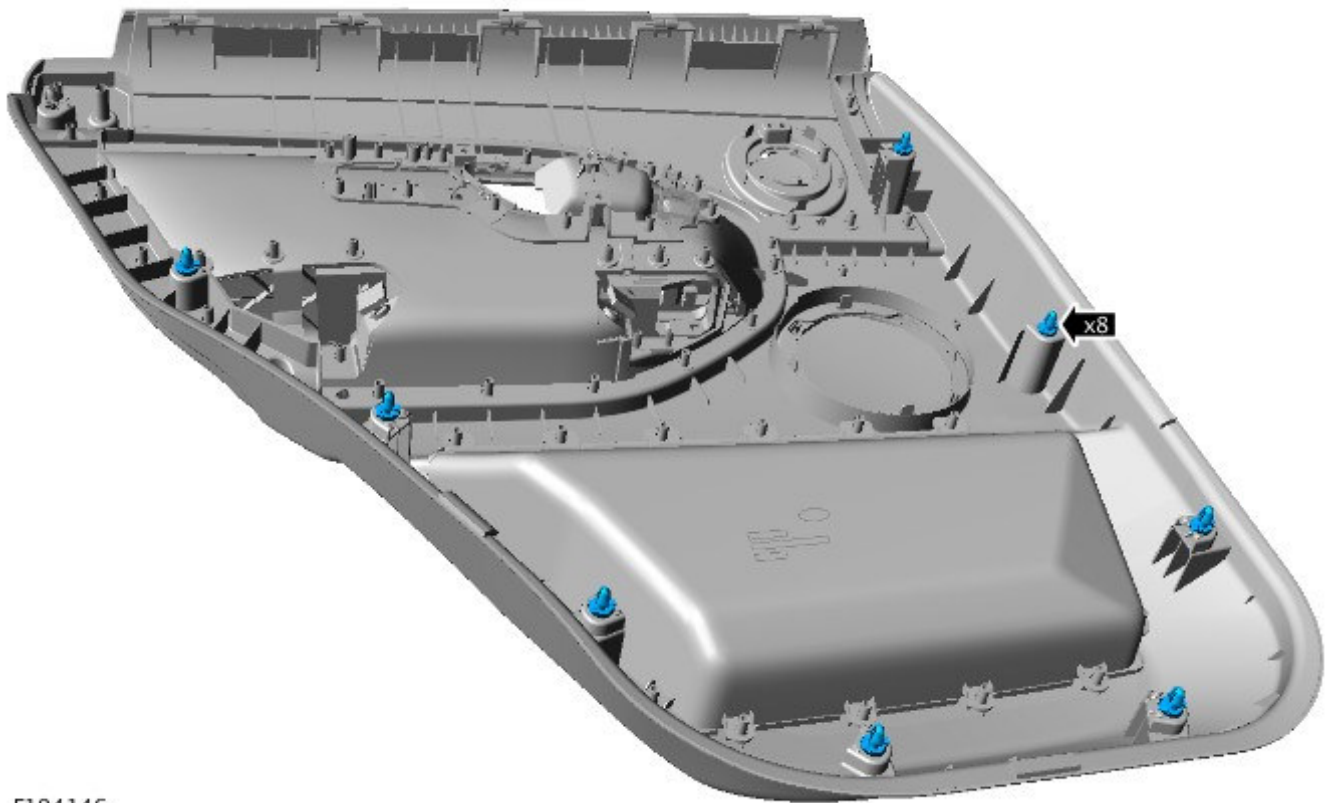
E194146

**NOTE: Rear right door trim panel shown; rear left similar.**

Inspect the other eight interior door trim clips.

- Replace clips as necessary.
