TECHNICAL BULLETIN JTB00500NAS1 21 JUN 2016

'Click' Noise From Front Right Seat Cushion

XJ Range (X351)

Model Year: 2016 Onwards
VIN: V90866 Onwards
Assembly Plant: Castle Bromwich

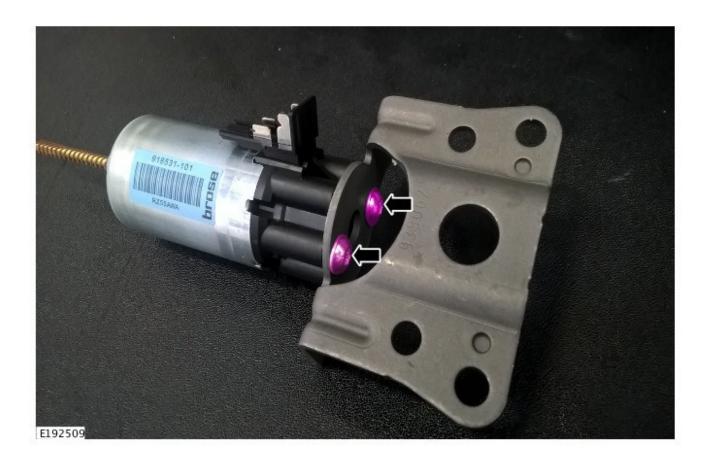
- 1. Remove the front right seat track motor (see TOPIx Workshop Manual section 501-10: Seating).
- 2. Remove the seat track motor from the seat track motor bracket.

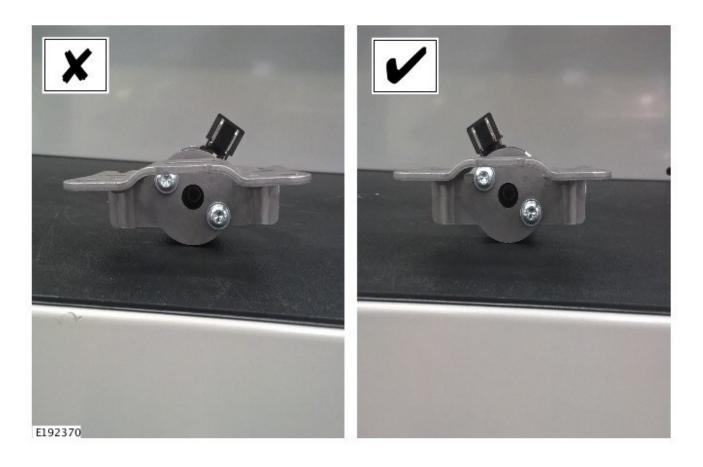
3. \bigcirc NOTE: The orientation of the front seat track motor to the bracket must be installed as shown (\checkmark).

Install the seat track motor to the seat track motor bracket as shown (${\mbox{\ensuremath{\checkmark}}}\xspace).$

• Torque: 1.7Nm +/- 0.2Nm
