TECHNICAL BULLETIN
K407 UPS4816-2bNAS1
27 JUN 2016

Update Prior to Sale: AWD V6 Petrol S/C Cross Brace Foul

XE (X760)

Model Year: 2017
VIN: 916794-952900
Assembly Plant: Solihull

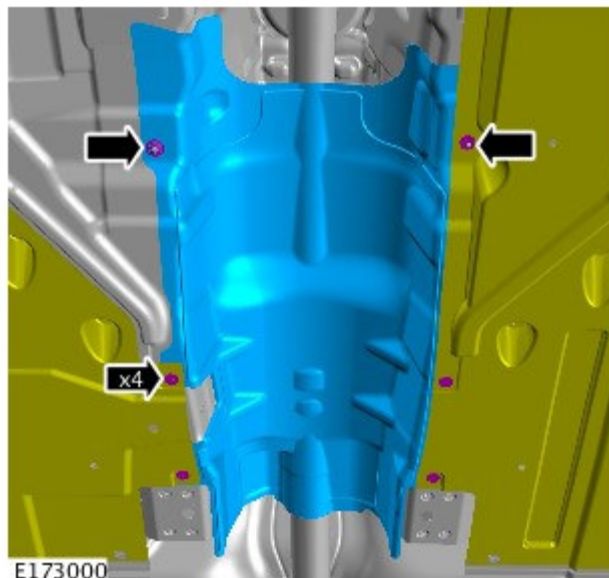
1. Remove the exhaust system for access (see TOPIx Workshop Manual section 309-00C: Exhaust System).
2. Remove the heat shield.

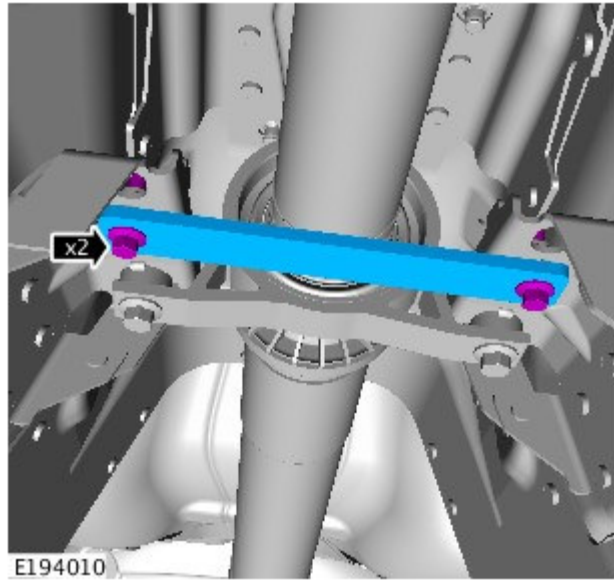
Situation: An issue has been identified on a limited number of vehicles within the listed Affected Vehicle Range where a support cross brace has been fitted to the All Wheel Drive variants when it was intended for Rear Wheel Drive only. Under specific circumstances the driveshaft may foul the cross brace, causing an audible noise that may be heard by the driver.

3. Remove the cross brace and fixings.

4. Inspect the driveshaft for signs of damage in the area the cross brace was installed.

- If the driveshaft has signs of damage, mark the removed cross brace and fixings with the Vehicle Identification Number (VIN) and keep in a secure place as this will be needed at a later date. **Hold the vehicle.**
- If the driveshaft has no signs of damage, discard the cross brace and fixings.
 - Continue to Step 5.

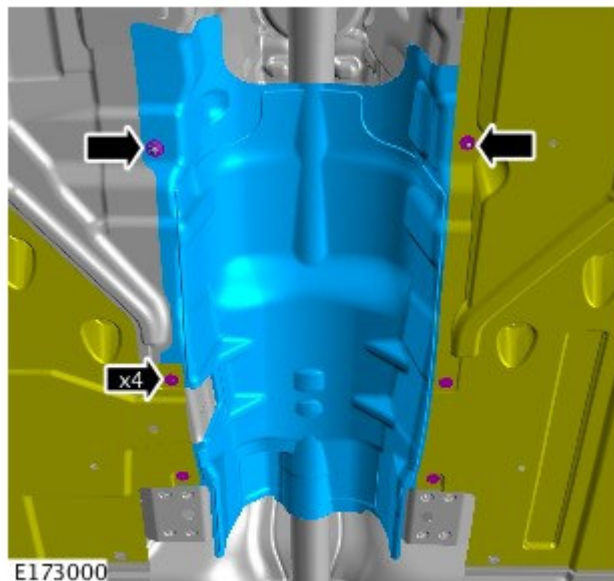
5. Install the heat shield.

- Torque: 9 Nm
