## **SERVICE ADVISORY # 16-256**

### Voltage Epic Series Quiet Cool

Keystone RV Company has determined that certain air conditioners may not have been installed over the opening correctly resulting in a possible roof leak. This advisory explains the process to properly diagnose and remedy this concern.

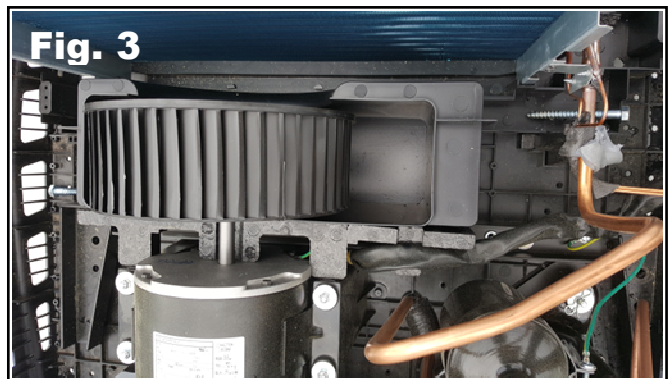
- A. Locate the interior fan and reach into the duct to the rear of the A/C. See Fig. 3.
- B. Feel the rear gasket and determine if it is sealing against the roof membrane. You may feel a gap between the 1 ½" gasket and the roof opening, feel the entire length of the gasket from door side to off door side, and front to back.
- C. If there is not a gap proceed to step 8.
- D. If there is a gap proceed to step 4.
