December 6, 2016

05398 Version 3

## Safety Recall: TSX Rear Wire Harness

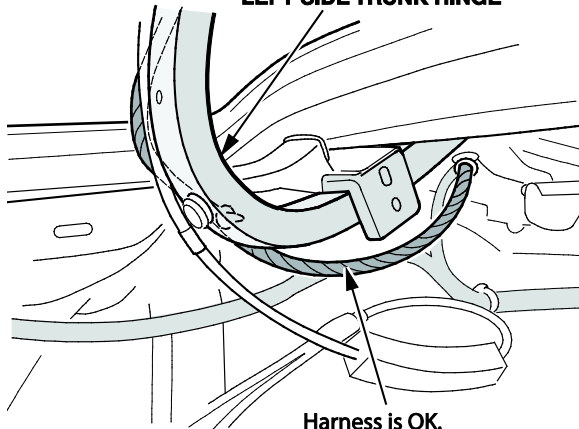
**GOOD**

Harness is OK.  
Install plastic tube and tape.

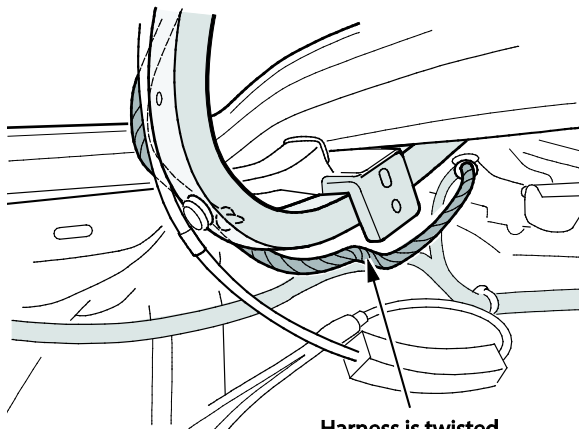
**NO GOOD**

Harness is twisted  
and must be replaced.
