# Service Bulletin

16-020

## **Product Update: Monroney Label (Hawaii Only)**

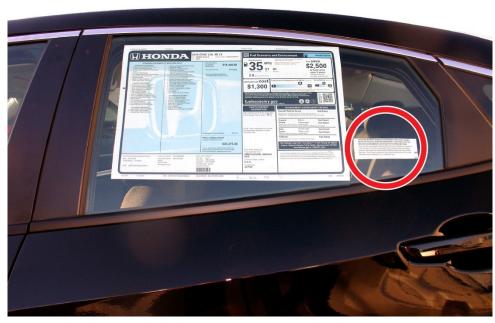
On the Monroney label, the bumper compliance statement is missing.

Make sure the inside window area is clean, dry, and at room temperature. Attach the Monroney update label in the position shown.

NOTE: If necessary, bring the vehicle inside to warm up to room temperature; otherwise the label may not stick to the glass.
