**November 3, 2016**

05097 Version 2

**Creak From the B-pillar**

(Supersedes 16-035, Dated July 23, 2016, to revise the information highlighted in yellow)

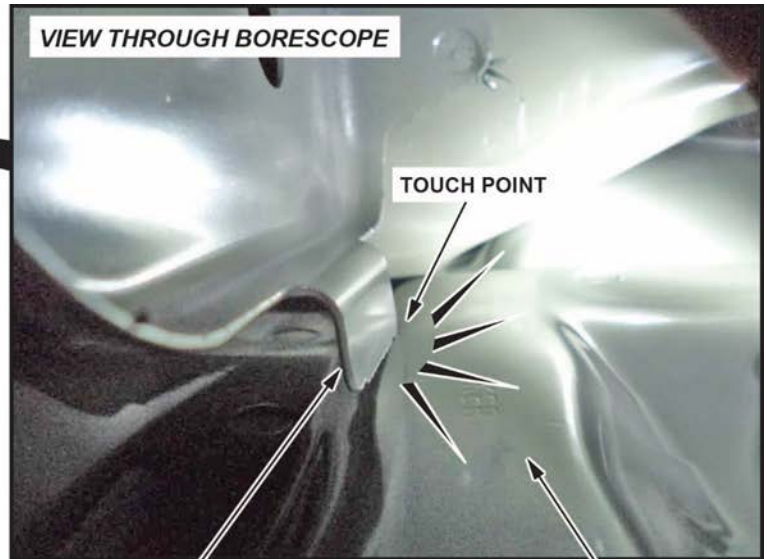
3. Use a borescope to look straight up into the hole.
  - If the bulkhead tab is touching the outer side panel, go to **REPAIR PROCEDURE A.**
  - If the bulkhead tab is not touching the outer side panel, go to **REPAIR PROCEDURE B.**

BULKHEAD TAB

OUTER SIDE PANEL

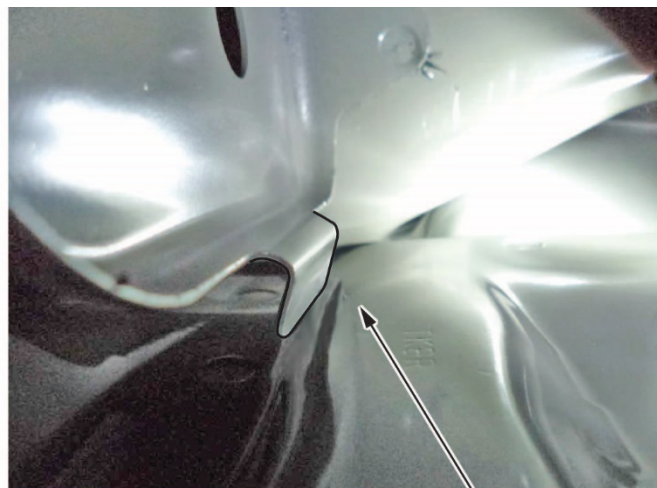
The tab is no longer touching.

2. After bending the bulkhead tab, test-drive the vehicle to confirm the noise has been eliminated.
  - If the noise is gone, no further action is needed.
  - If the noise is still present, go to **REPAIR PROCEDURE B**.

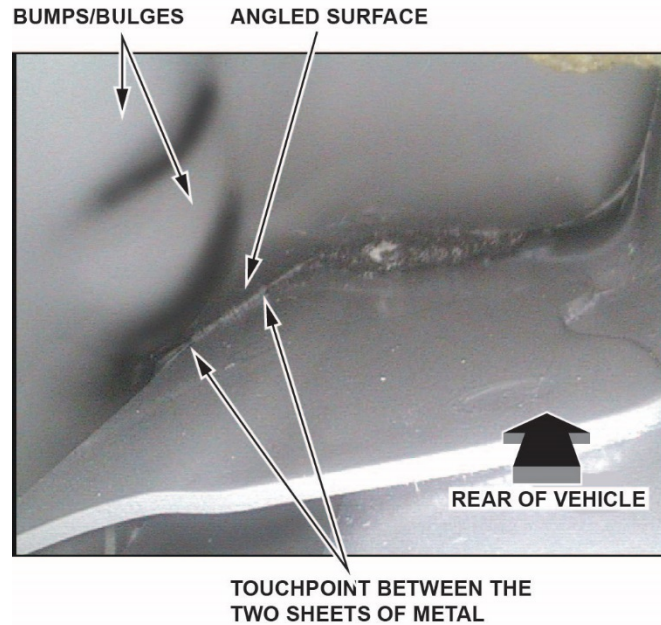
***BORESCOPE VIEW INSIDE THE  
DRIVER'S SIDE B-PILLAR***

The sheet metal has a touch point deep within the base of the B-pillar.

12. Position the camera to inspect the specified location to confirm the touch point area.
