<b>Subject:</b> WHITE MILKY STAINS ON INNER SURFACE OF HEADLIGHT LENS	<b>Bulletin No:</b> 09-014/16
	<b>Last Issued:</b> 03/14/2016

2013-2016 CX-5 vehicles with VINs between JM3KE\*\*\*\*\*486578 - 745219 (produced between May 28, 2014 and Nov. 23, 2015)

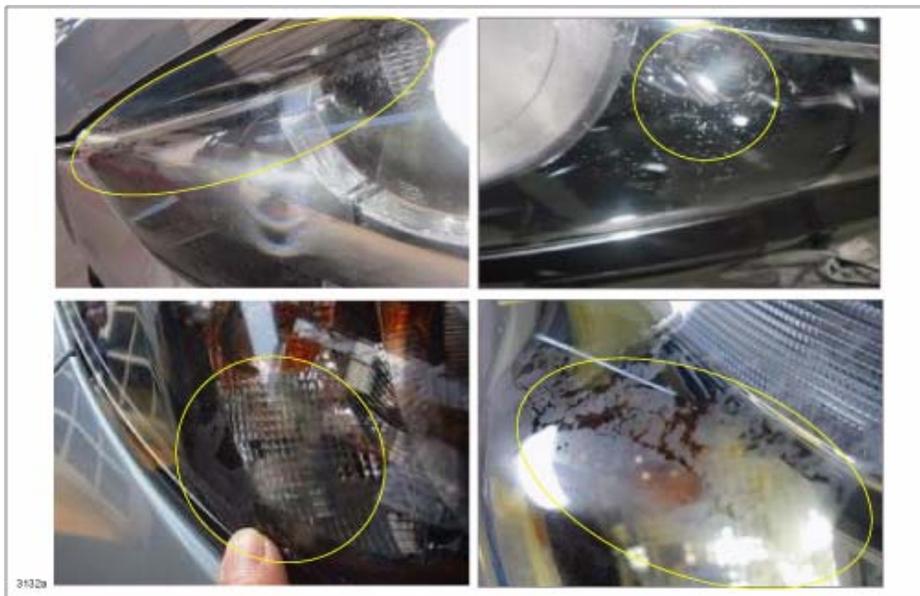
Some vehicles equipped with LED or Discharge type headlights may exhibit white milky stains on the inner surface of the headlight lens. Some customers may complain of the poor appearance.

This concern is caused by gas that emits from a gasket in the lamp unit. The gas adheres to the inner surface of the headlight lens and reacts with the anti-clouding coating and moisture in the air to create white milky stains.

The gasket material has been improved to eliminate this concern.

2. Replace the affected head lamp unit(s) with modified parts according to the instructions on MS3 online or the Workshop Manual (section 09-18 FRONT COMBINATION LIGHT REMOVAL/INSTALLATION).
