<b>Subject:</b> <b>CONVERTIBLE TOP INNER CLOTH FALLING DOWN CAUSING POOR APPEARANCE AND OBSTRUCTING VIEW OF BACK WINDOW</b>	<b>Bulletin No:</b> 09-021/16
	<b>Last Issued:</b> 03/31/2016

2016 MX-5 vehicles with VINs lower than JM1ND\*\*\*\*\*110159 (produced before January 19, 2016)

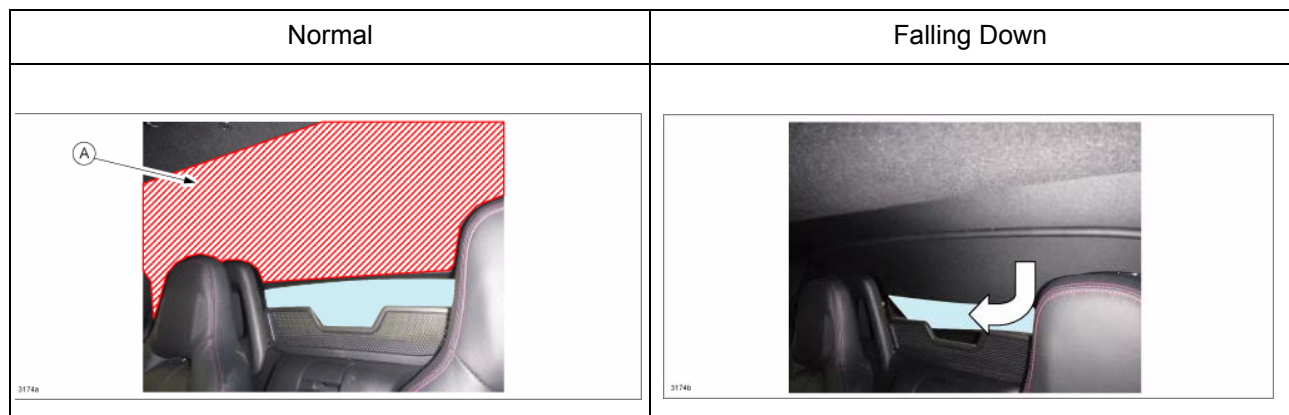
Some vehicles may exhibit the inner cloth (A) falling down at the rear end causing a poor appearance and obstructing the view of the back window.

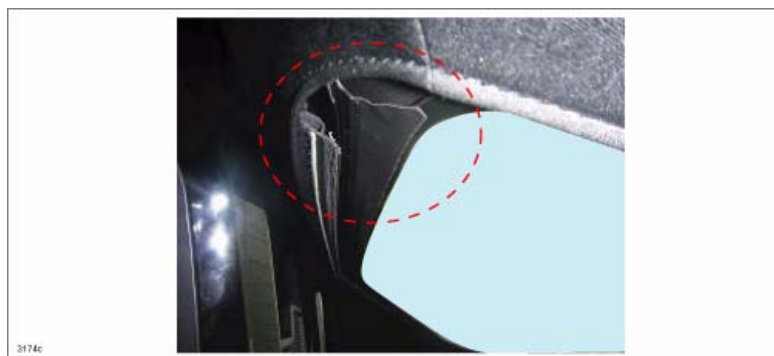
This is caused by the J-hook binding holding the inner cloth coming loose during the opening/closing of the convertible top, from vibration during driving or from high ambient temperatures.

To correct the problem, two top-protector clips have been additionally installed to both side edges of the J-hook to prevent the J-hook from loosening and separating.
